Document Title:	HCC Petone Wharf – Approach Structure – Pile Condition Survey & Reporting
Document No.:	UCL – 2021.01 – HCC Wharf Approach PCS&R001 – V2
	Prepared for: Tom Arthur – Calibre Group Janet Lawson – Hutt City Council Francis O’Riley – G.K. Shaw Ltd.

Petone Wharf – Approach Structure

Pile Condition Survey & Reporting

January 2021

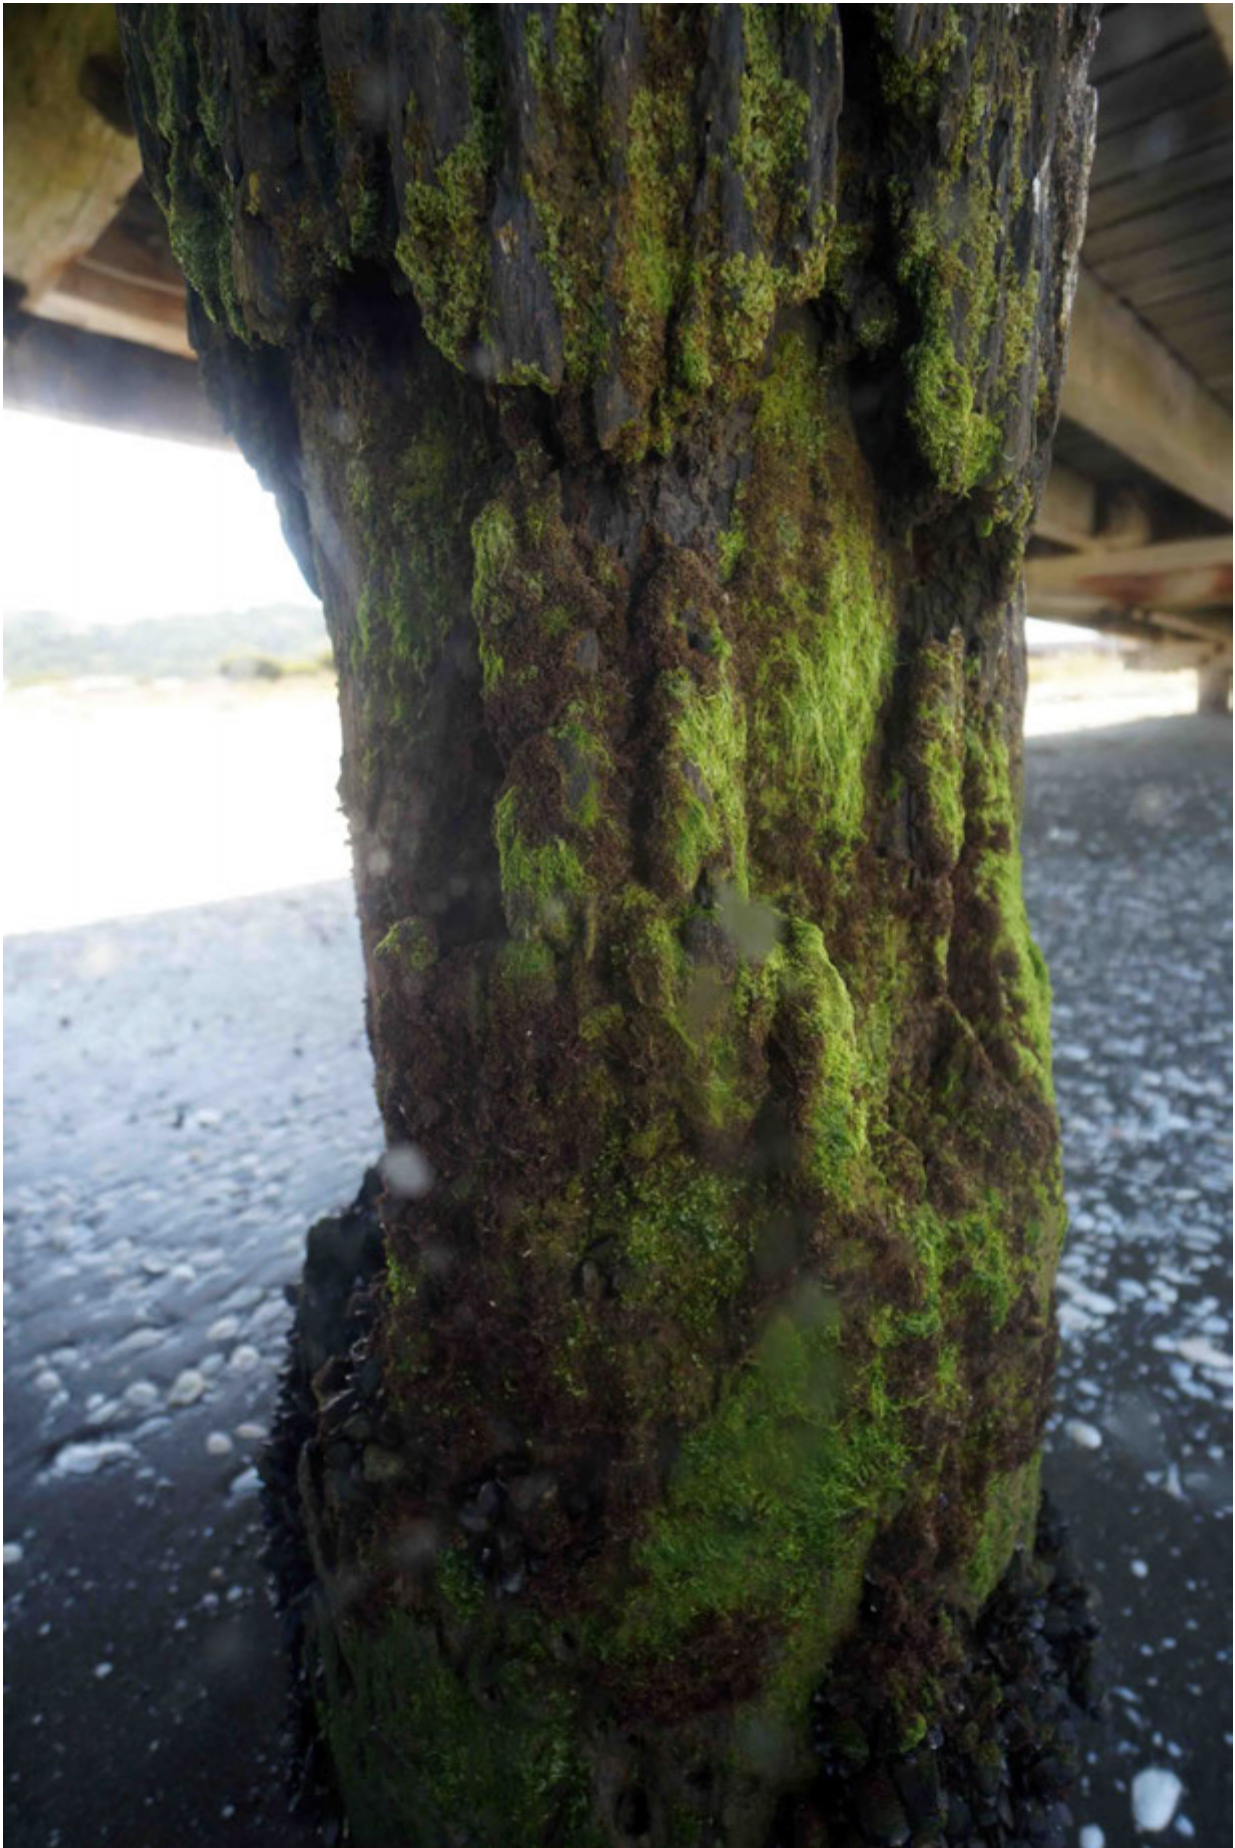
Pile 10C: Fair Condition – 40% loss of section within tidal zone

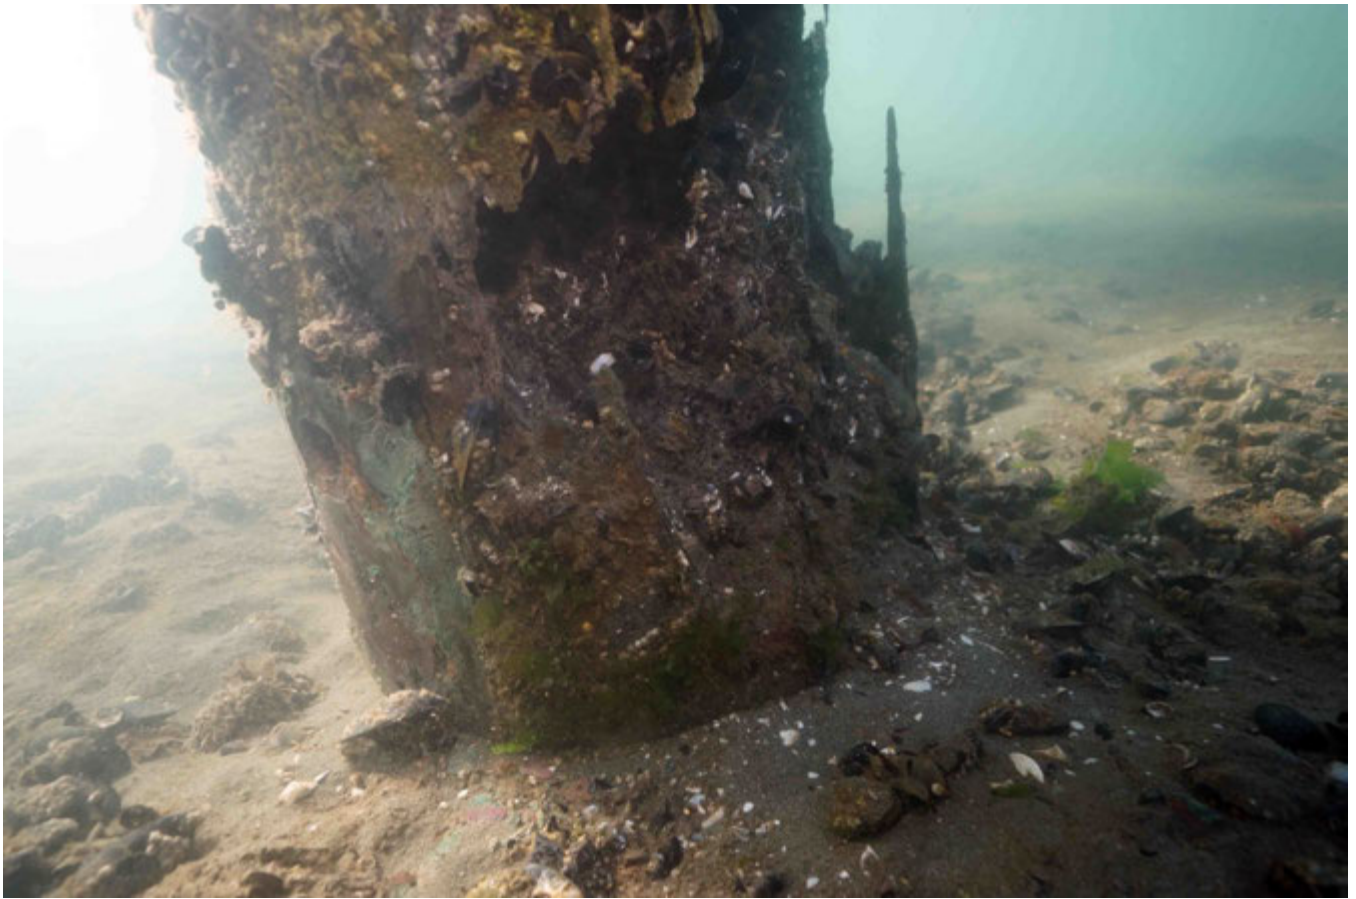
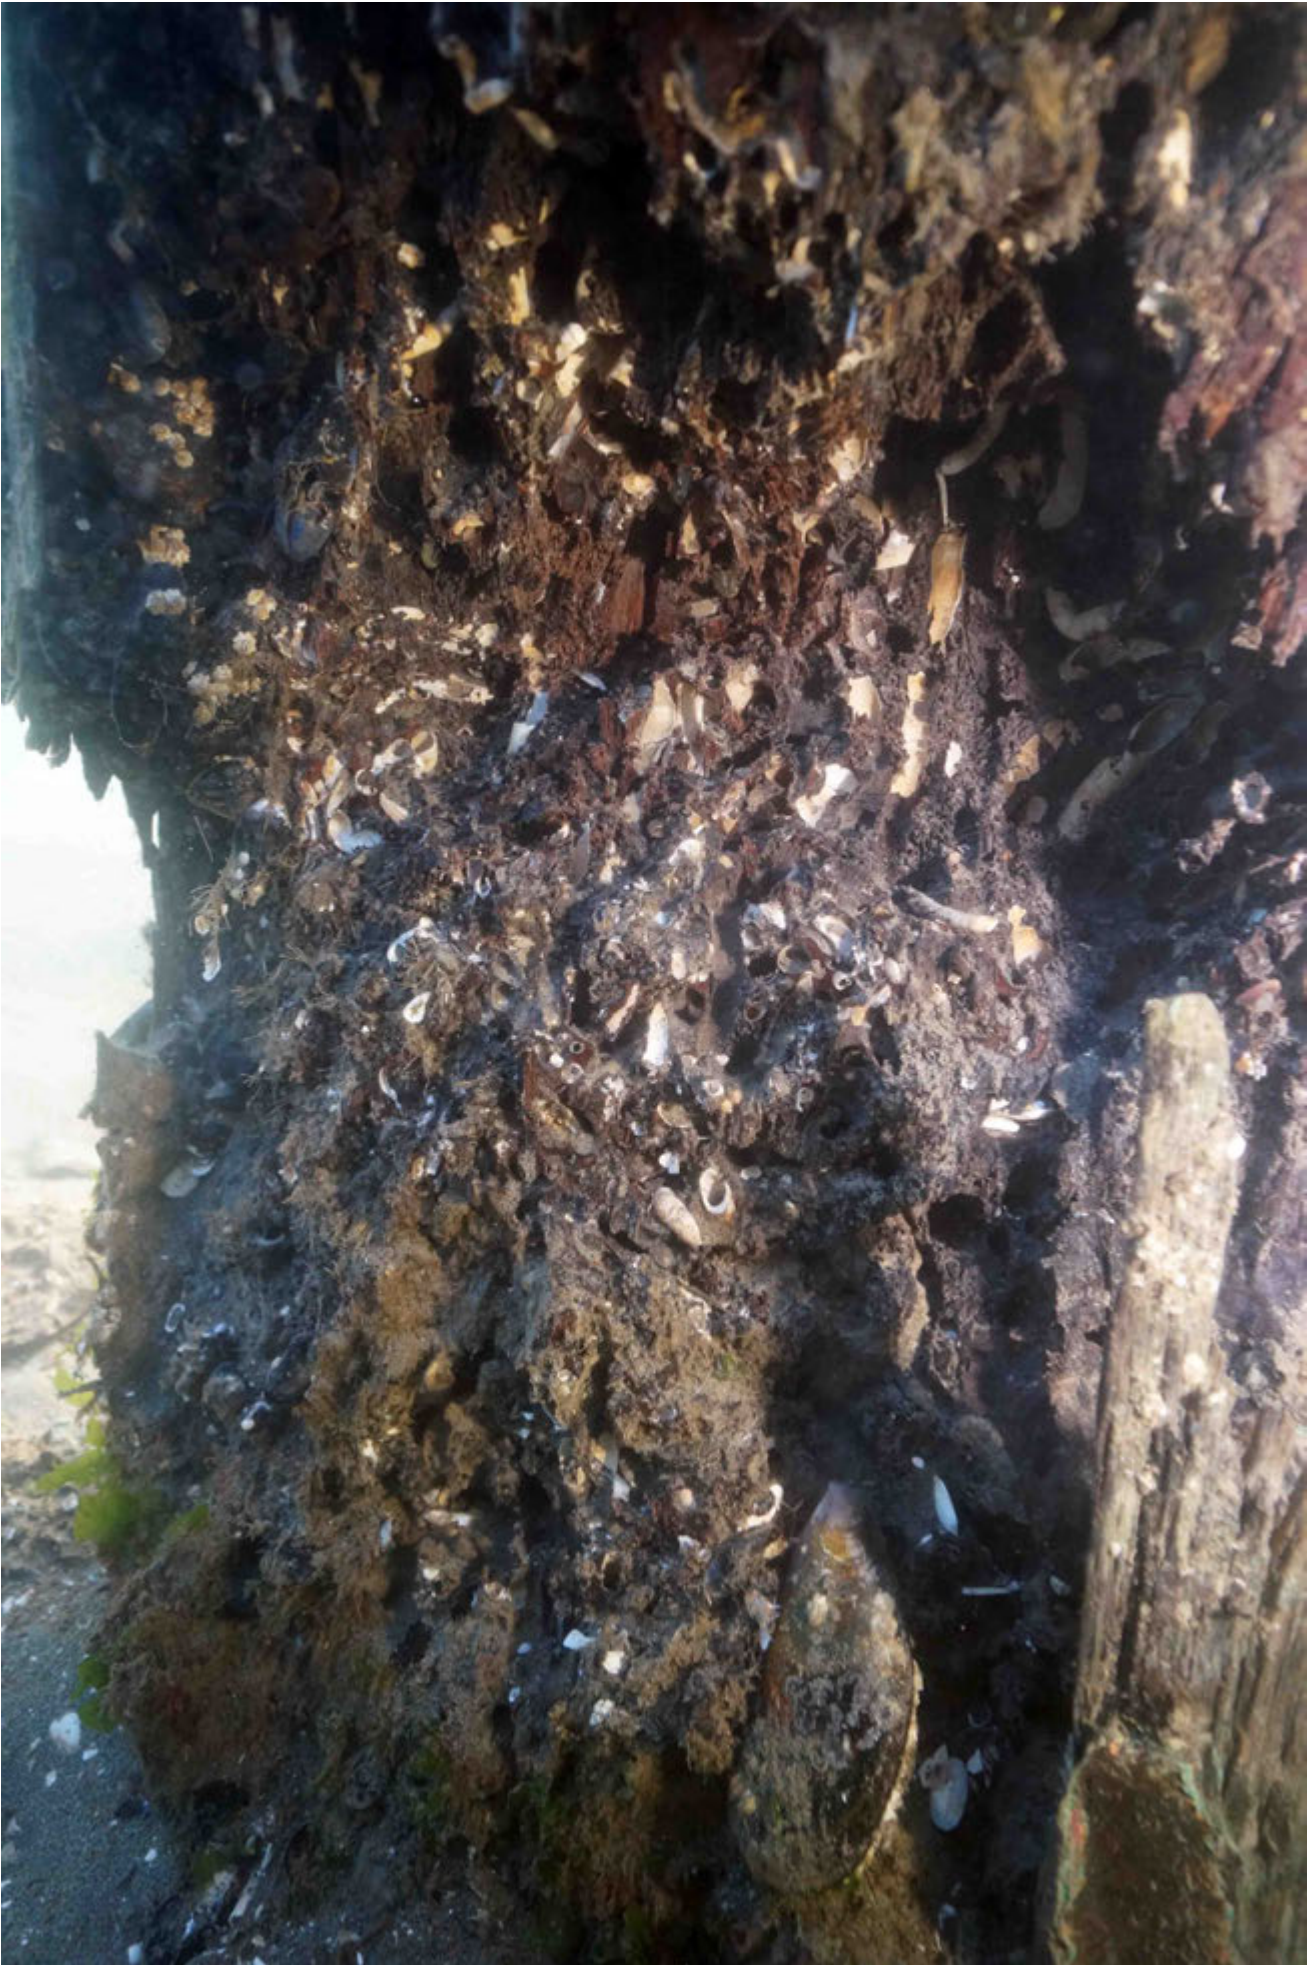
Pile 14D: Poor Condition – 60% loss of section within tidal zone. Severe hollowing

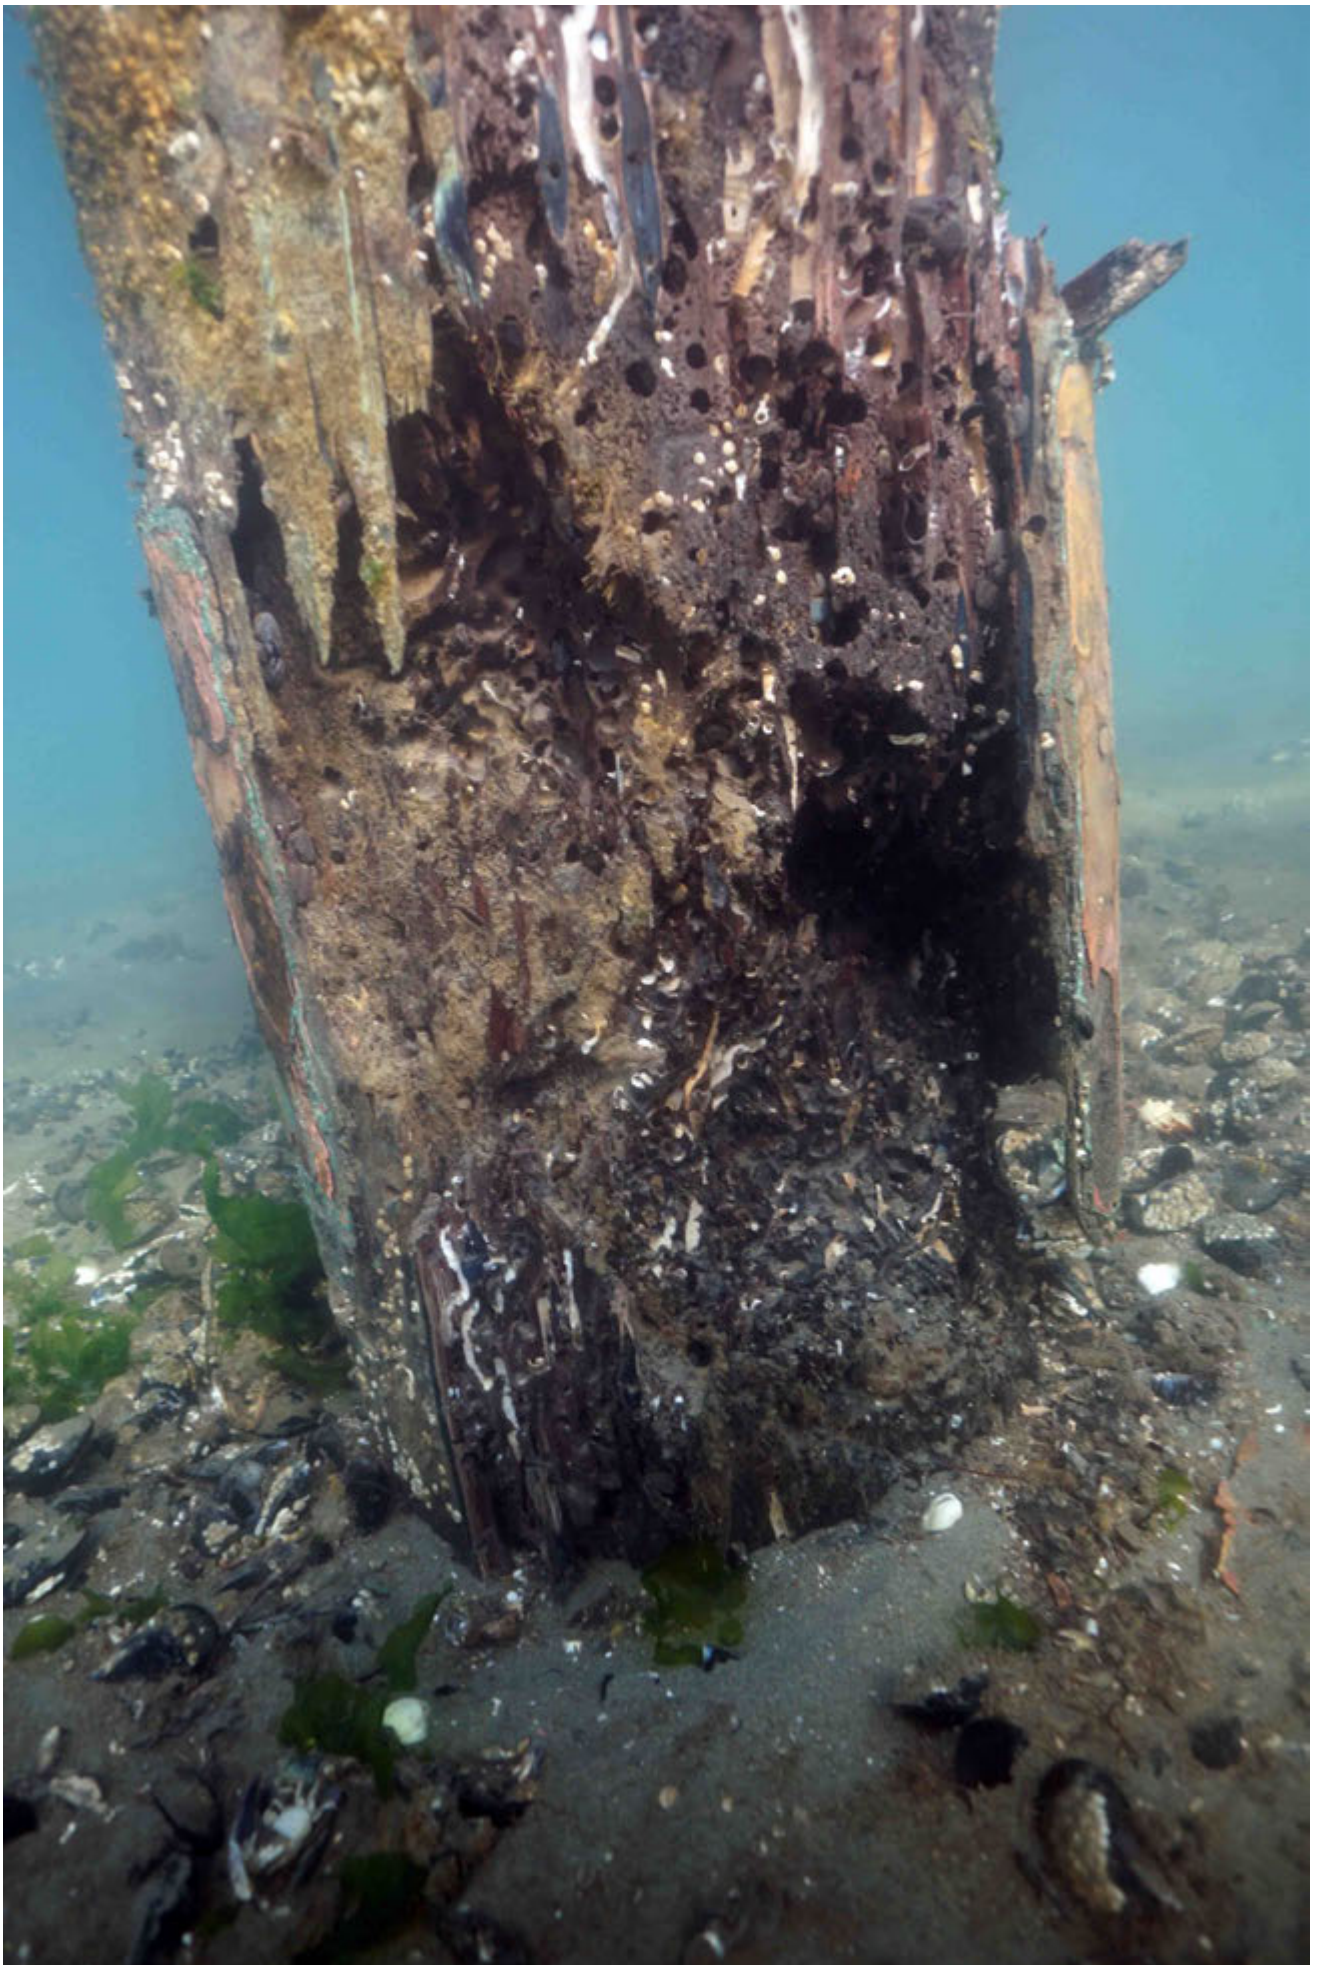
Pile 15C: Poor Condition – 50% loss of section within tidal zone

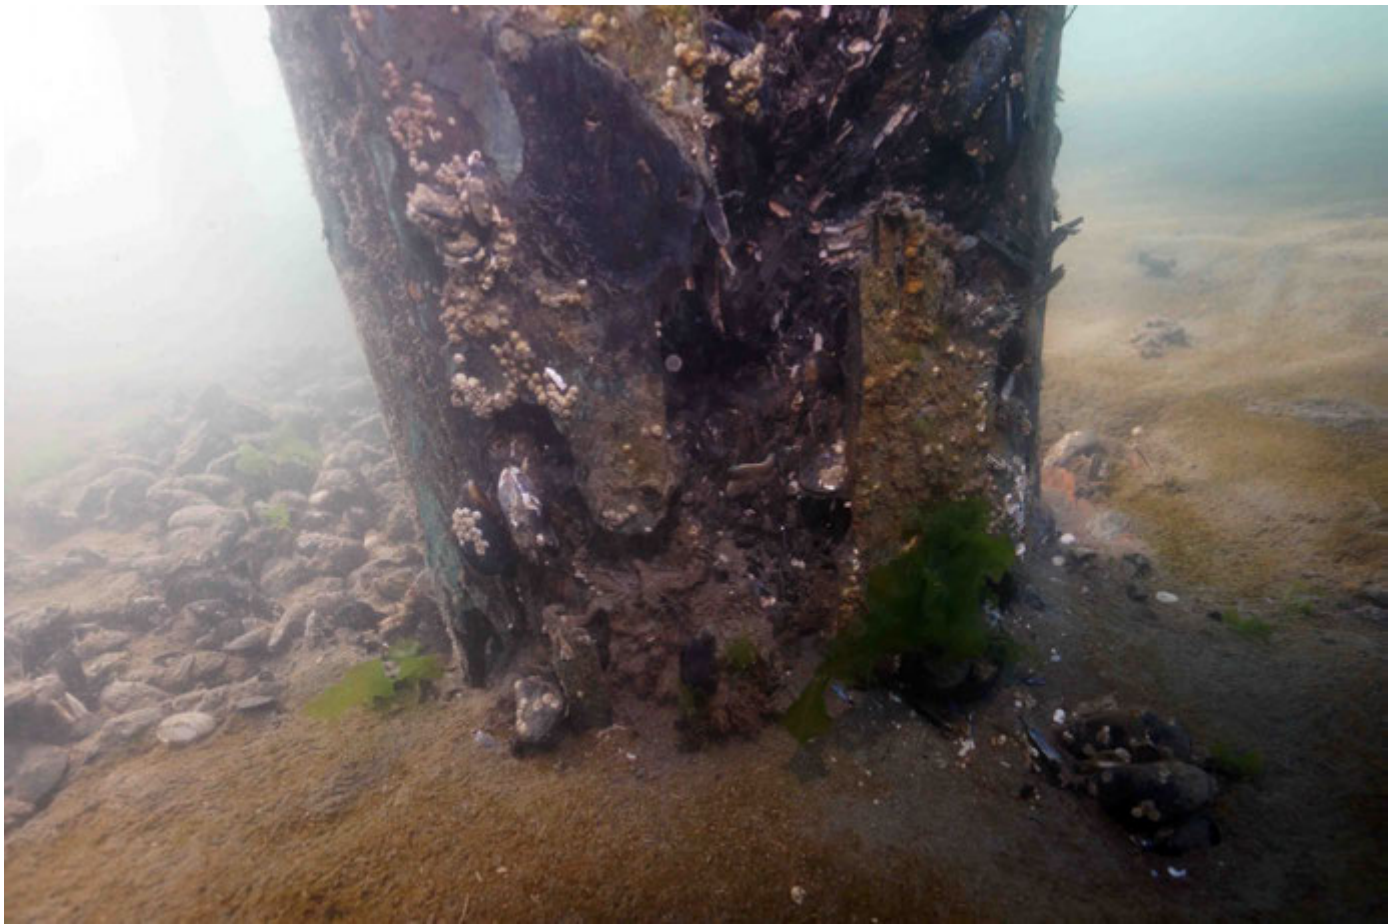
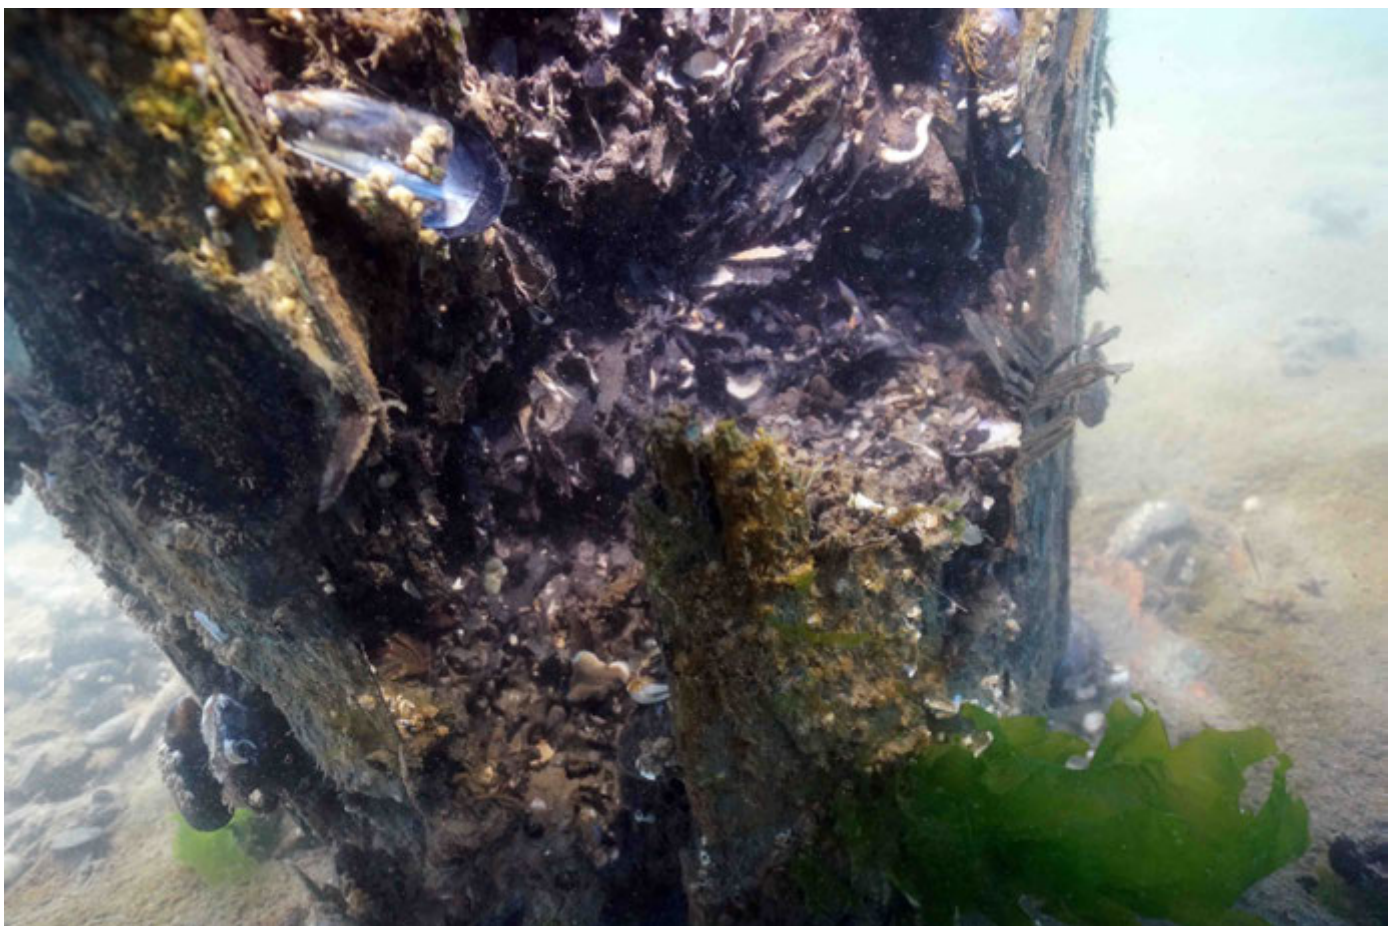
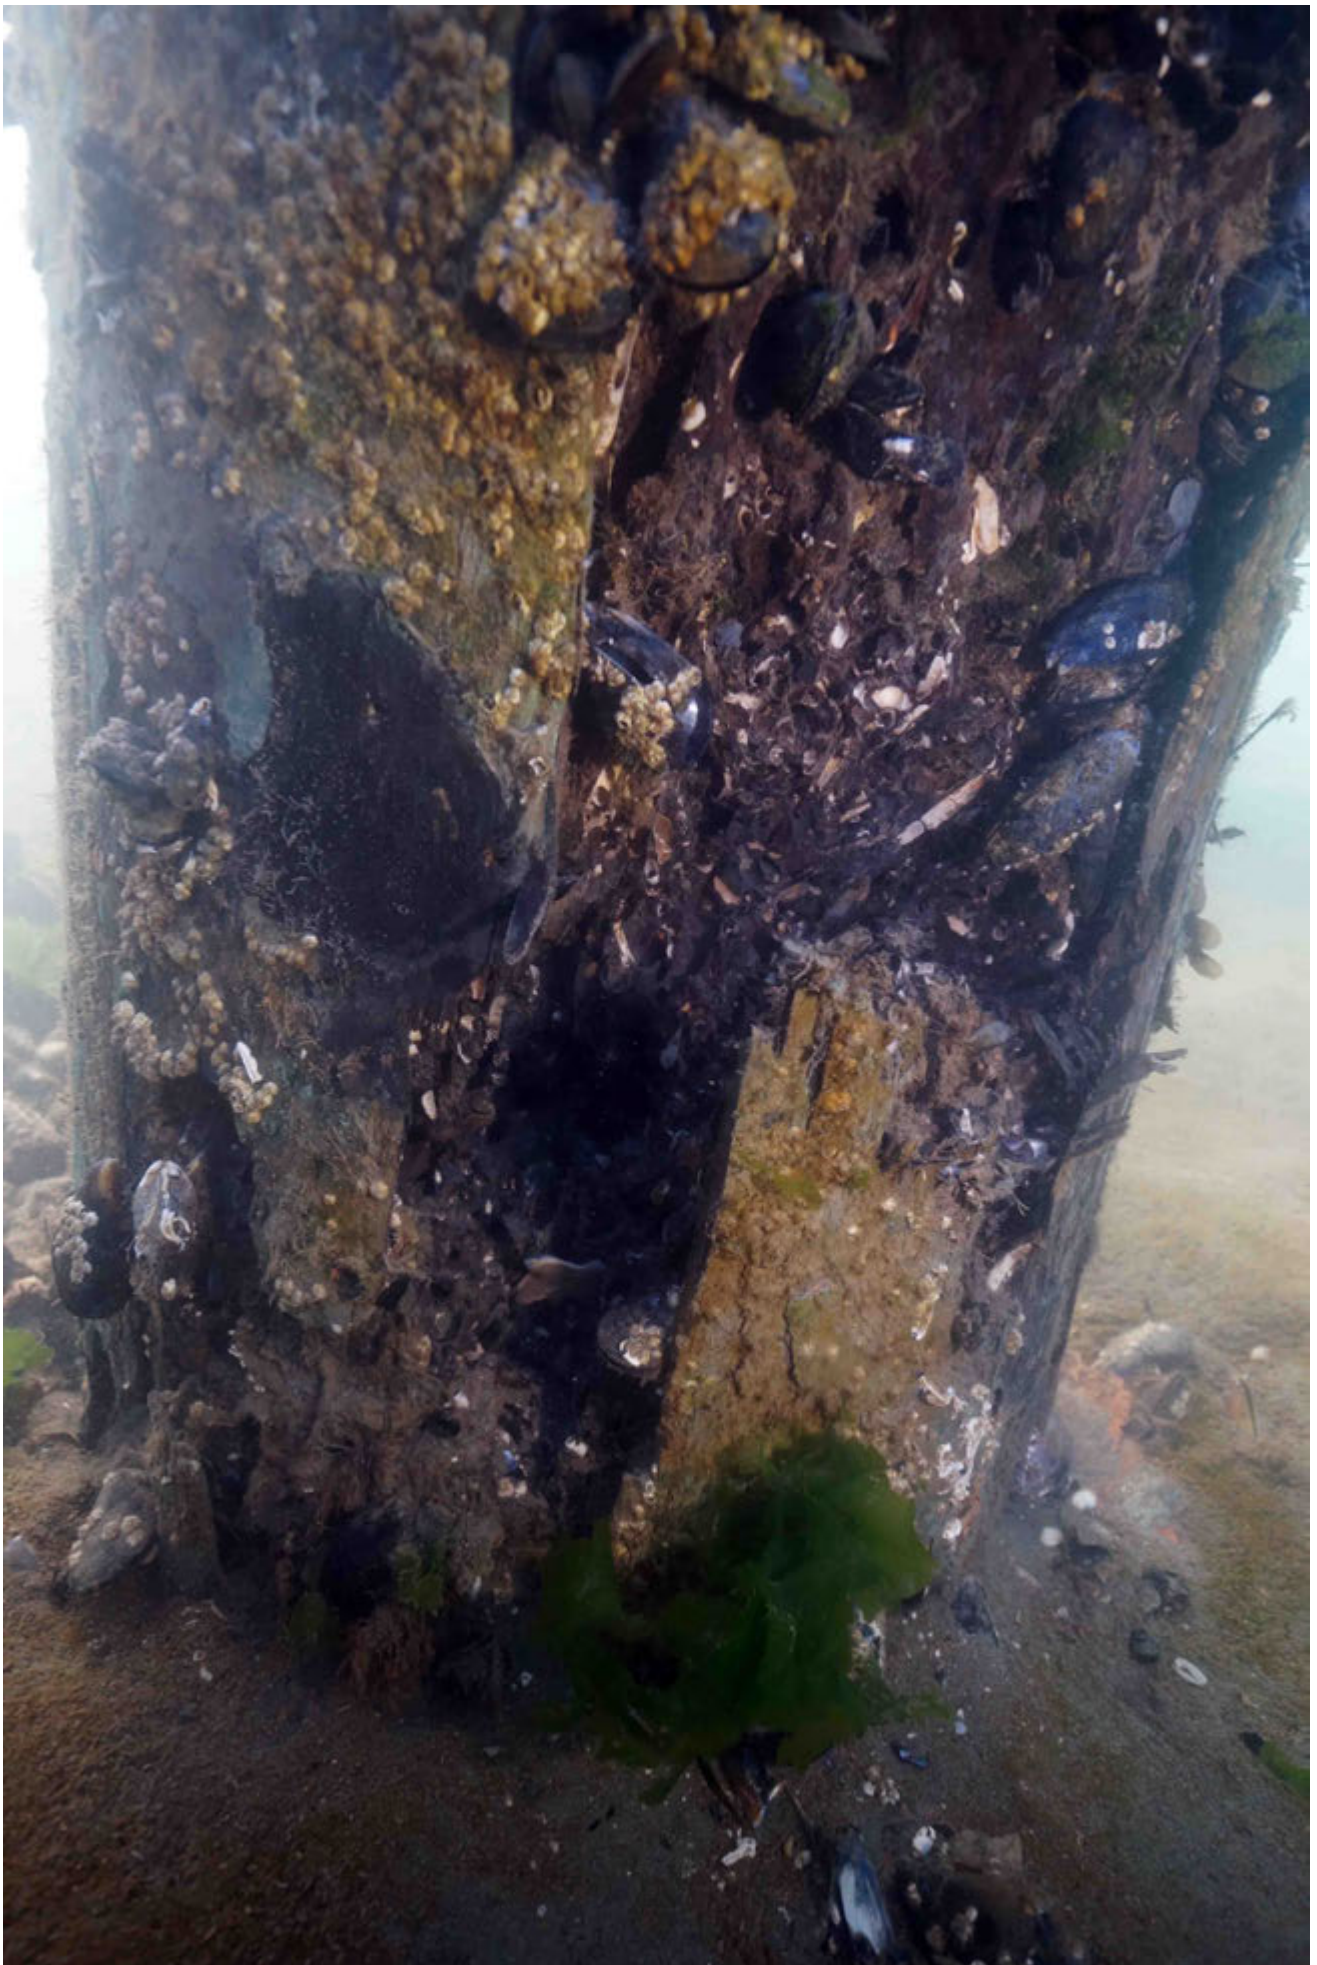
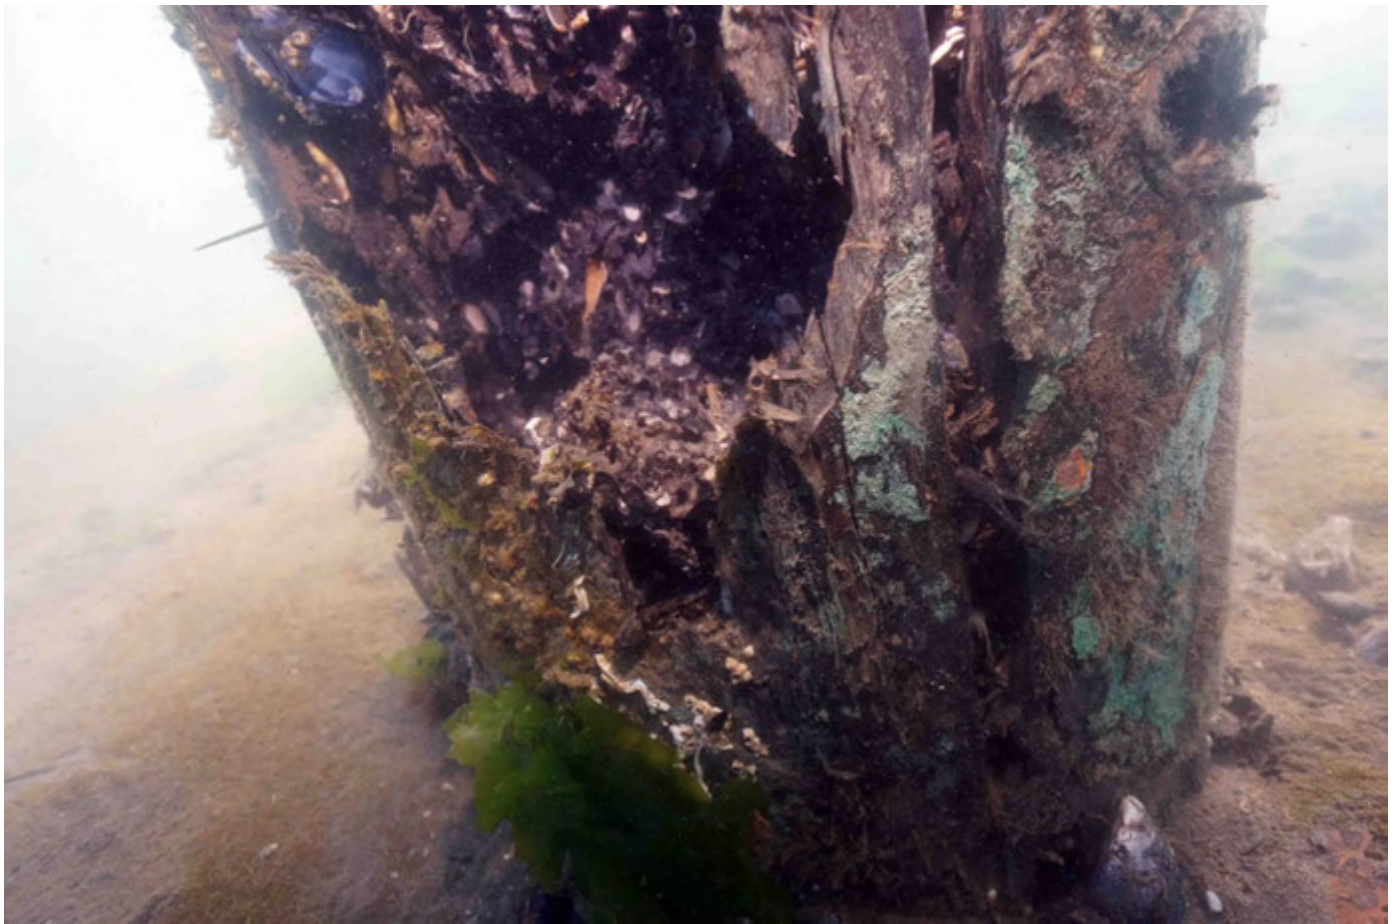
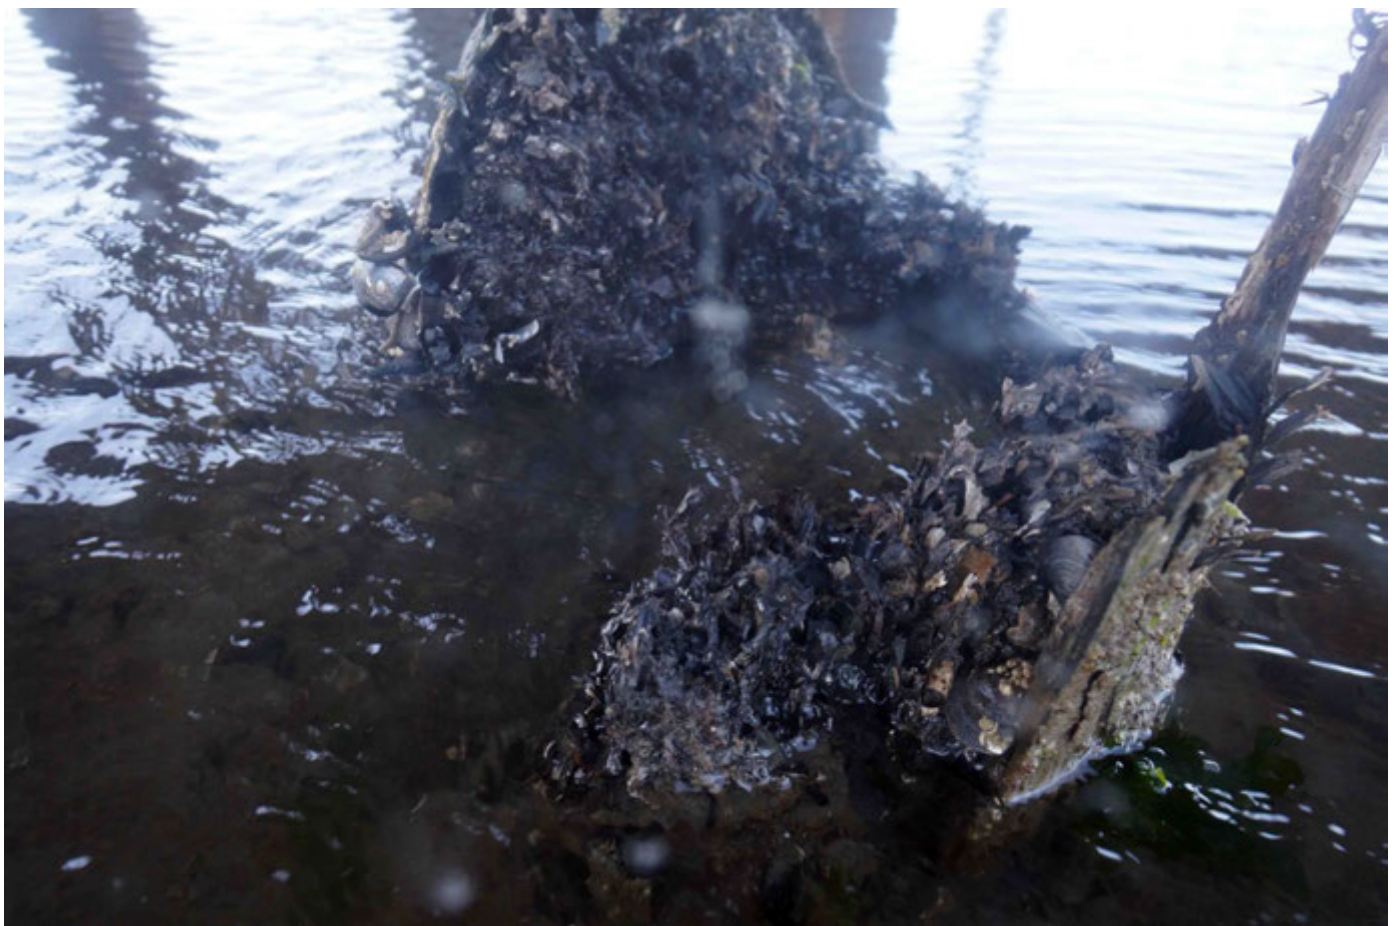
Pile 16D: Very Poor Condition – broken pile

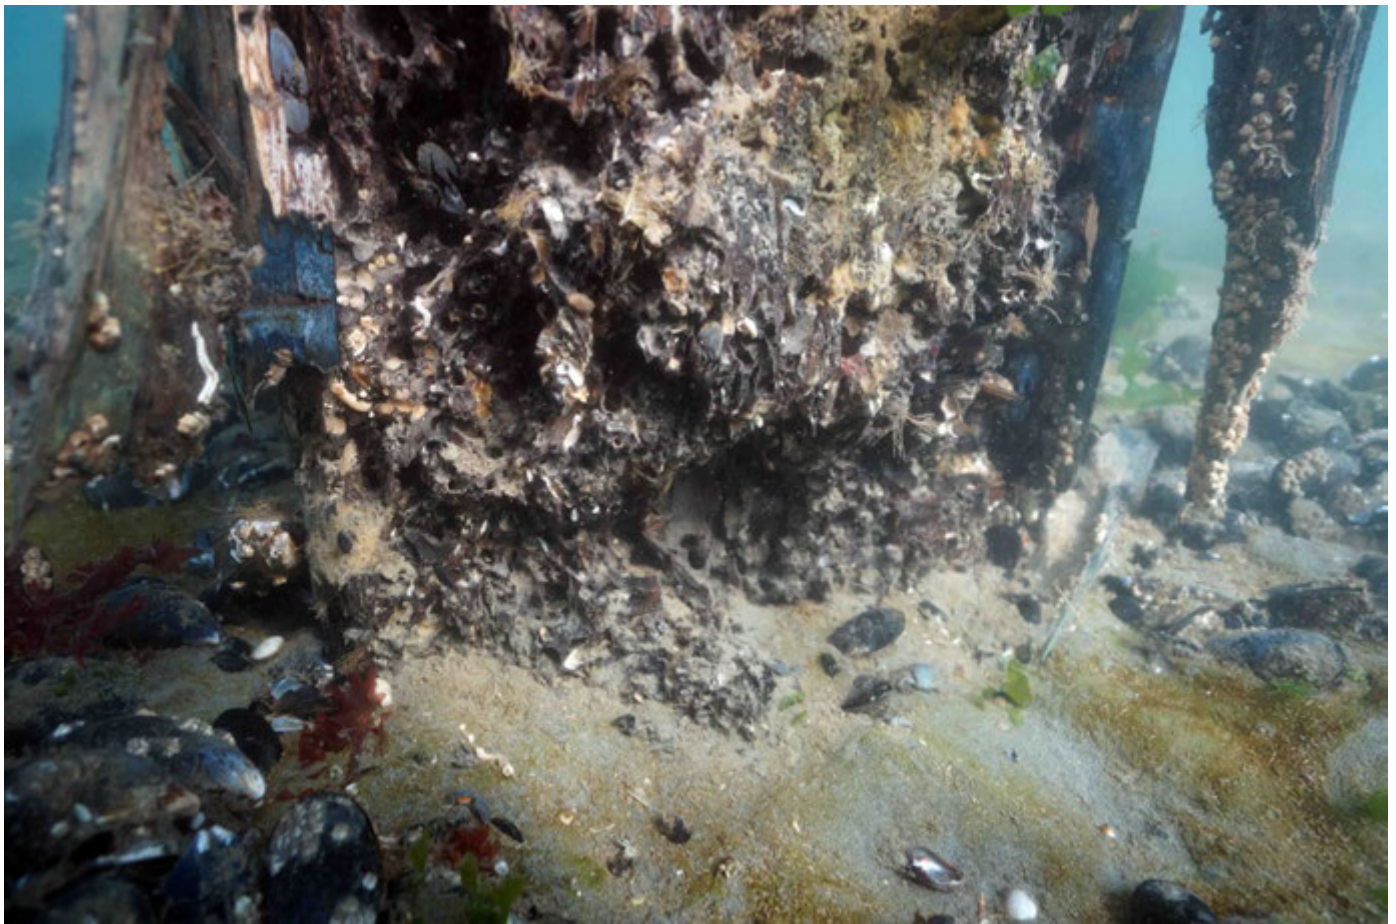
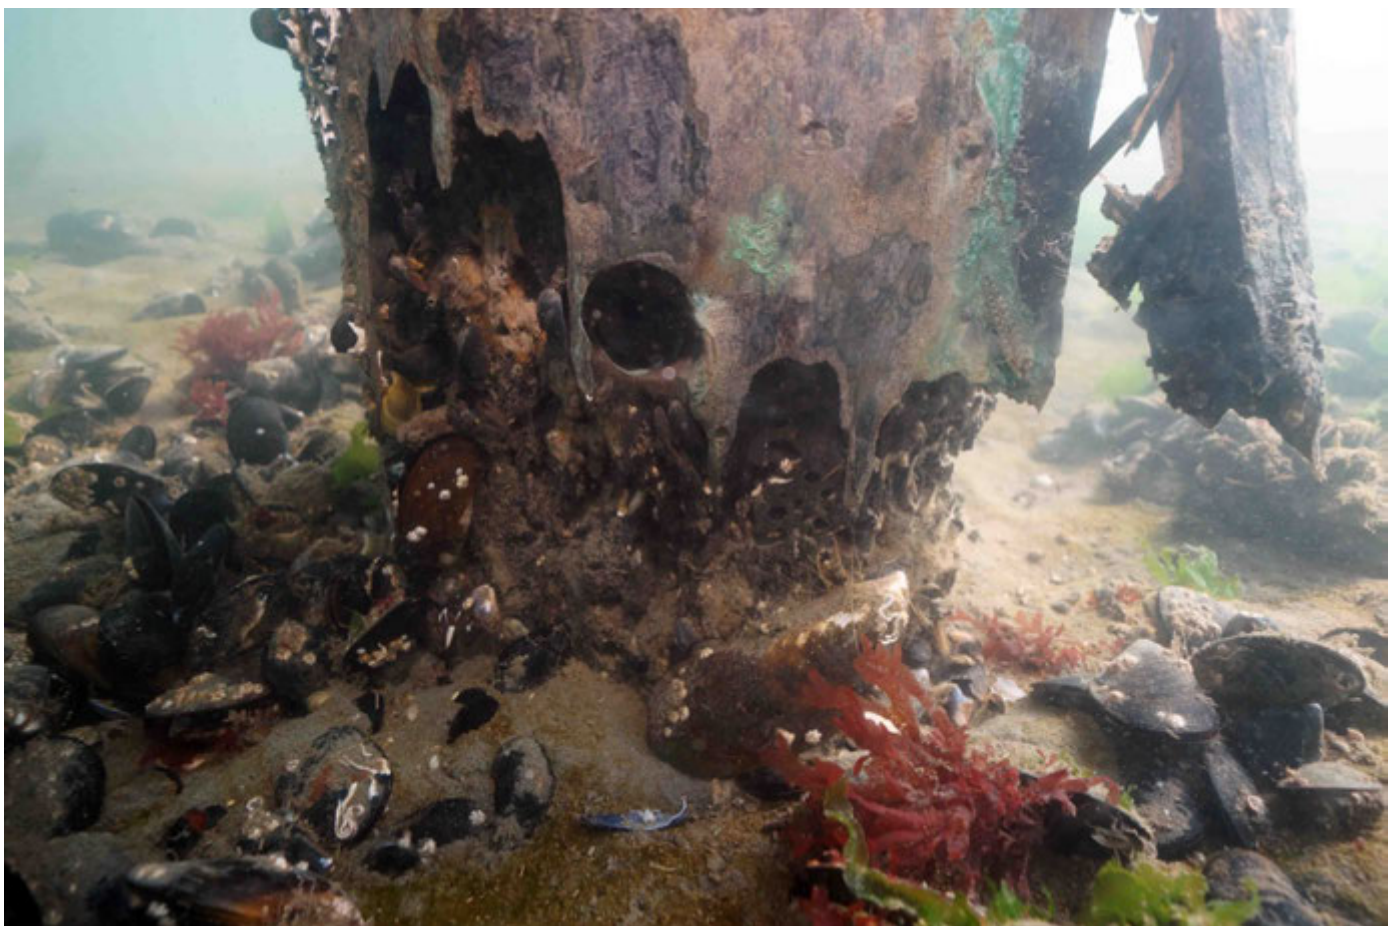
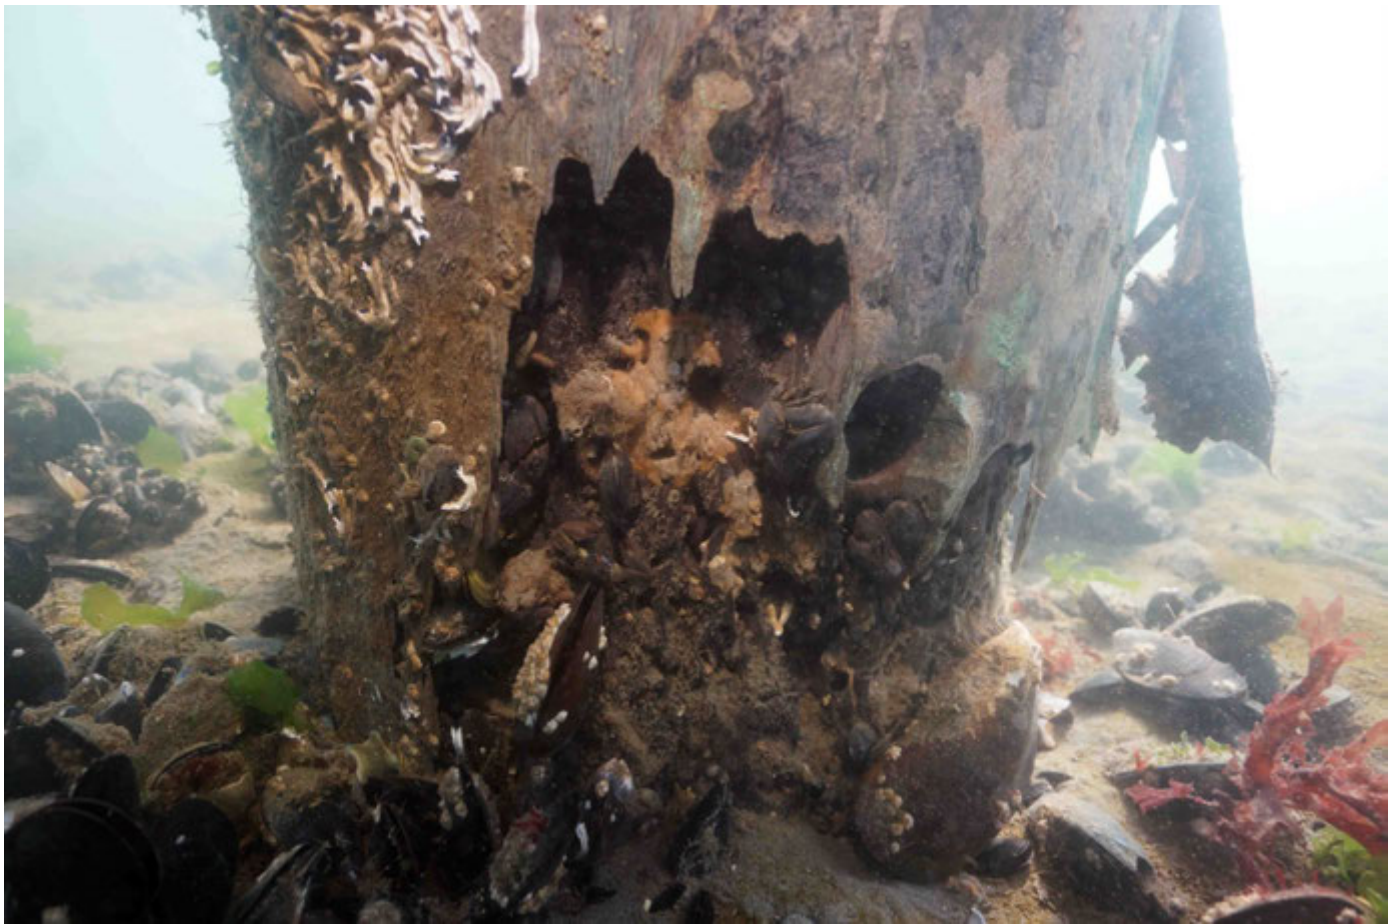
Pile 18C: Poor Condition – 50% loss of section within tidal zone
