Document Title:	HCC Petone Wharf – Approach Structure – Pile Condition Survey & Reporting
Document No.:	UCL – 2021.01 – HCC Wharf Approach PCS&R001 – V2
	Prepared for: Tom Arthur – Calibre Group Janet Lawson – Hutt City Council Francis O’Riley – G.K. Shaw Ltd.

Petone Wharf – Approach Structure

Pile Condition Survey & Reporting

January 2021

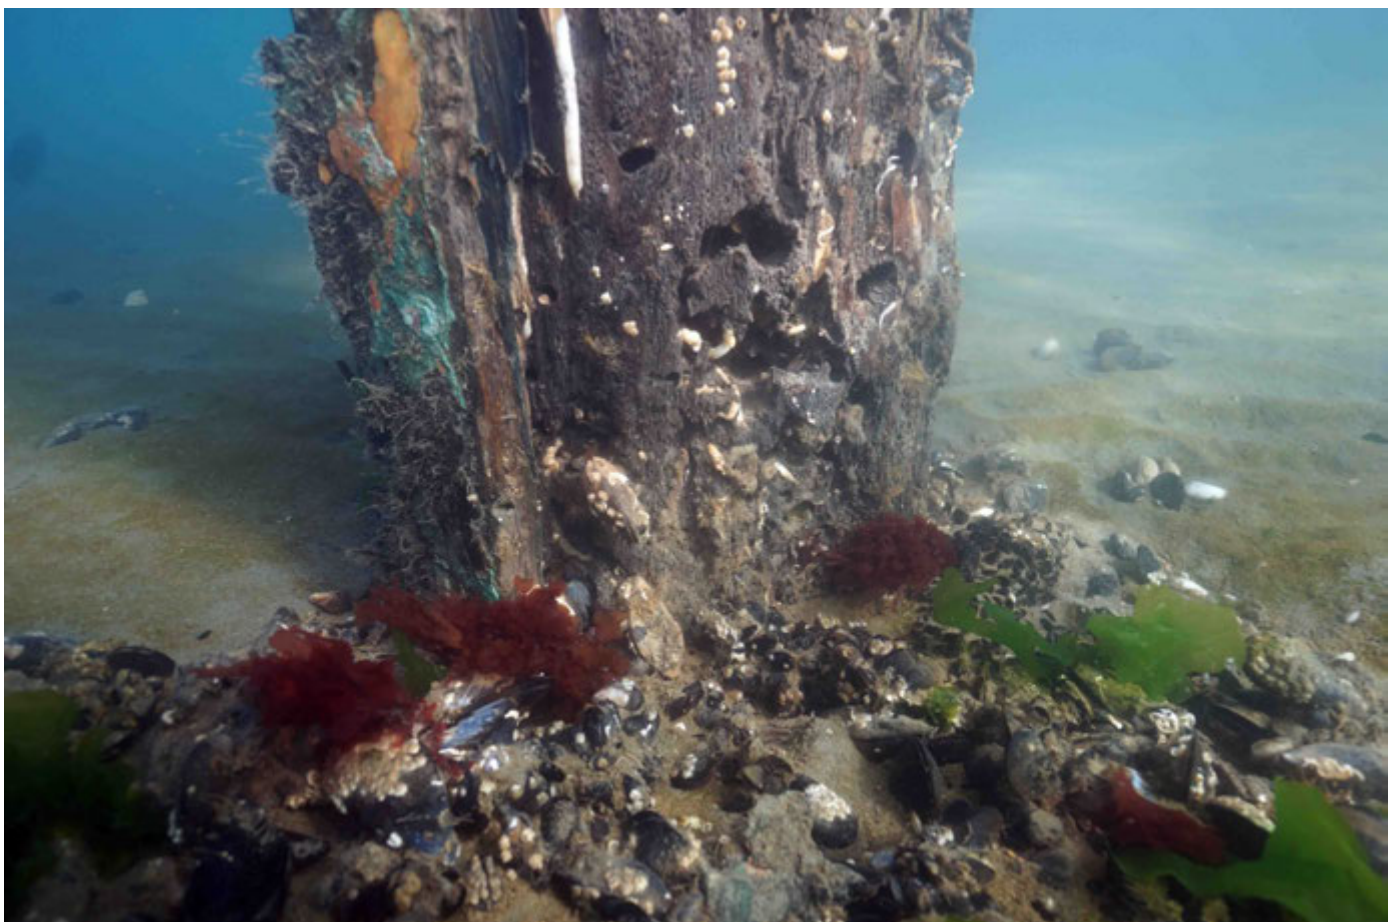
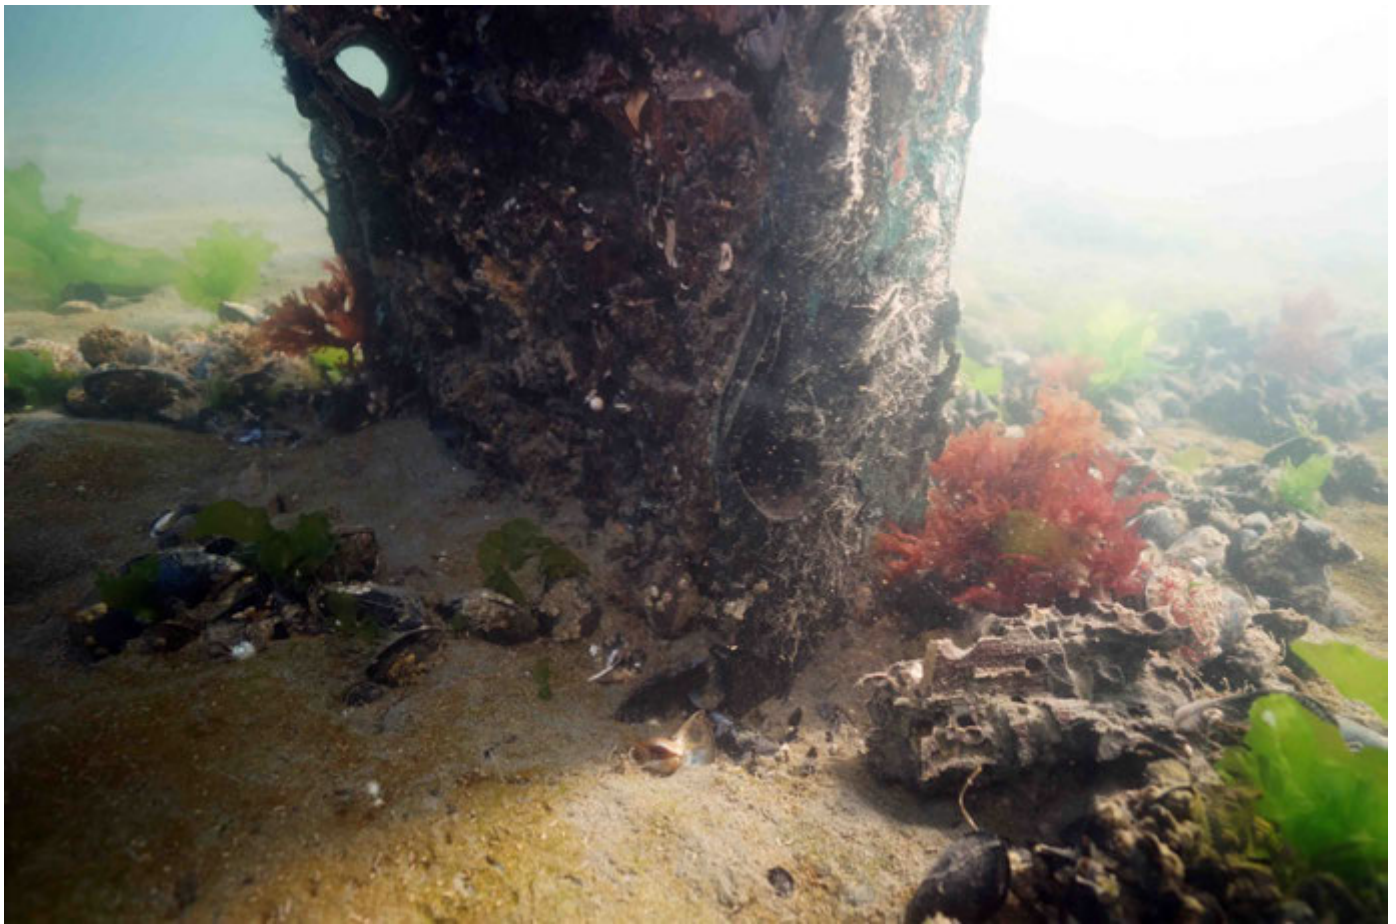
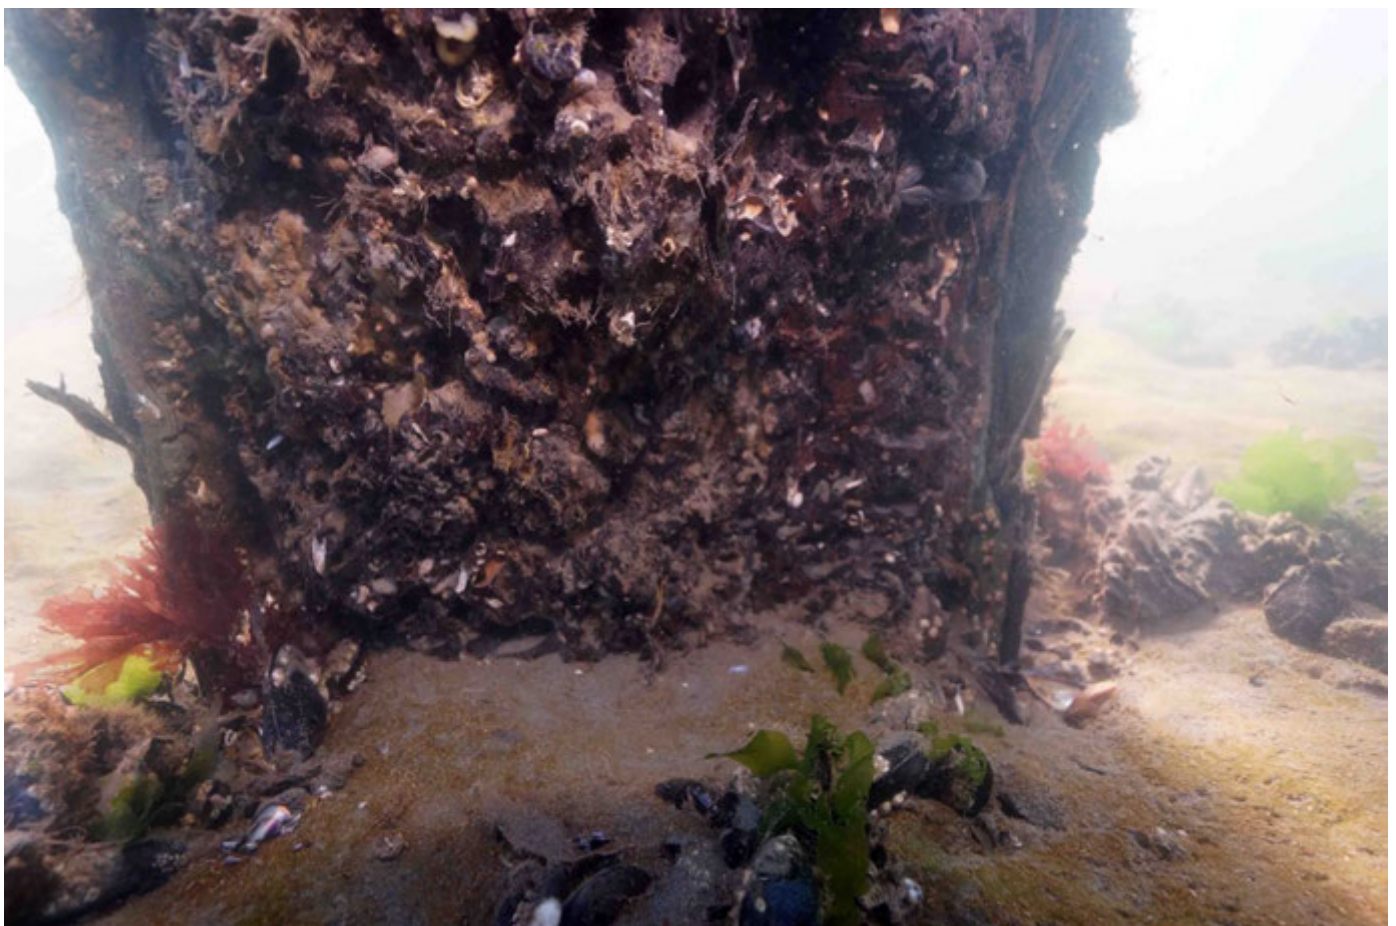
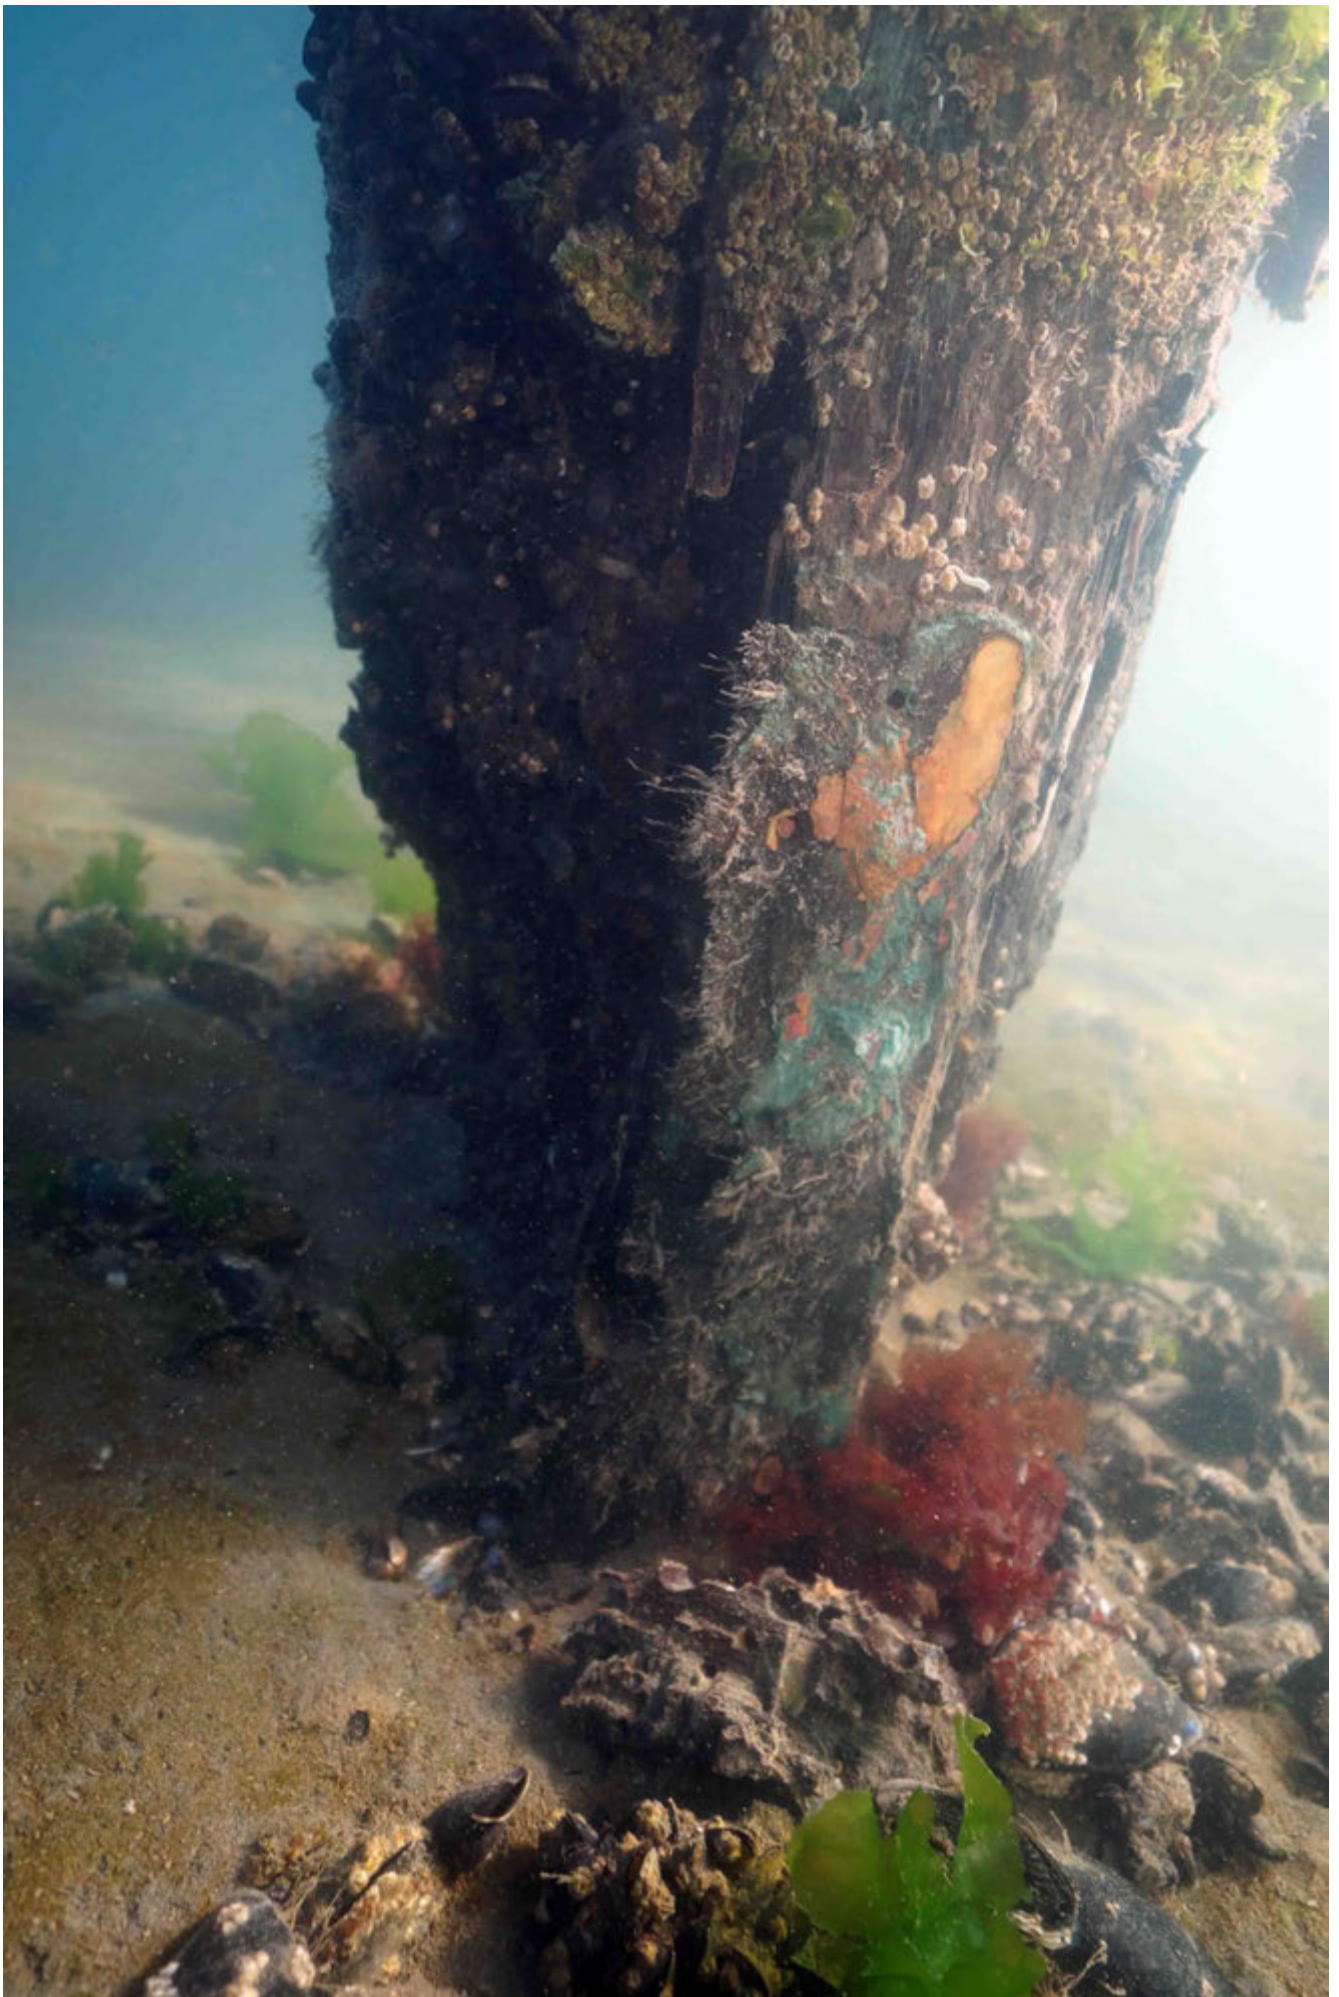
Pile 18D: Poor Condition – 60% loss of section within tidal zone

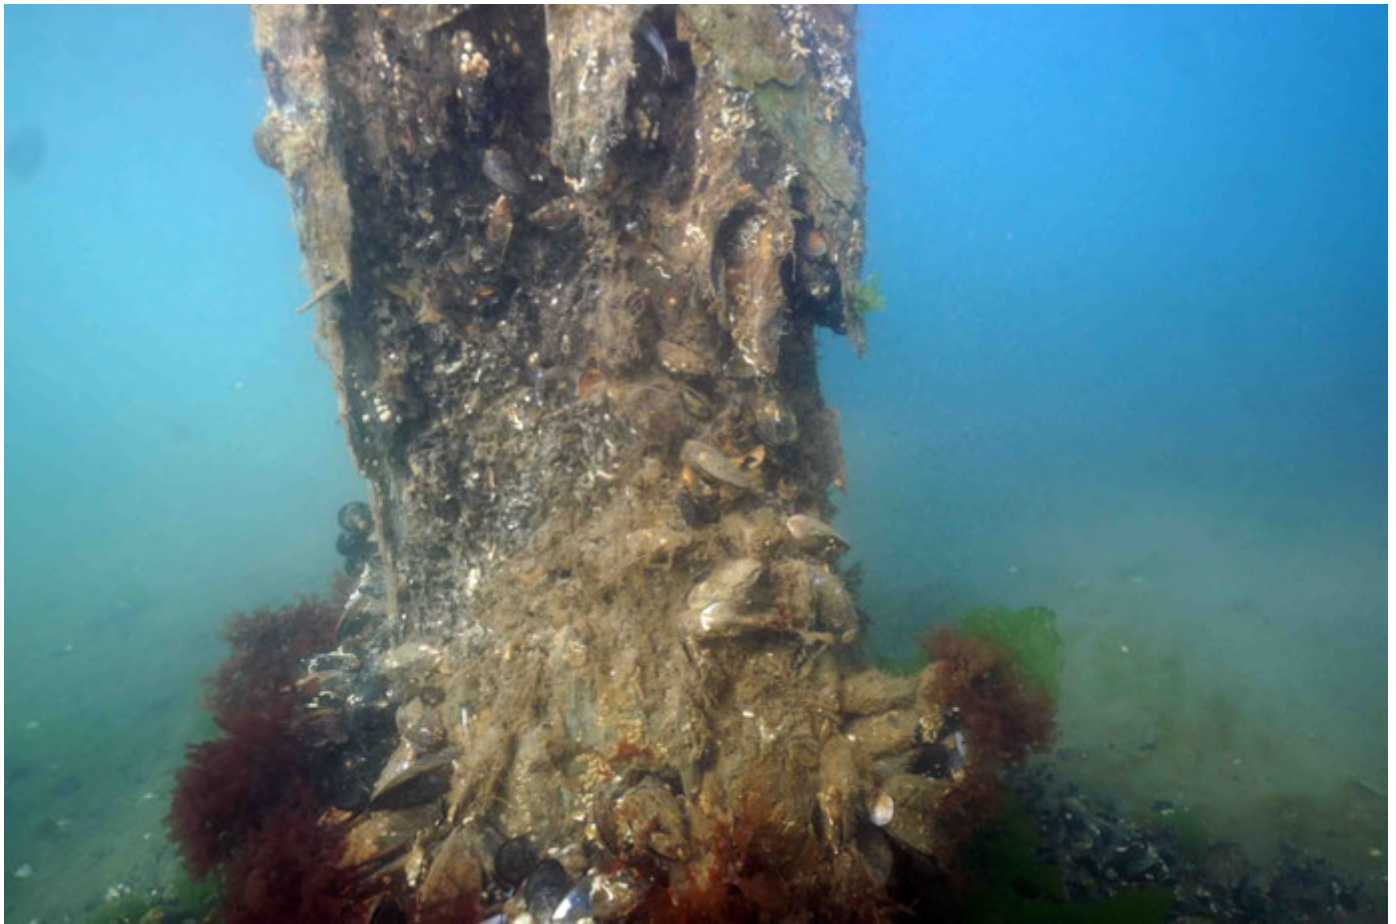
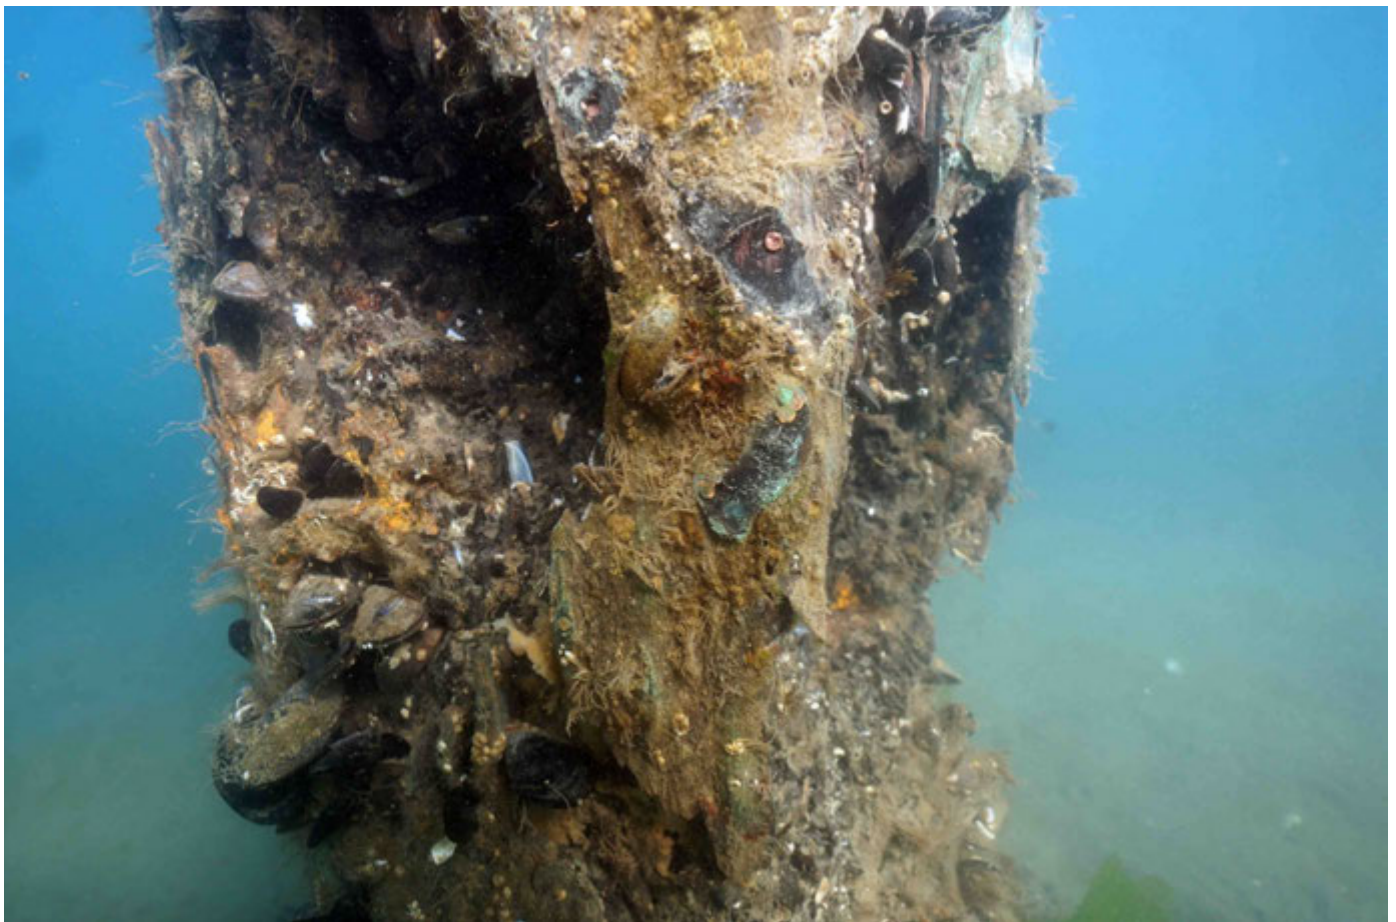
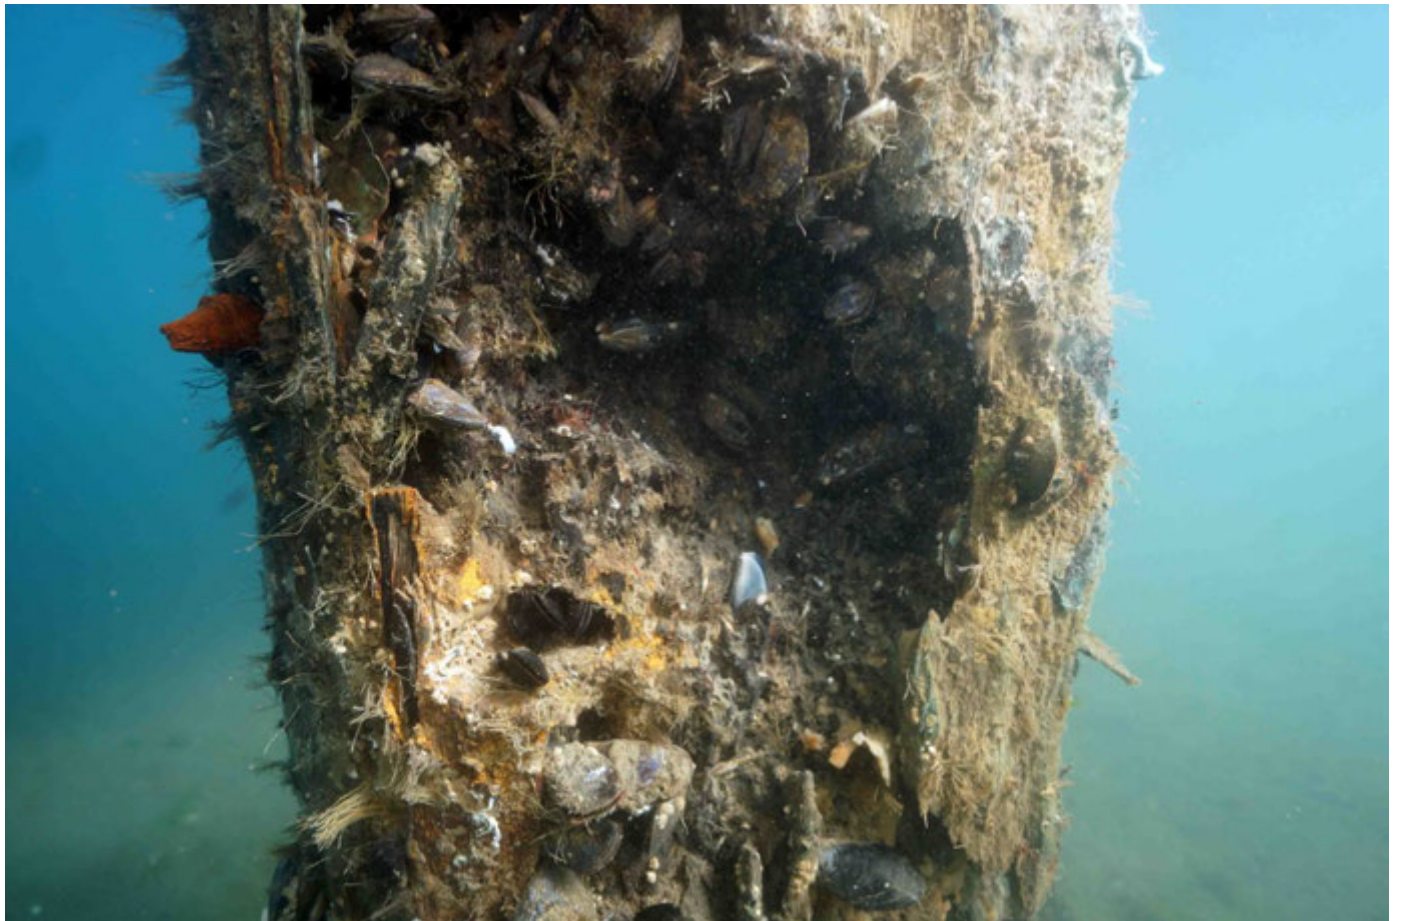
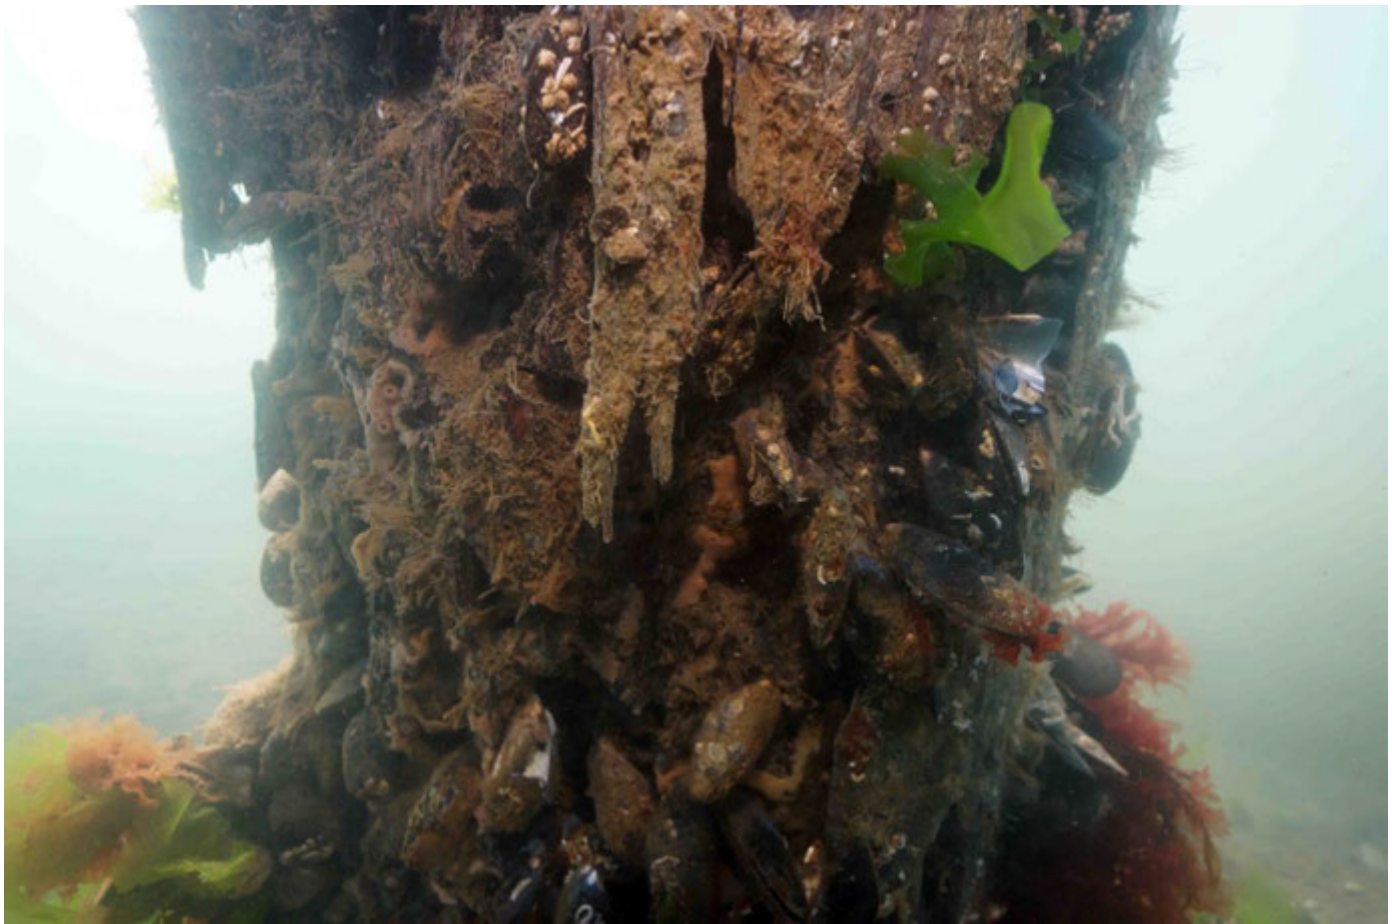
Pile 22D: Poor Condition – 60% loss of section at seabed

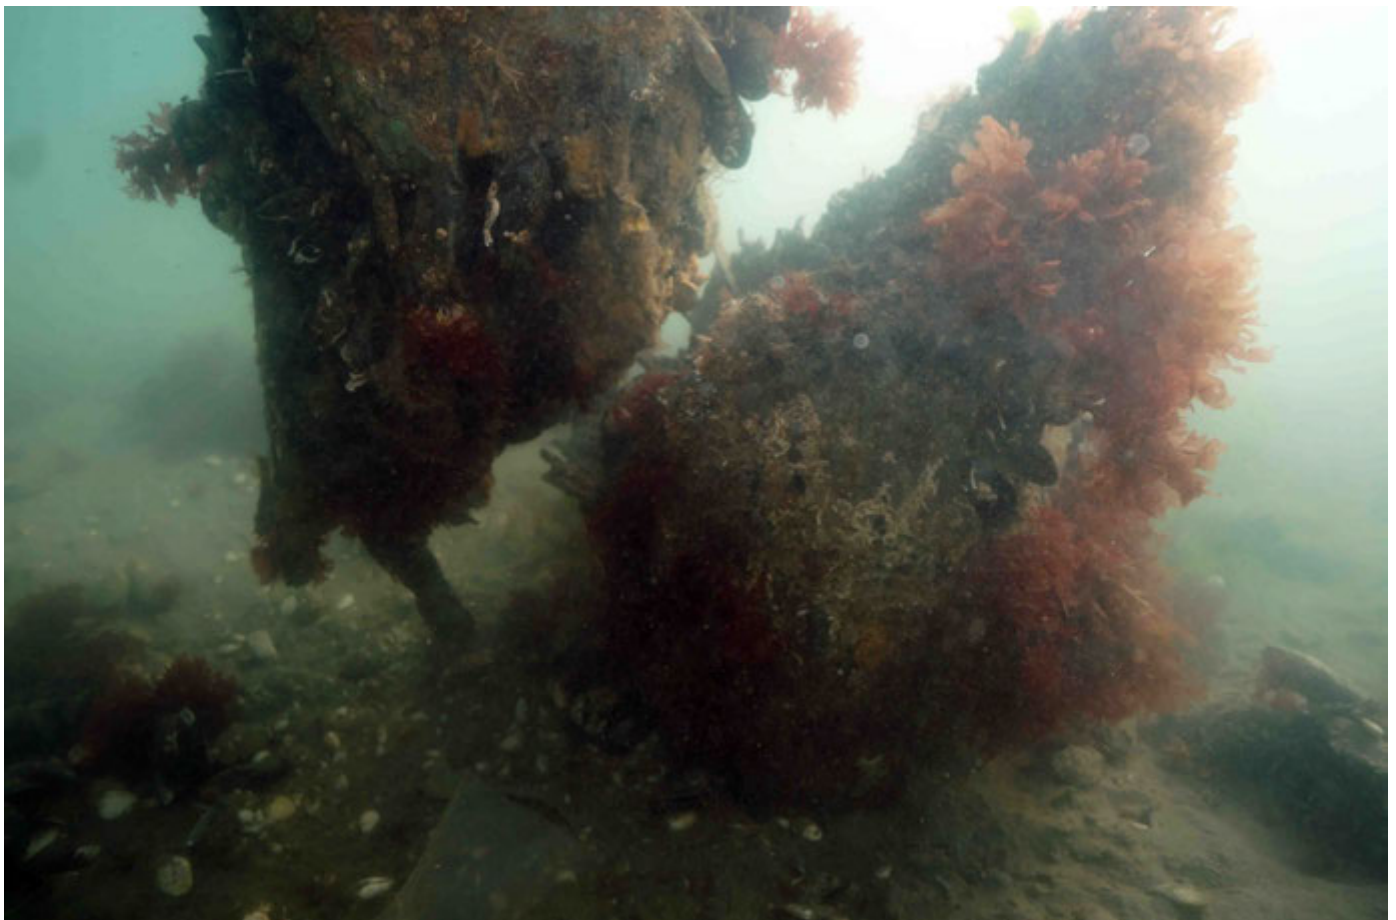
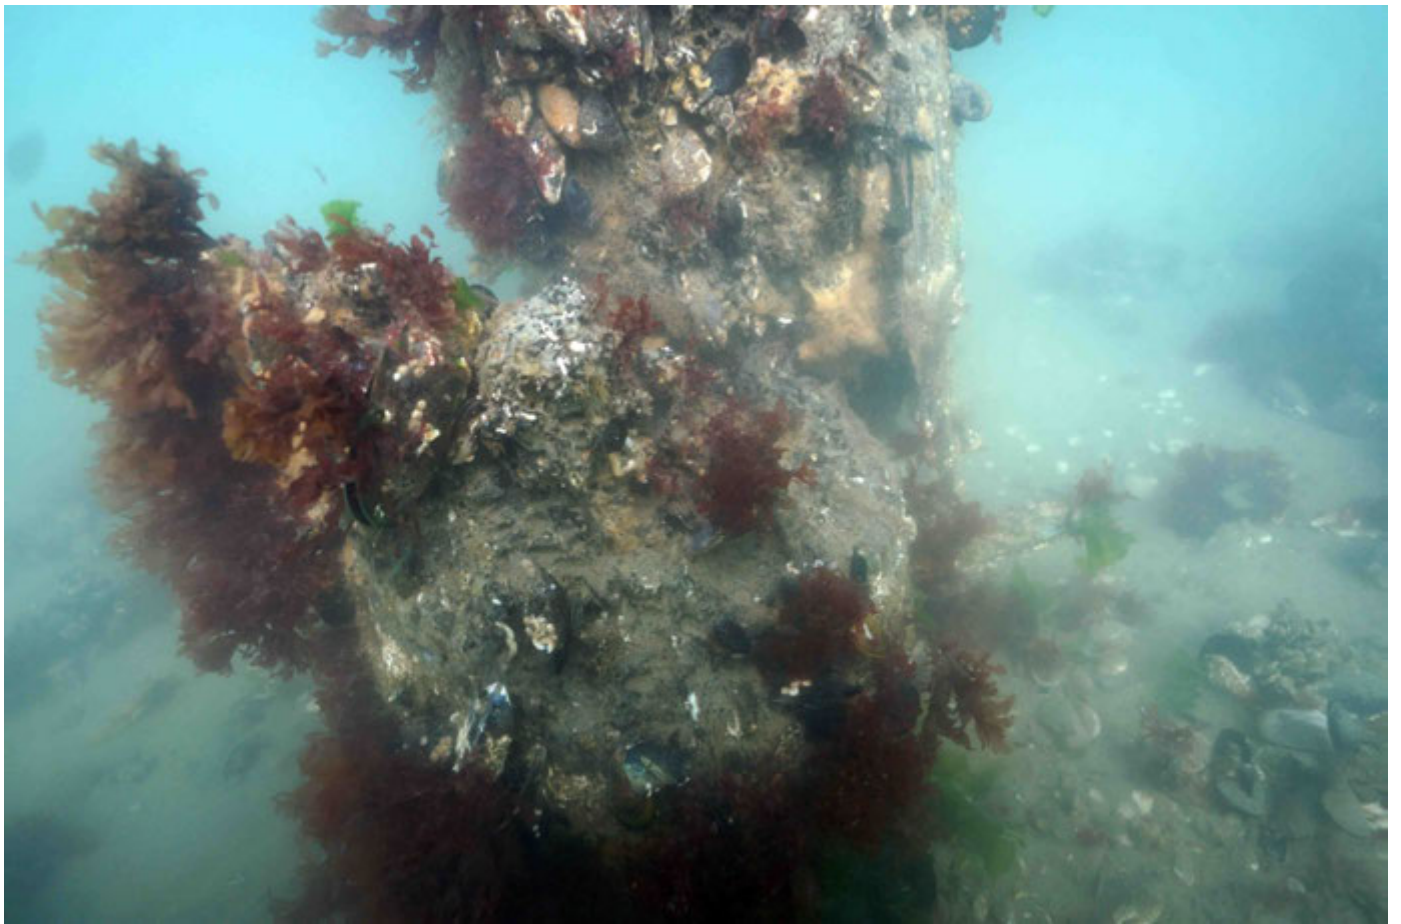
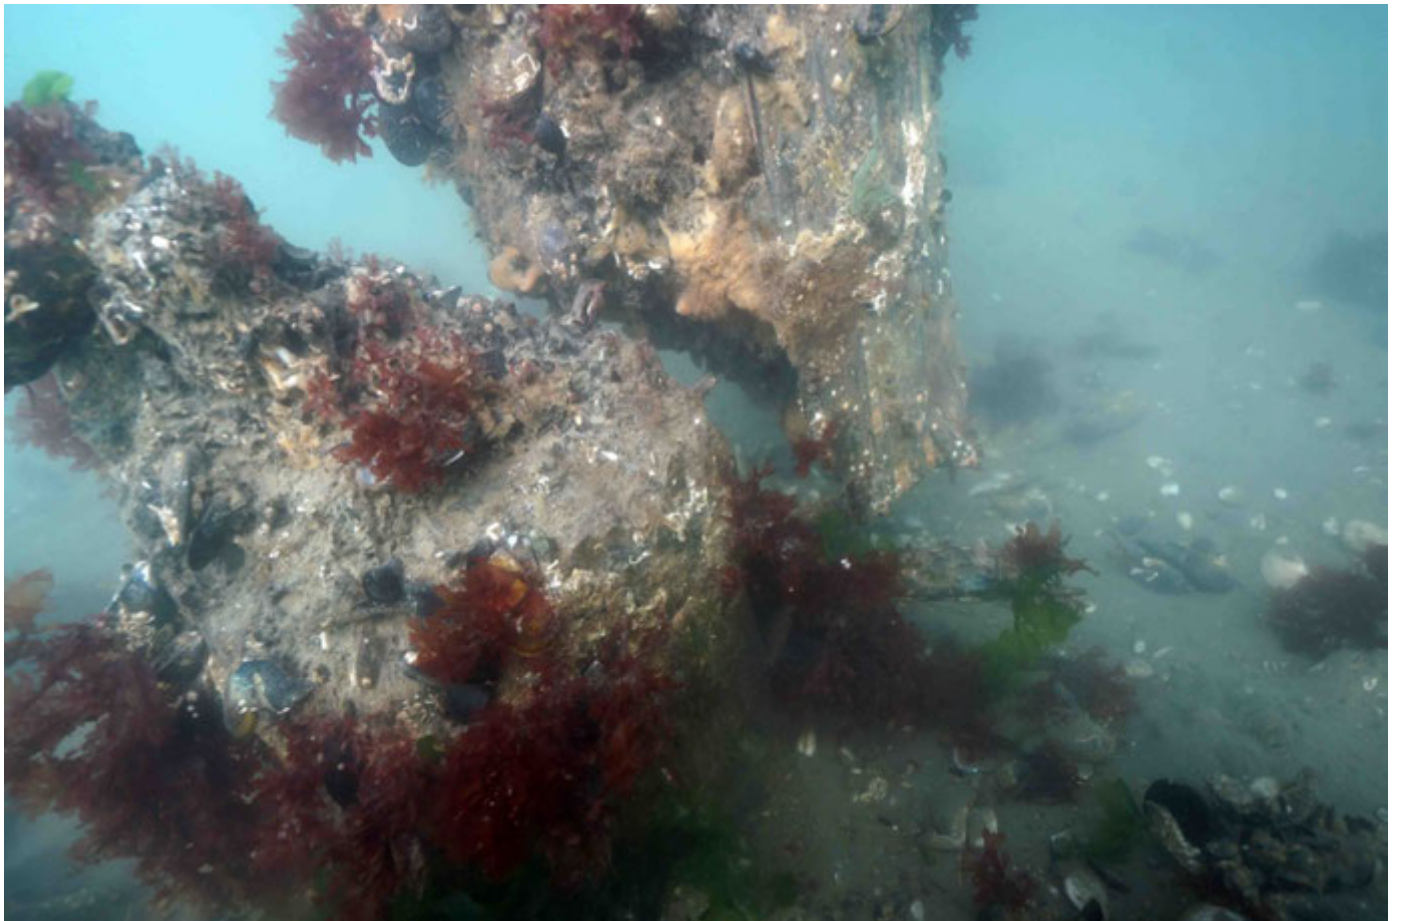
Pile 23C: Very Poor Condition – broken pile

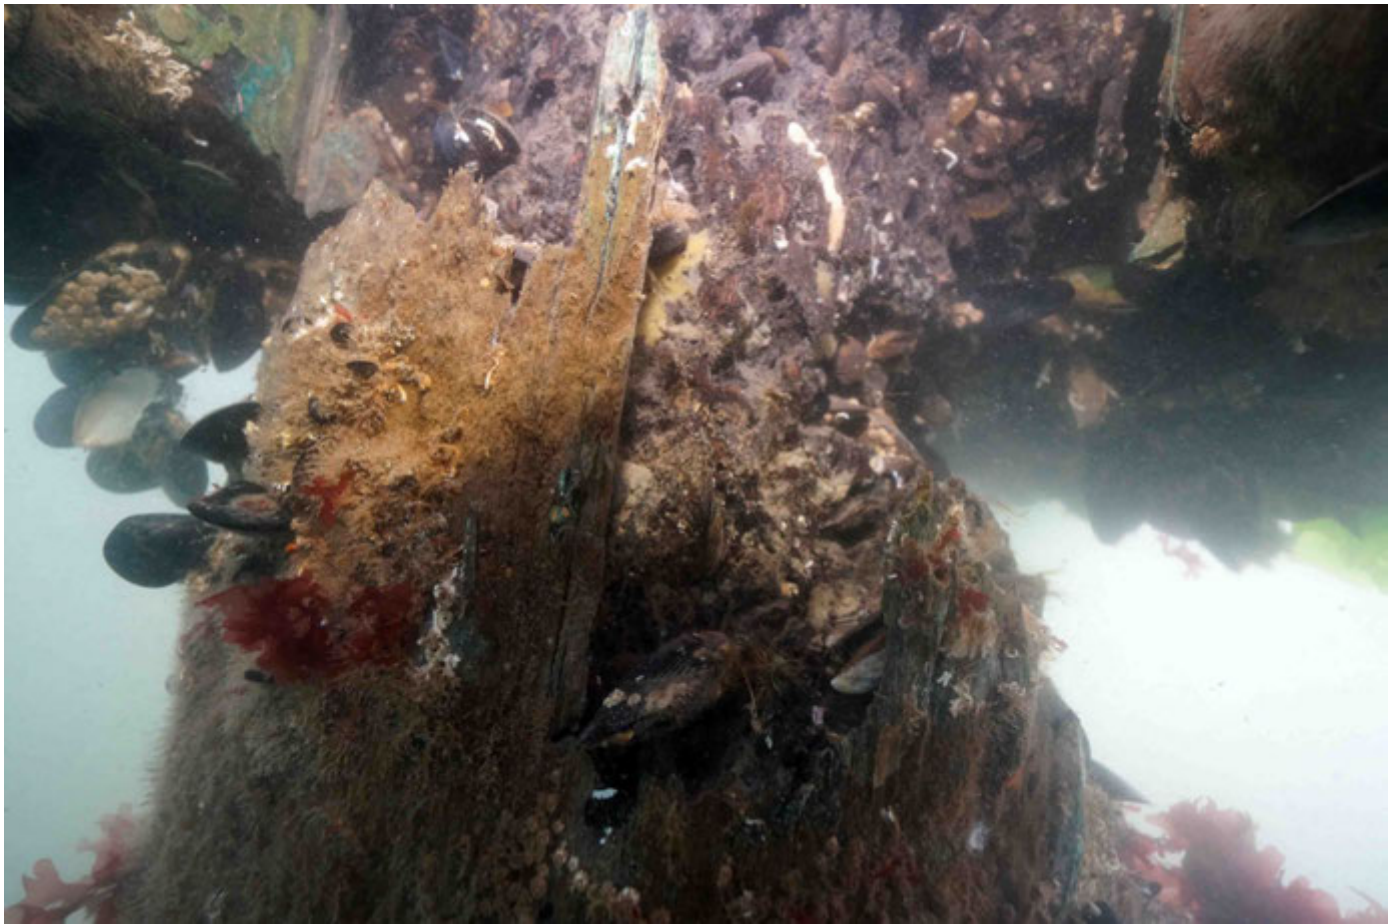
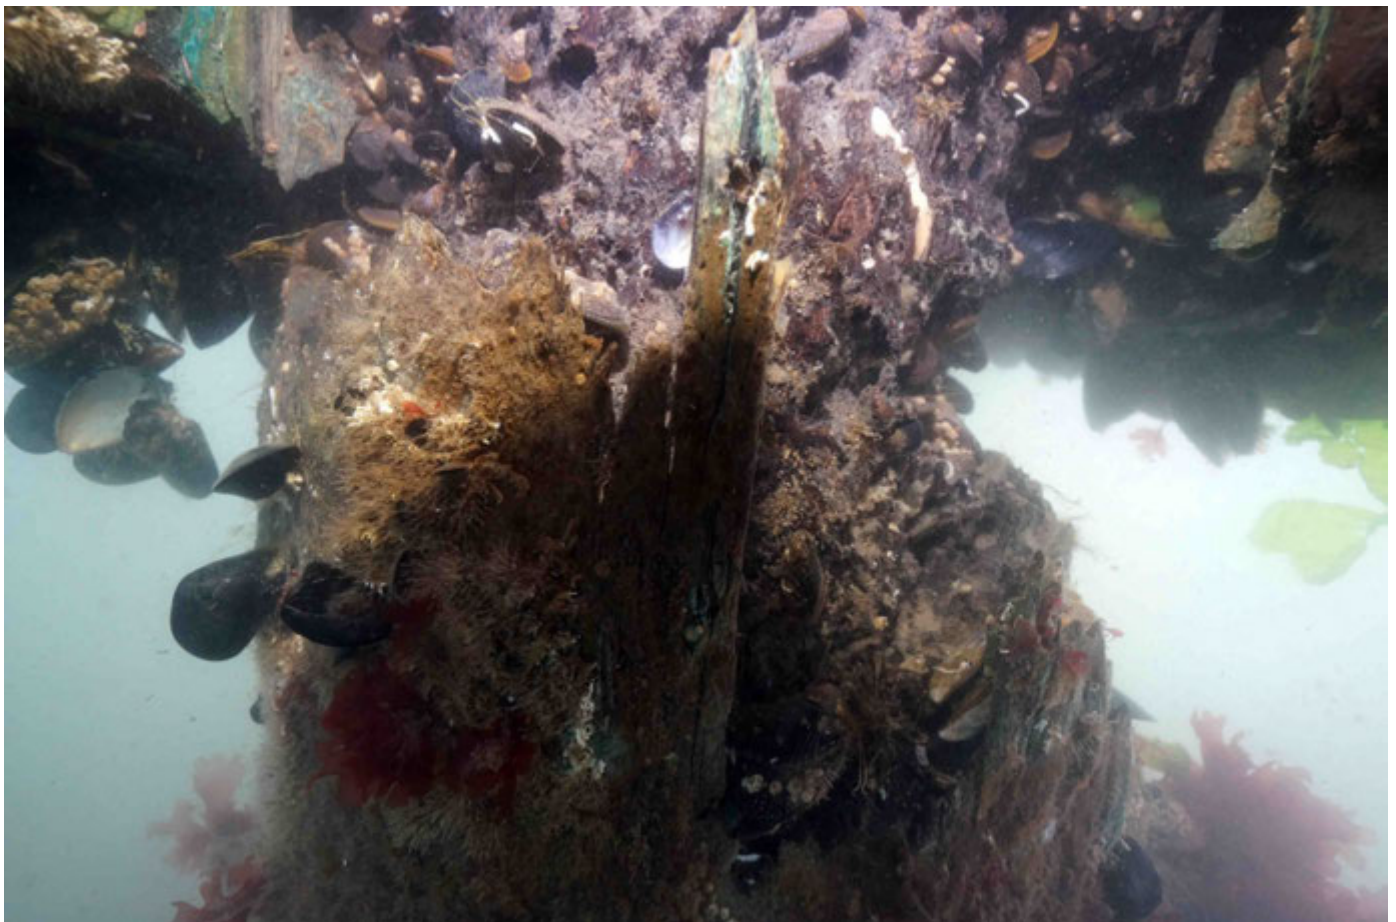
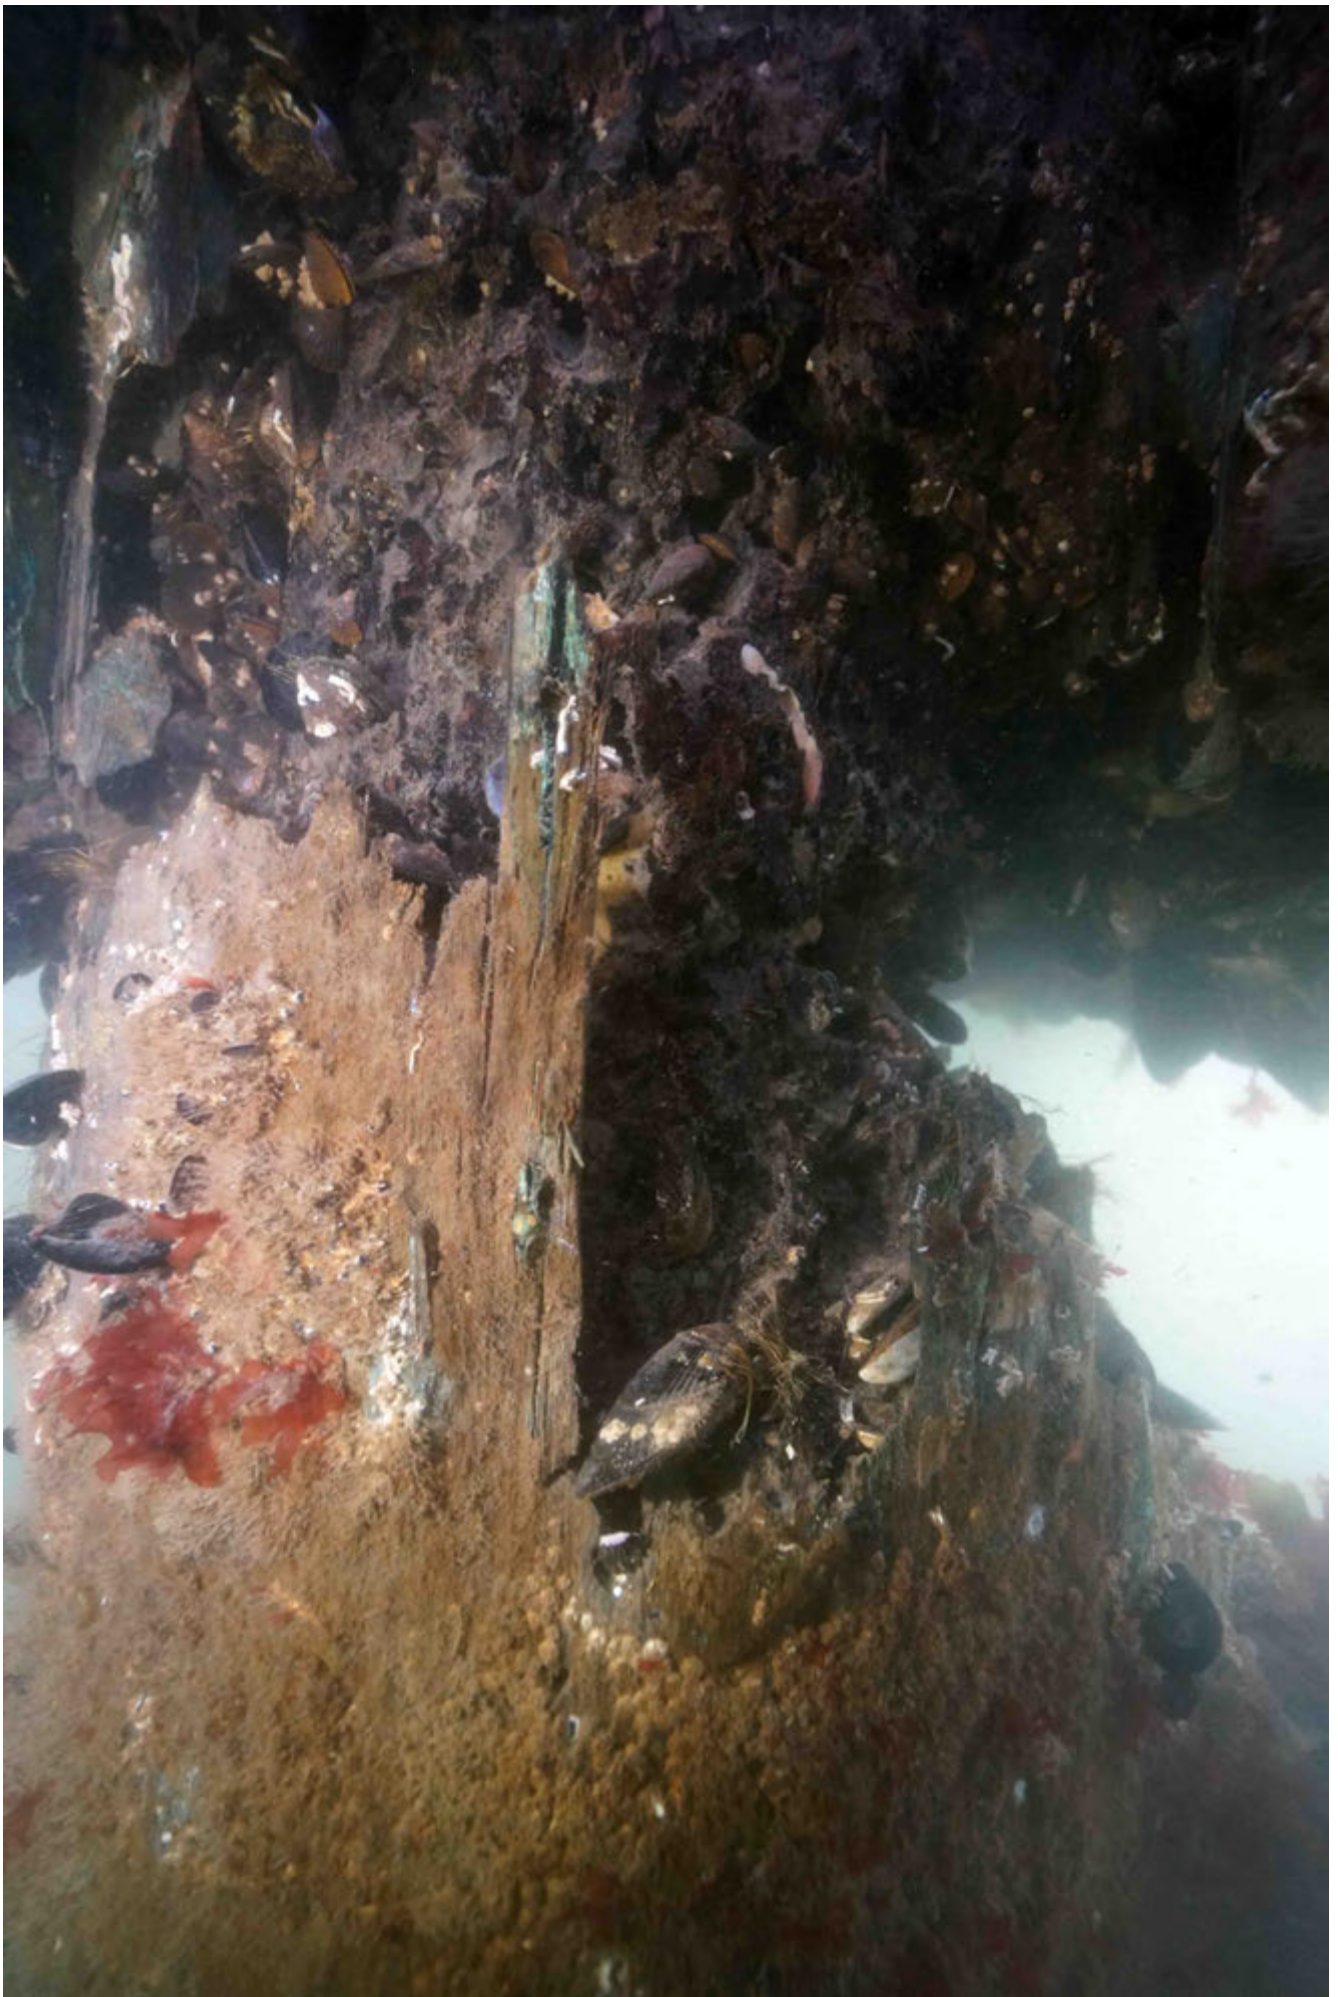
Pile 25D: Poor Condition – 60% loss of section within tidal zone

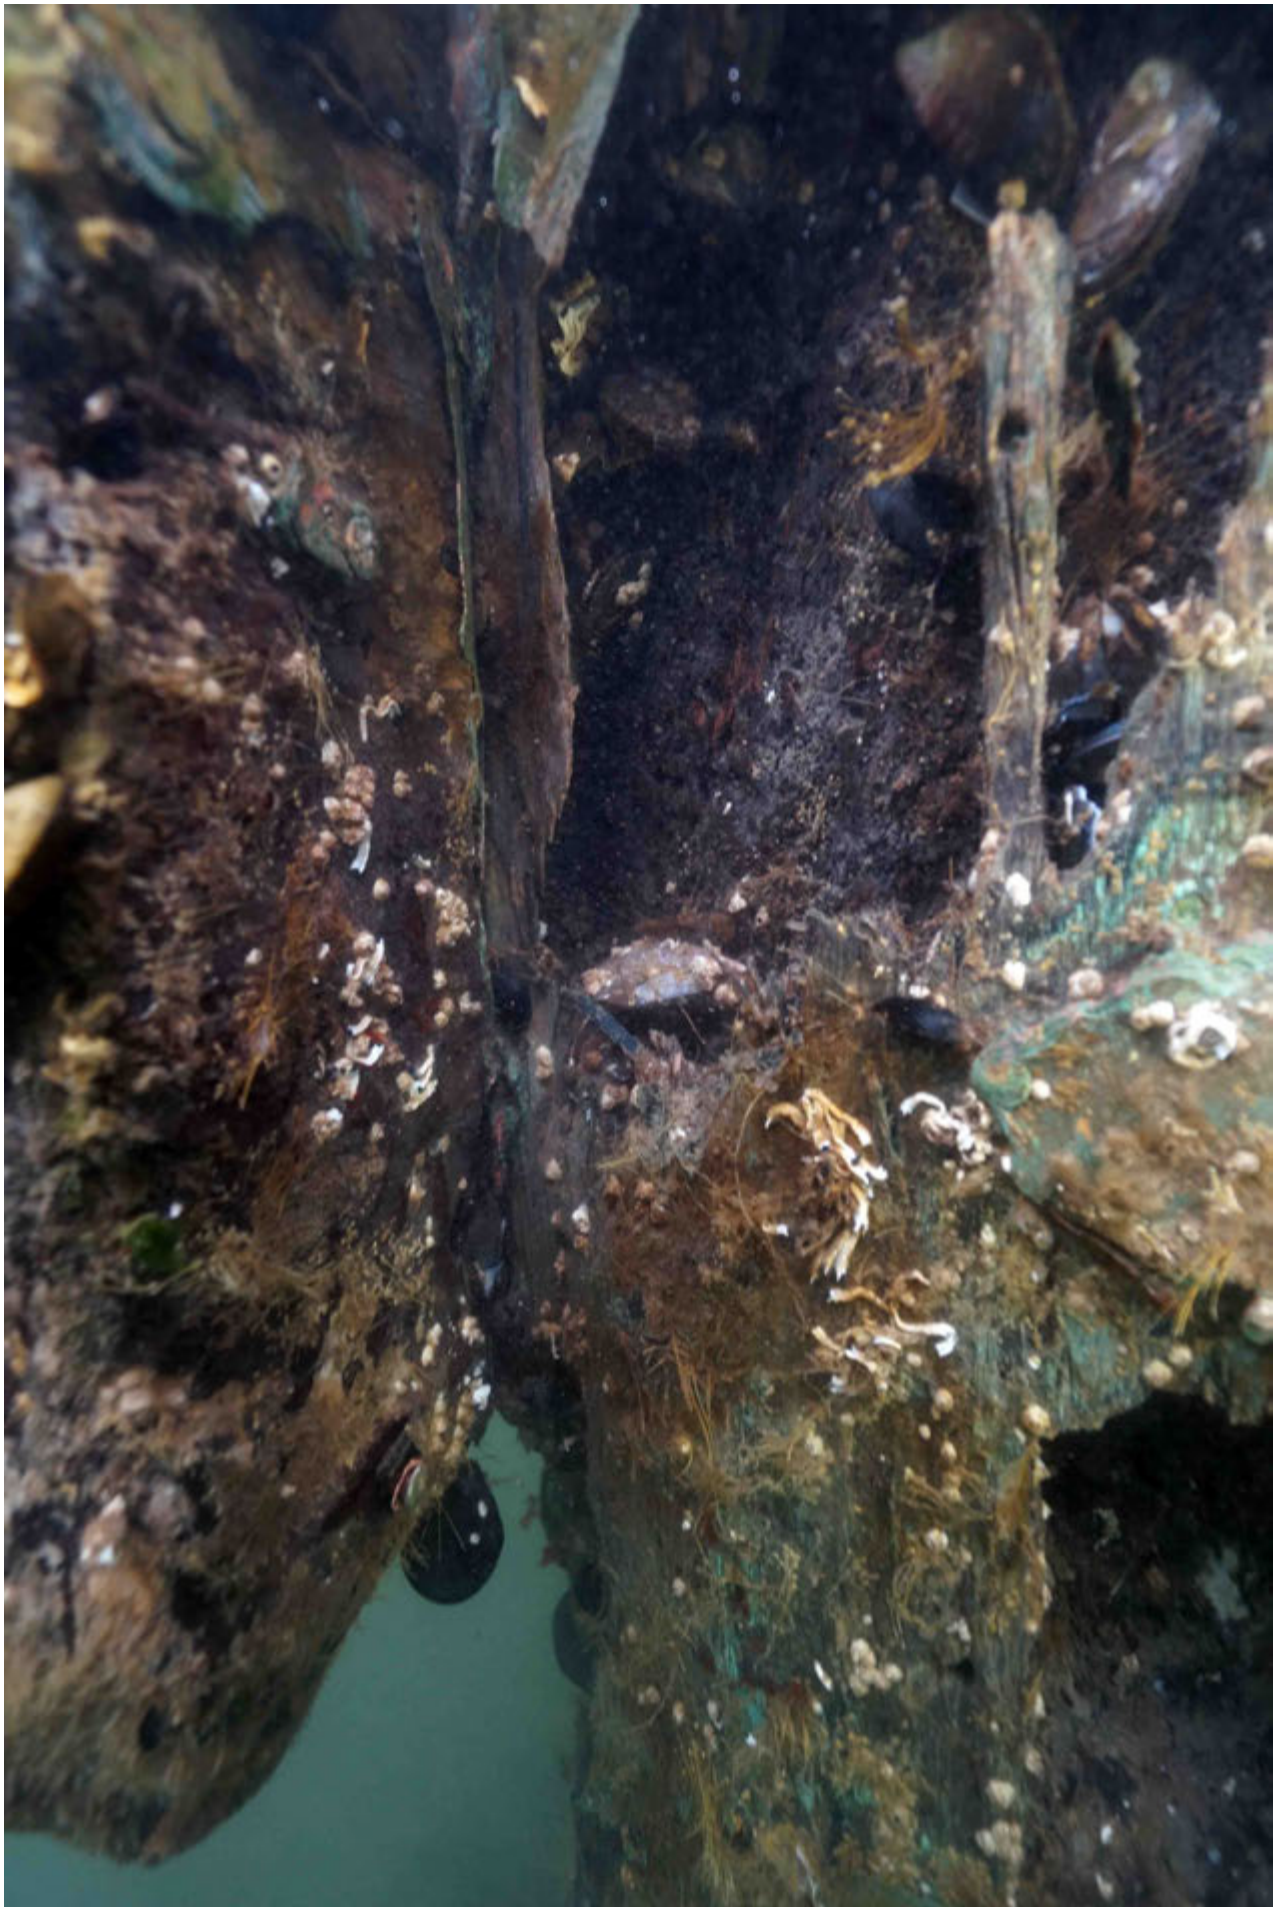
Pile 26F: Poor Condition – 60% loss of section – lower tidal zone
