Document Title:	HCC Petone Wharf – Approach Structure – Pile Condition Survey & Reporting
Document No.:	UCL – 2021.01 – HCC Wharf Approach PCS&R001 – V2
	Prepared for: Tom Arthur – Calibre Group Janet Lawson – Hutt City Council Francis O’Riley – G.K. Shaw Ltd.

Petone Wharf – Approach Structure

Pile Condition Survey & Reporting

January 2021

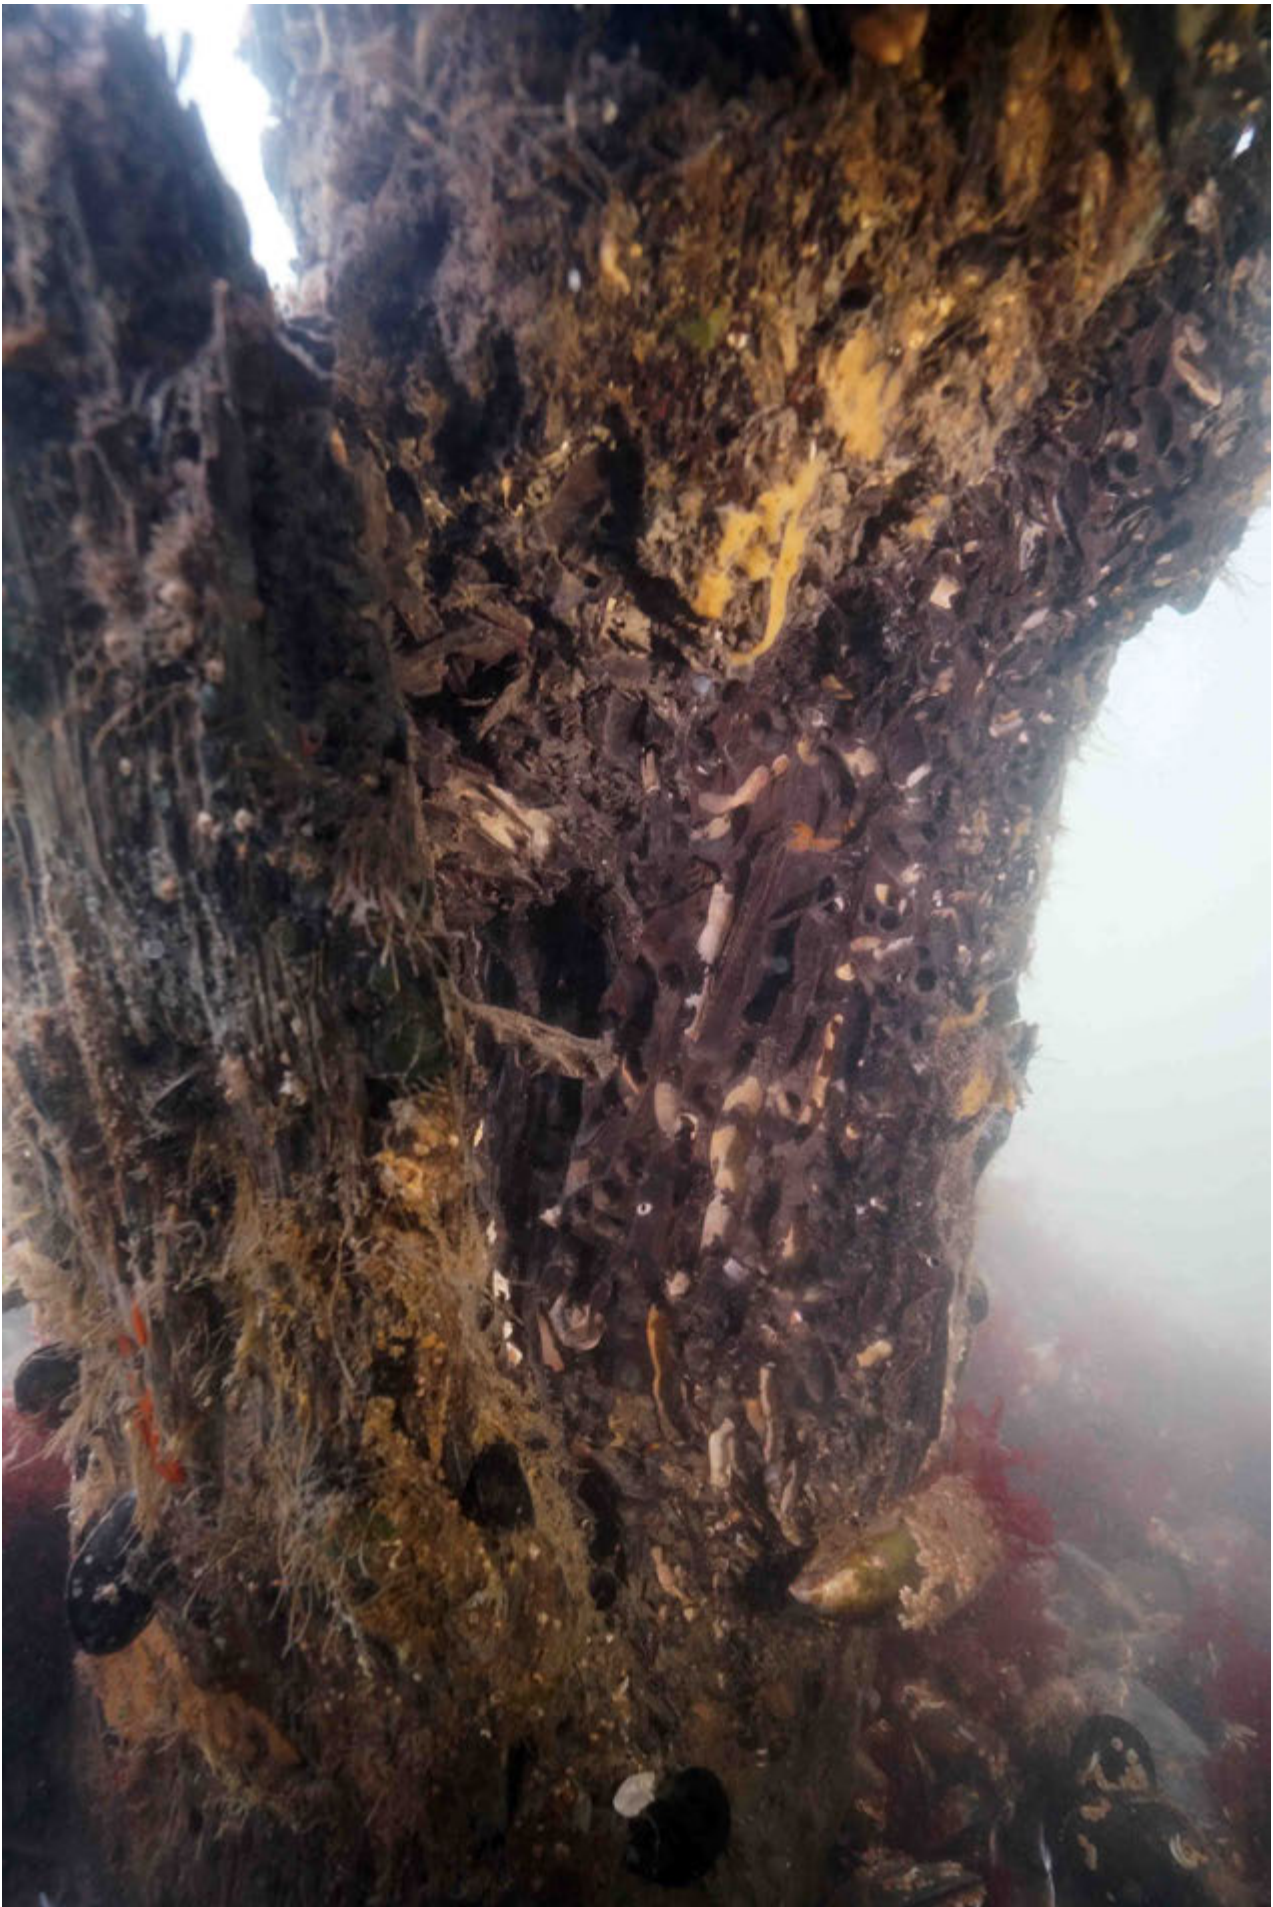
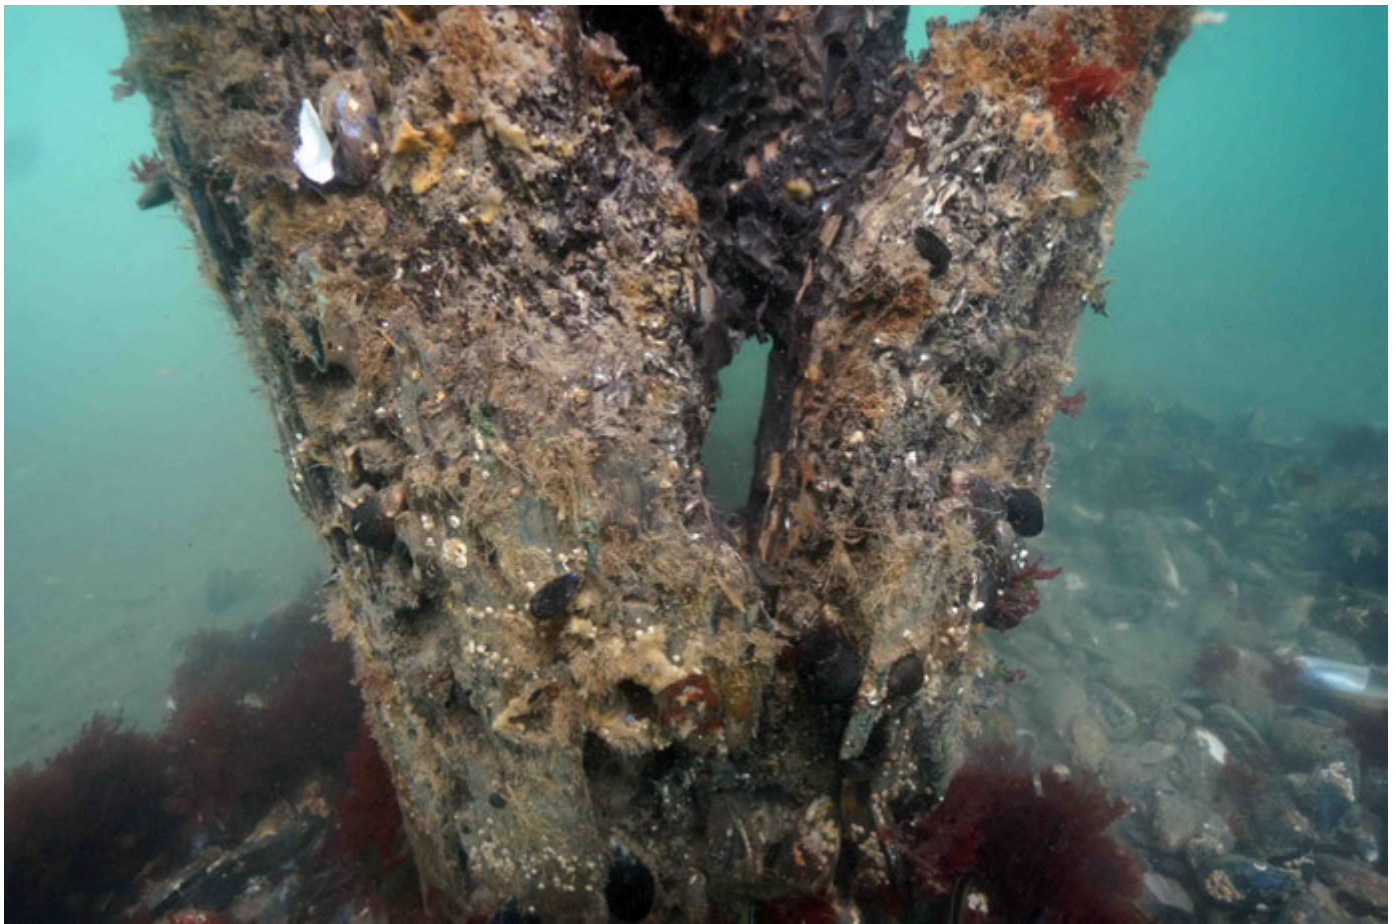
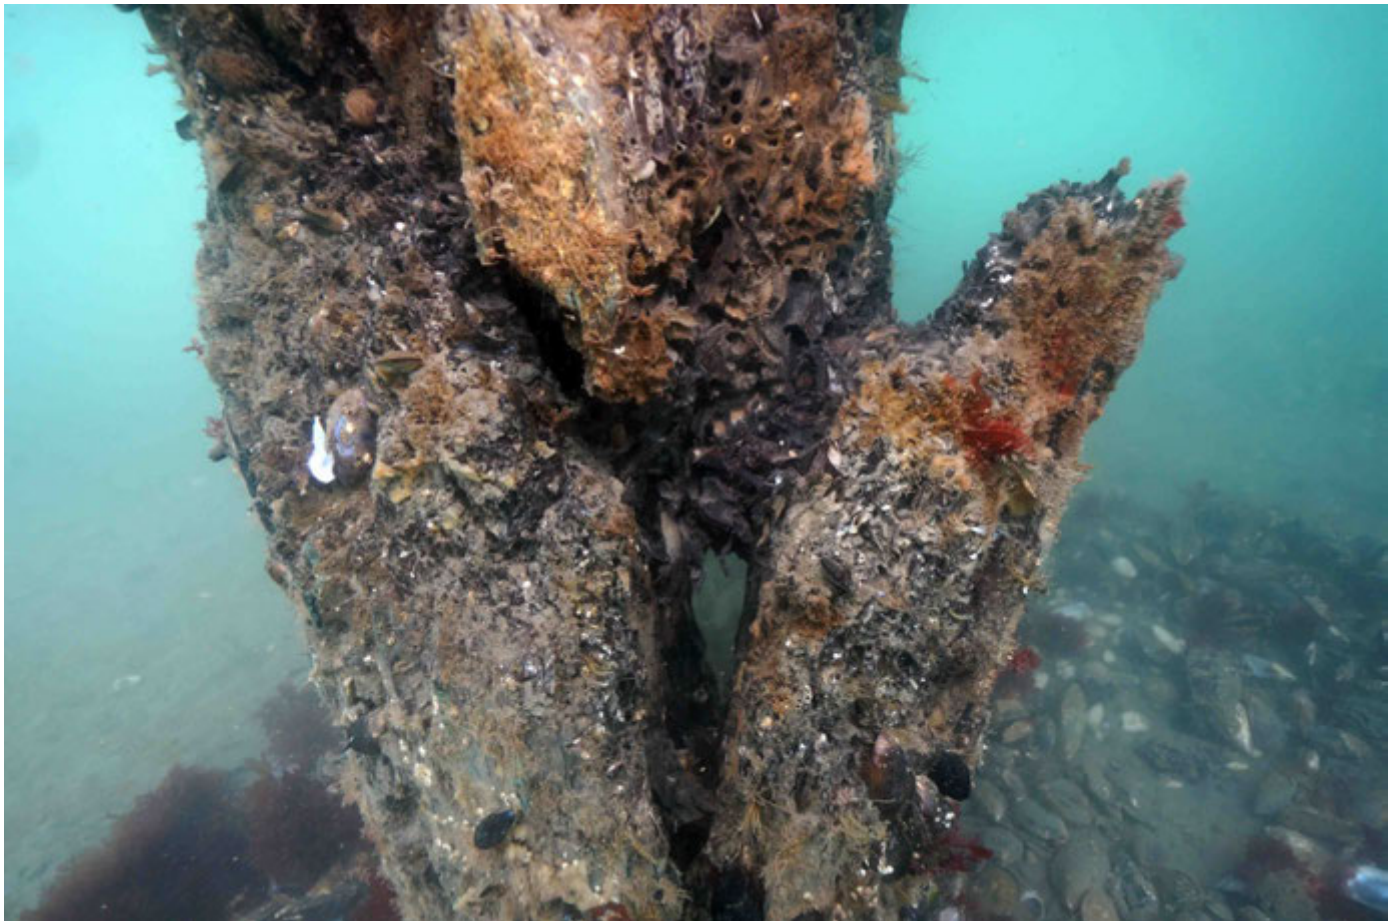
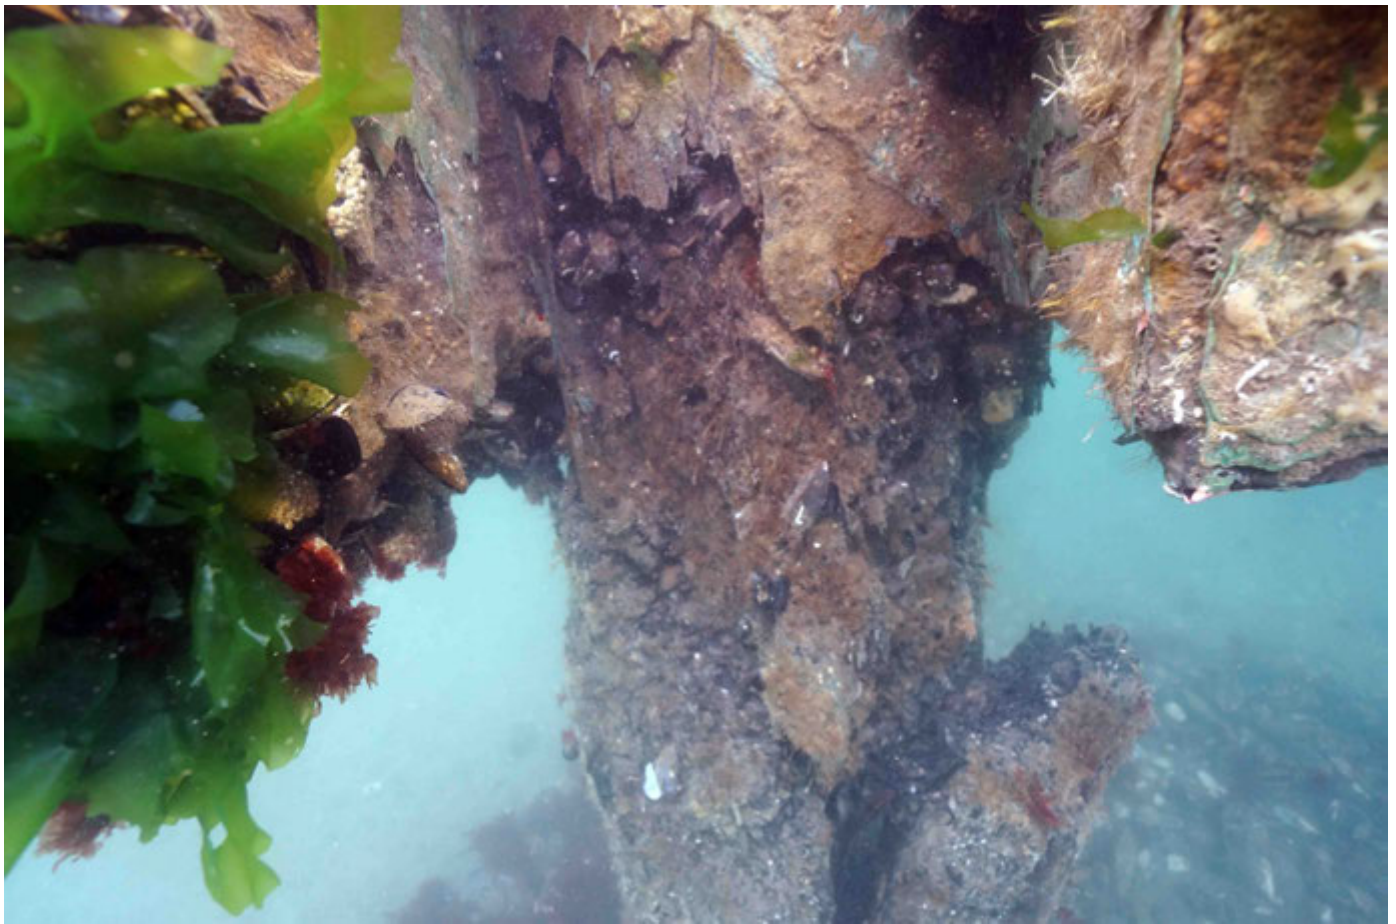
Pile 27C: Very Poor Condition – broken pile

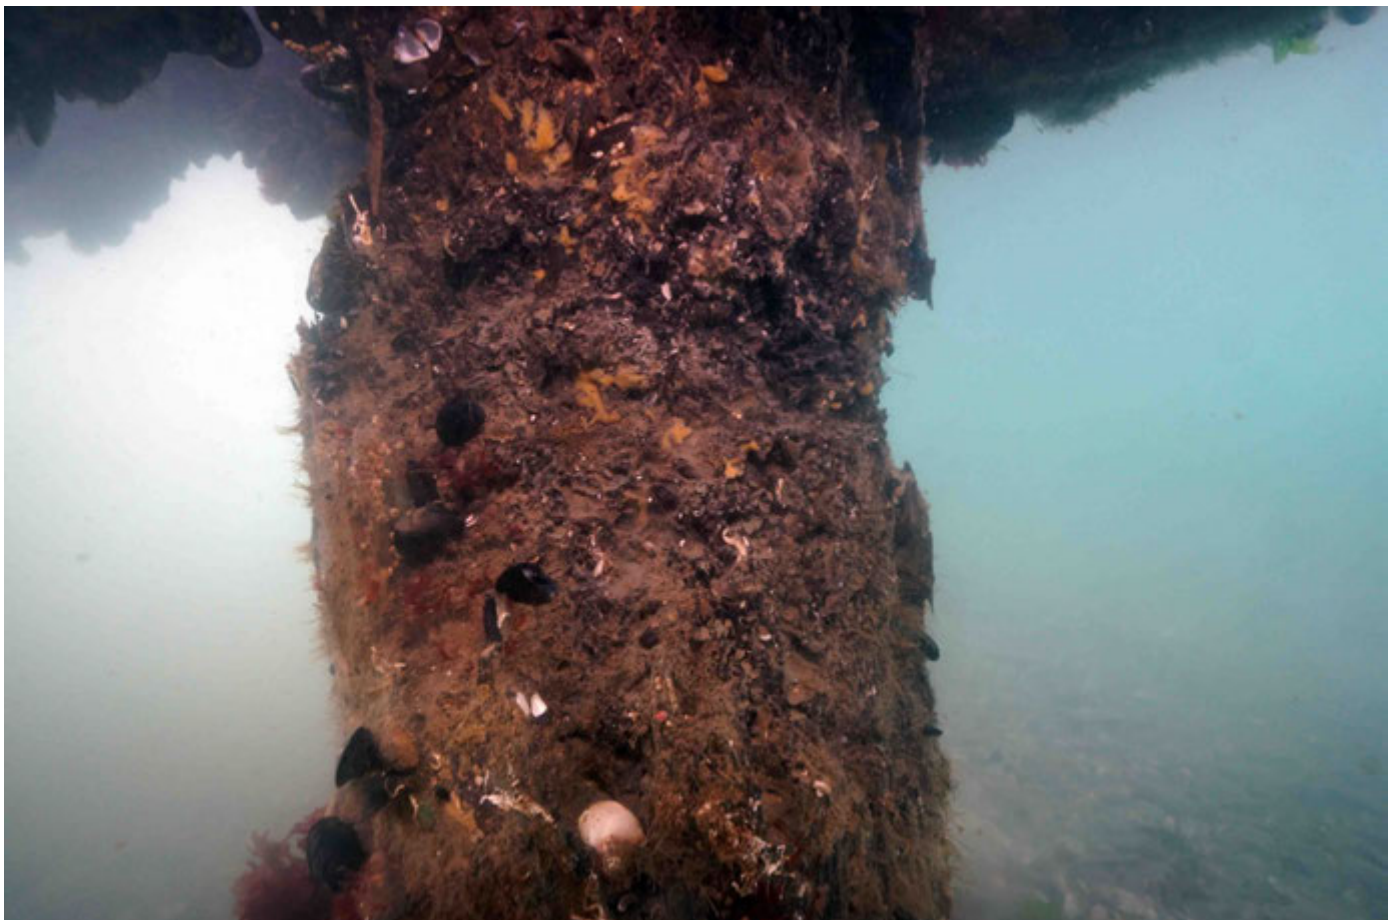
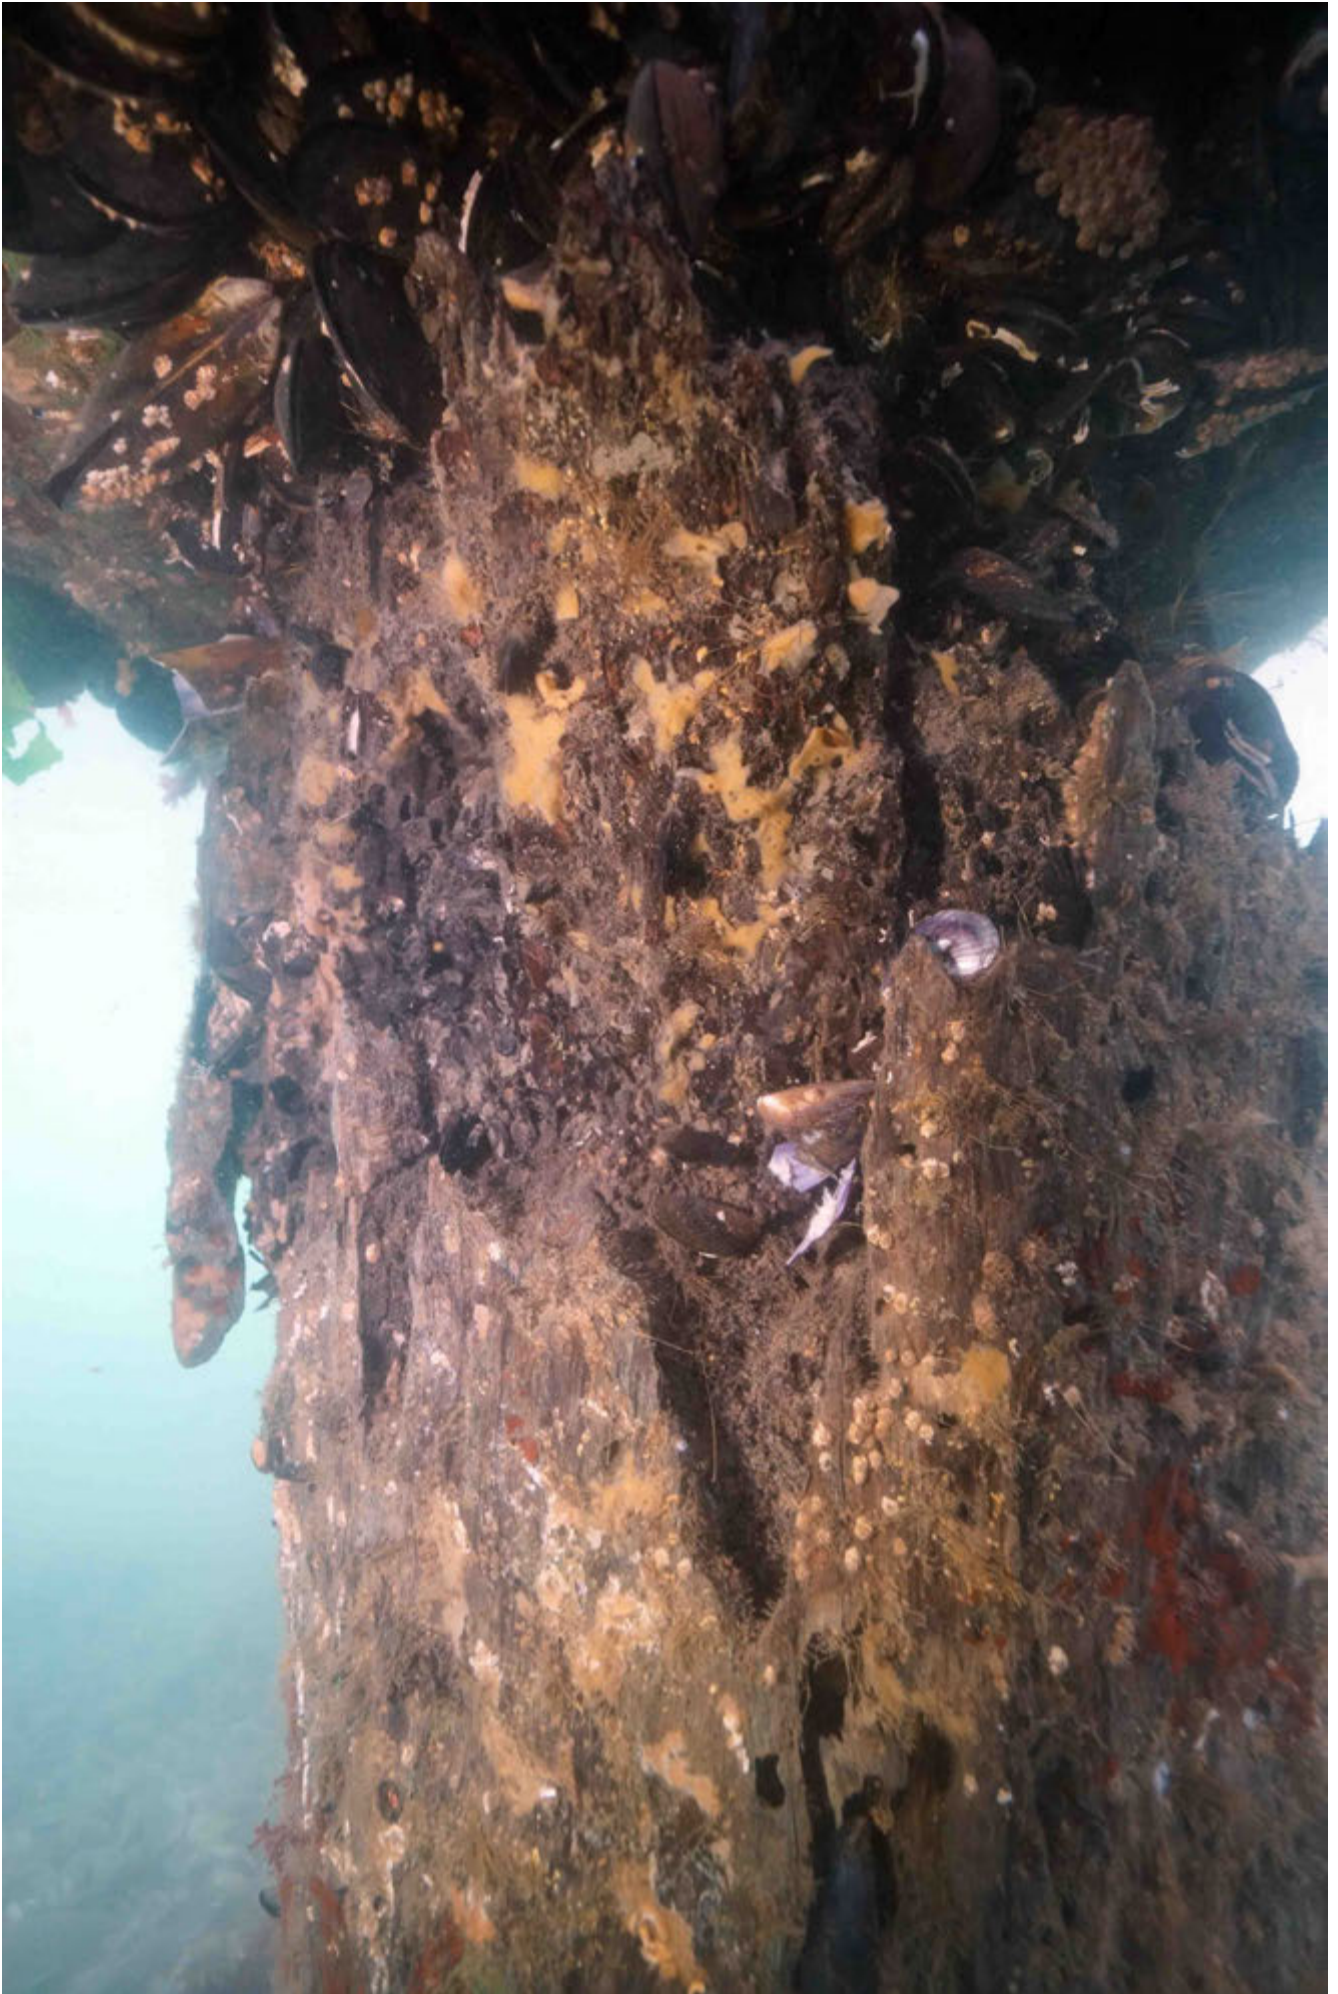
Pile 27D: Very Poor Condition – broken pile

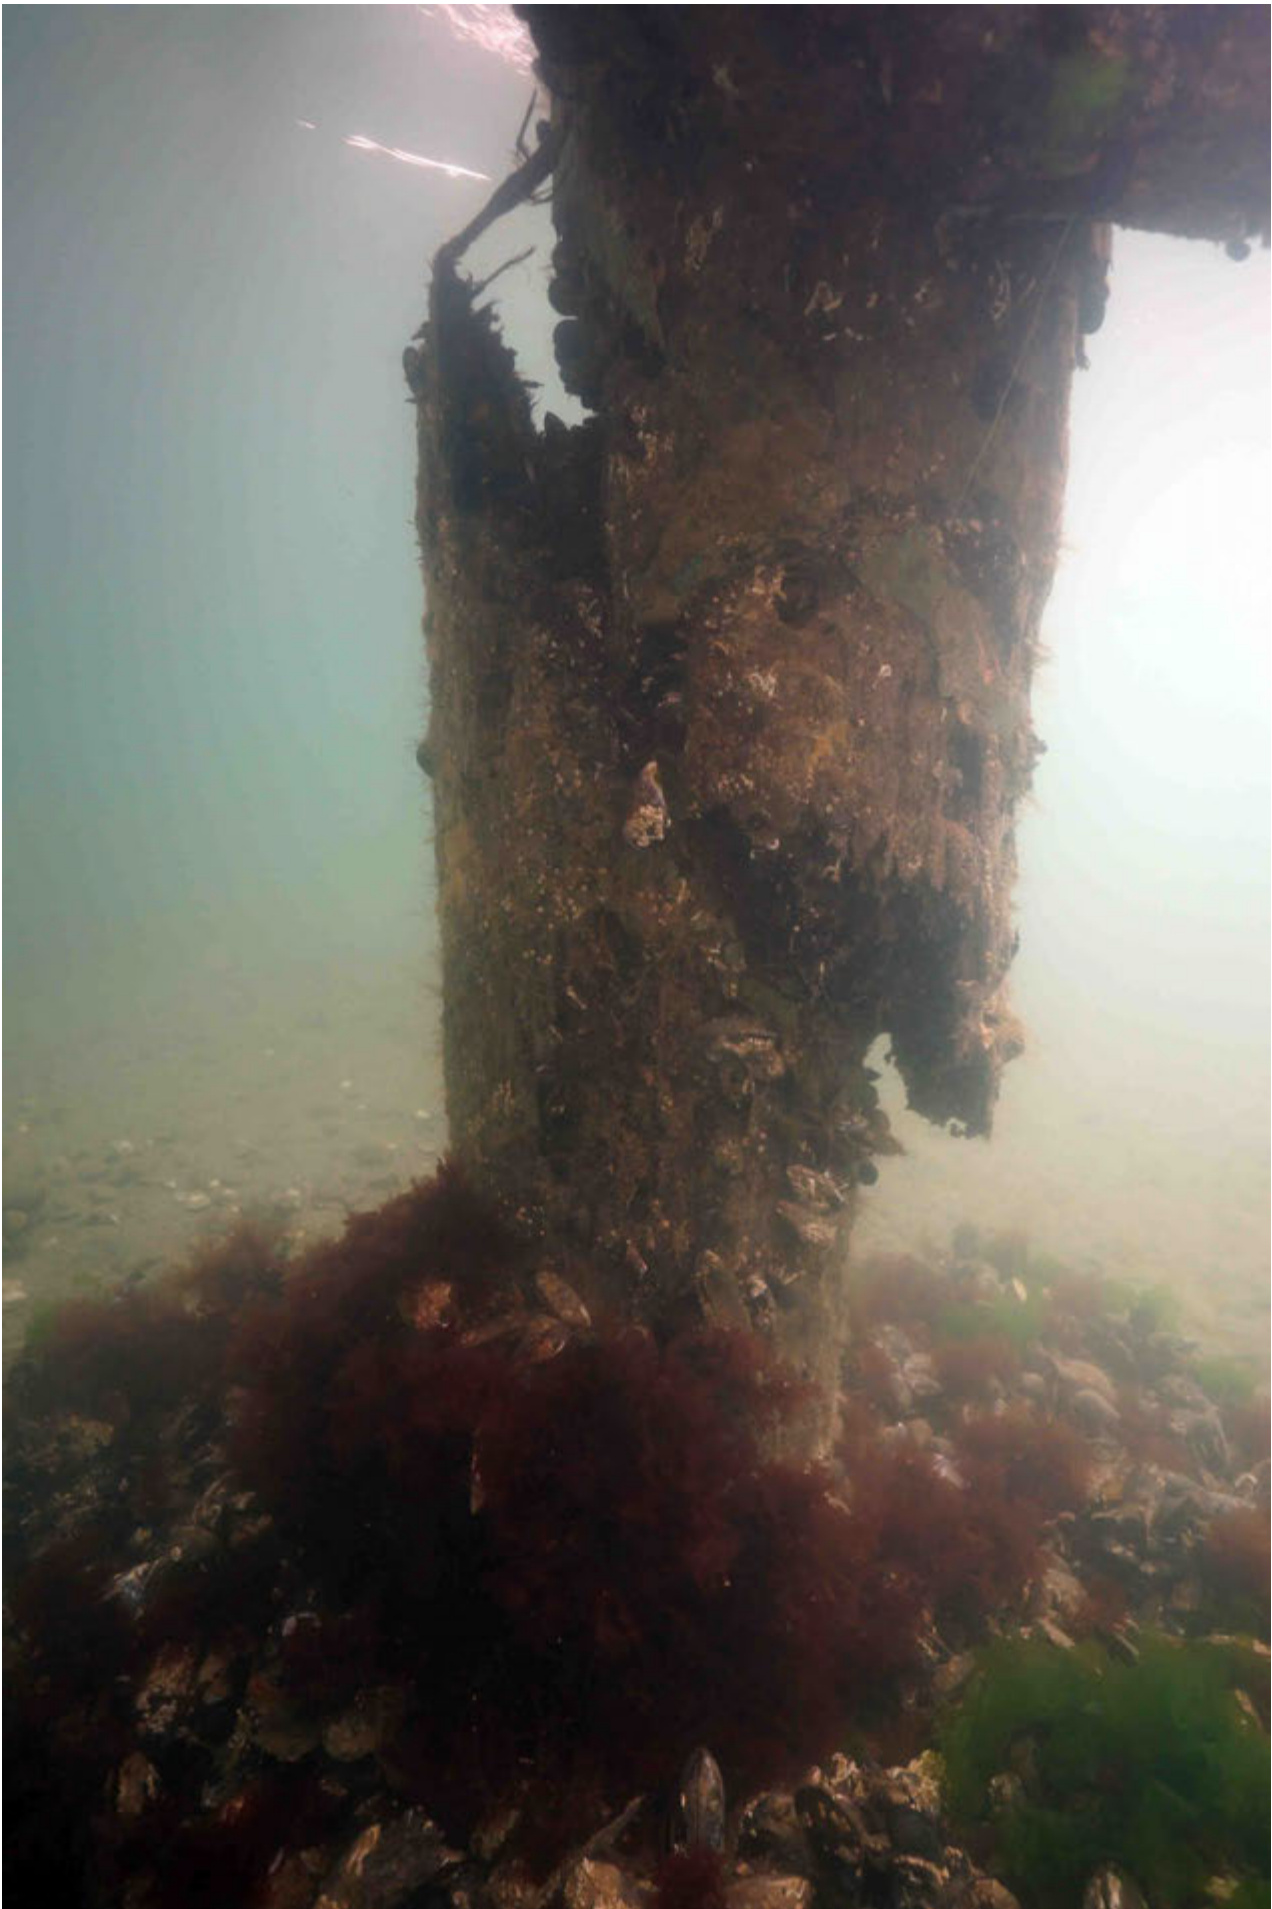
Pile 28C: Very Poor Condition – broken pile

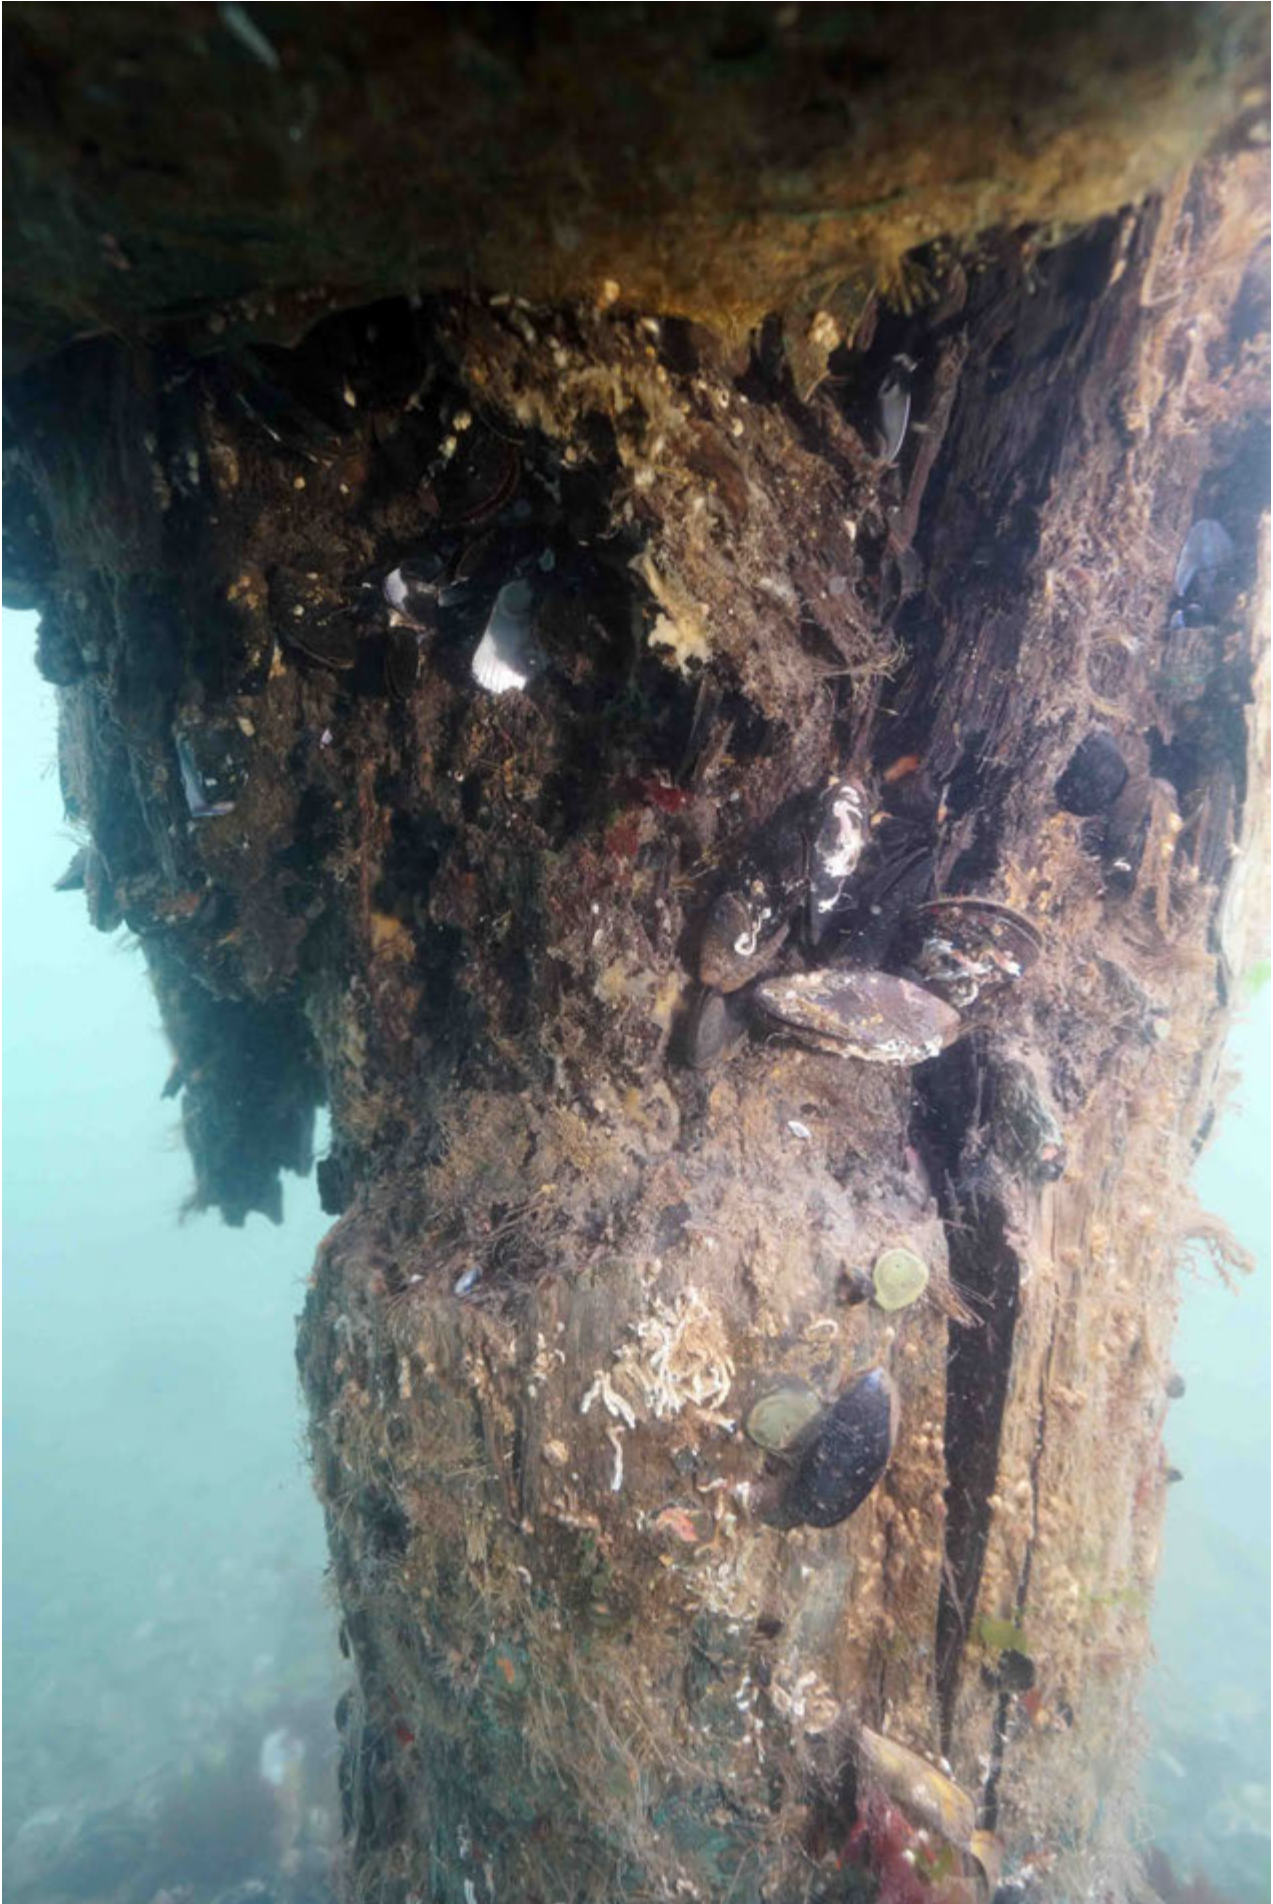
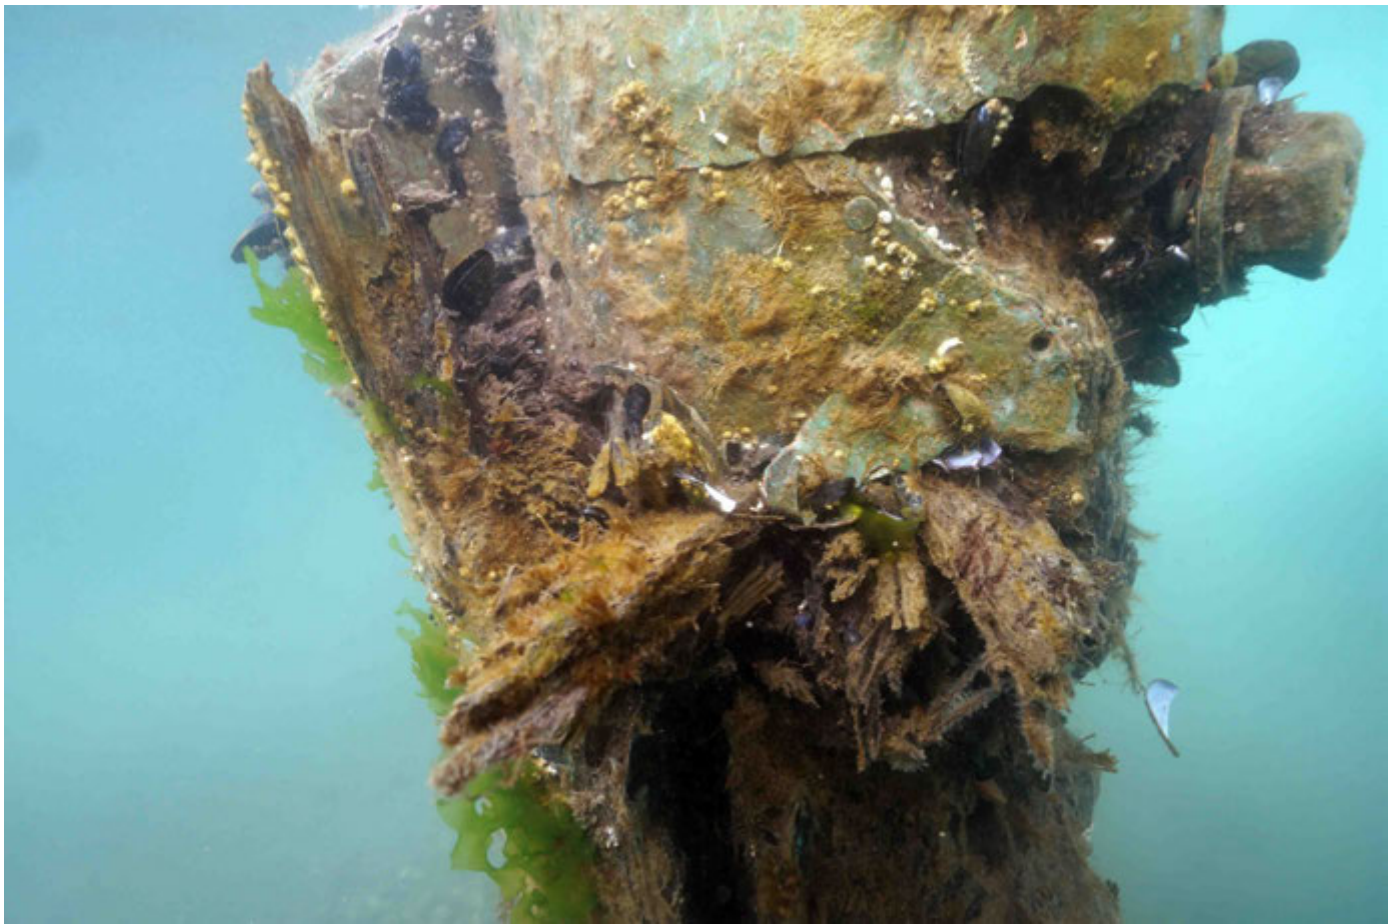
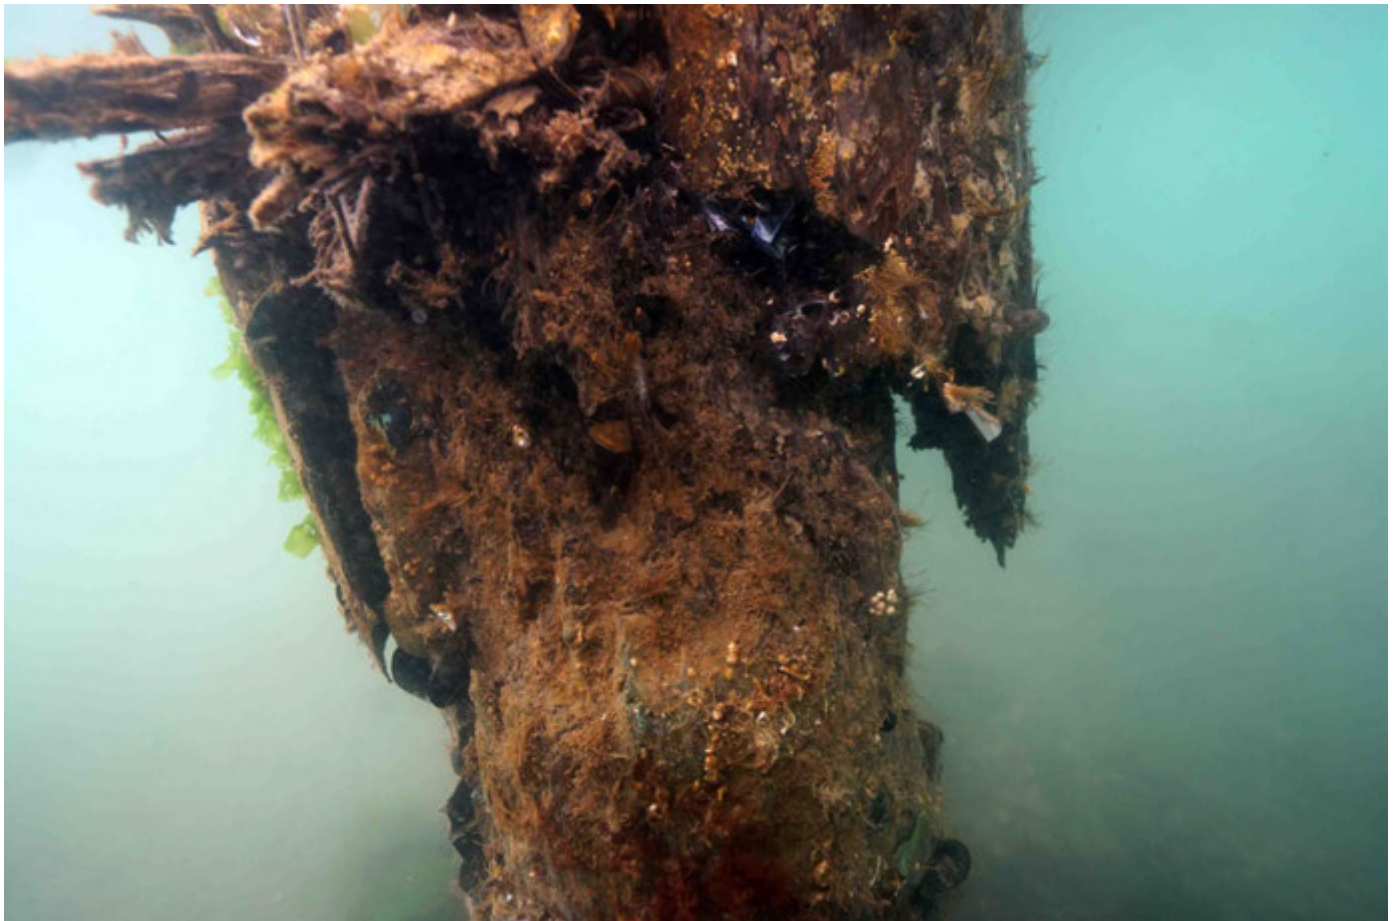
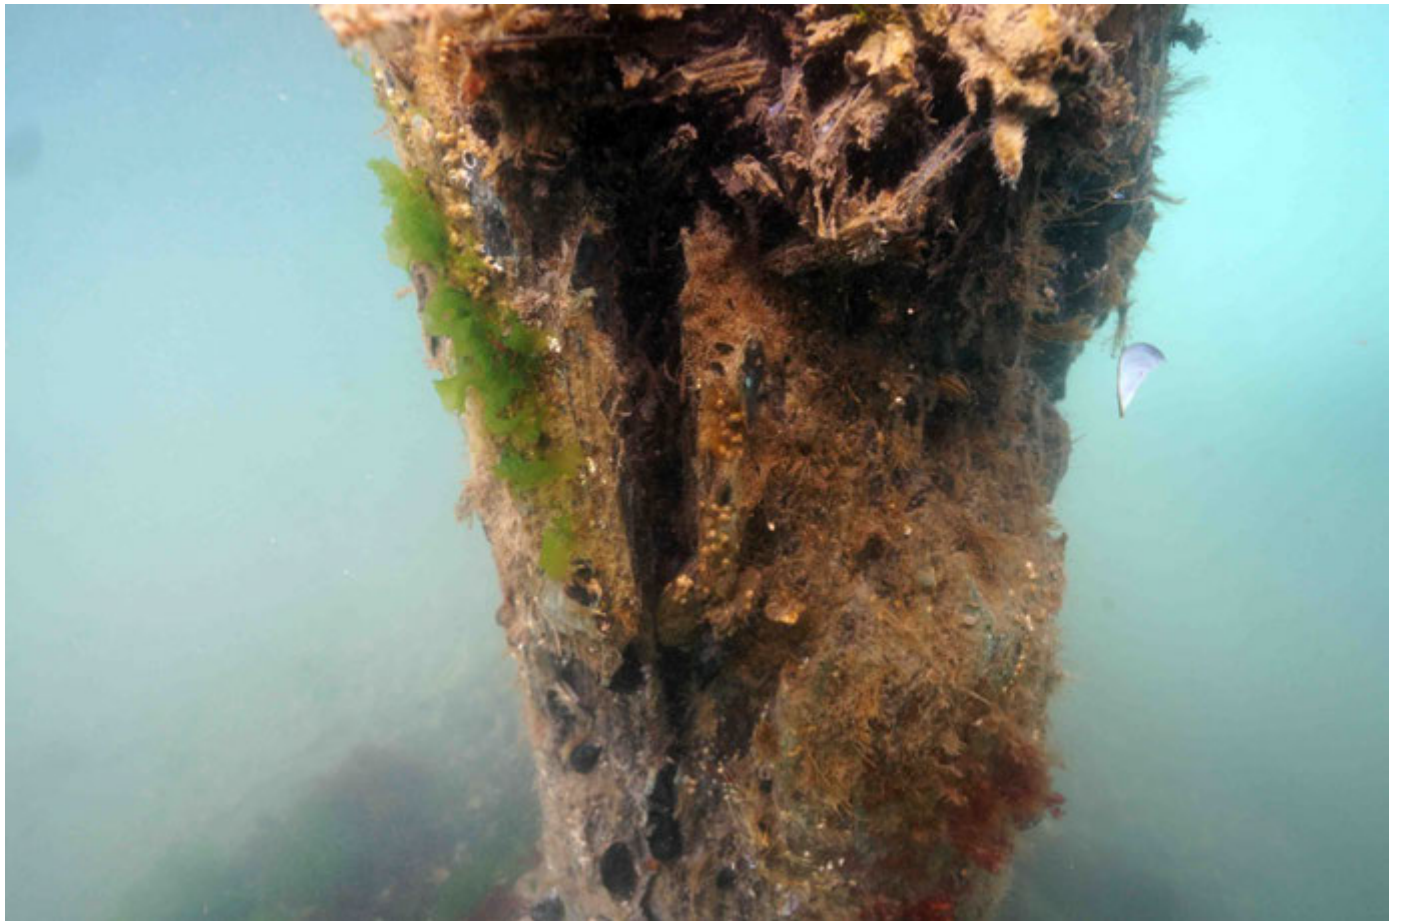
Pile 28D: Very Poor Condition – broken pile
