Document Title:	HCC Petone Wharf – Approach Structure – Pile Condition Survey & Reporting
Document No.:	UCL – 2021.01 – HCC Wharf Approach PCS&R001 – V2
	Prepared for: Tom Arthur – Calibre Group Janet Lawson – Hutt City Council Francis O’Riley – G.K. Shaw Ltd.

Petone Wharf – Approach Structure

Pile Condition Survey & Reporting

January 2021

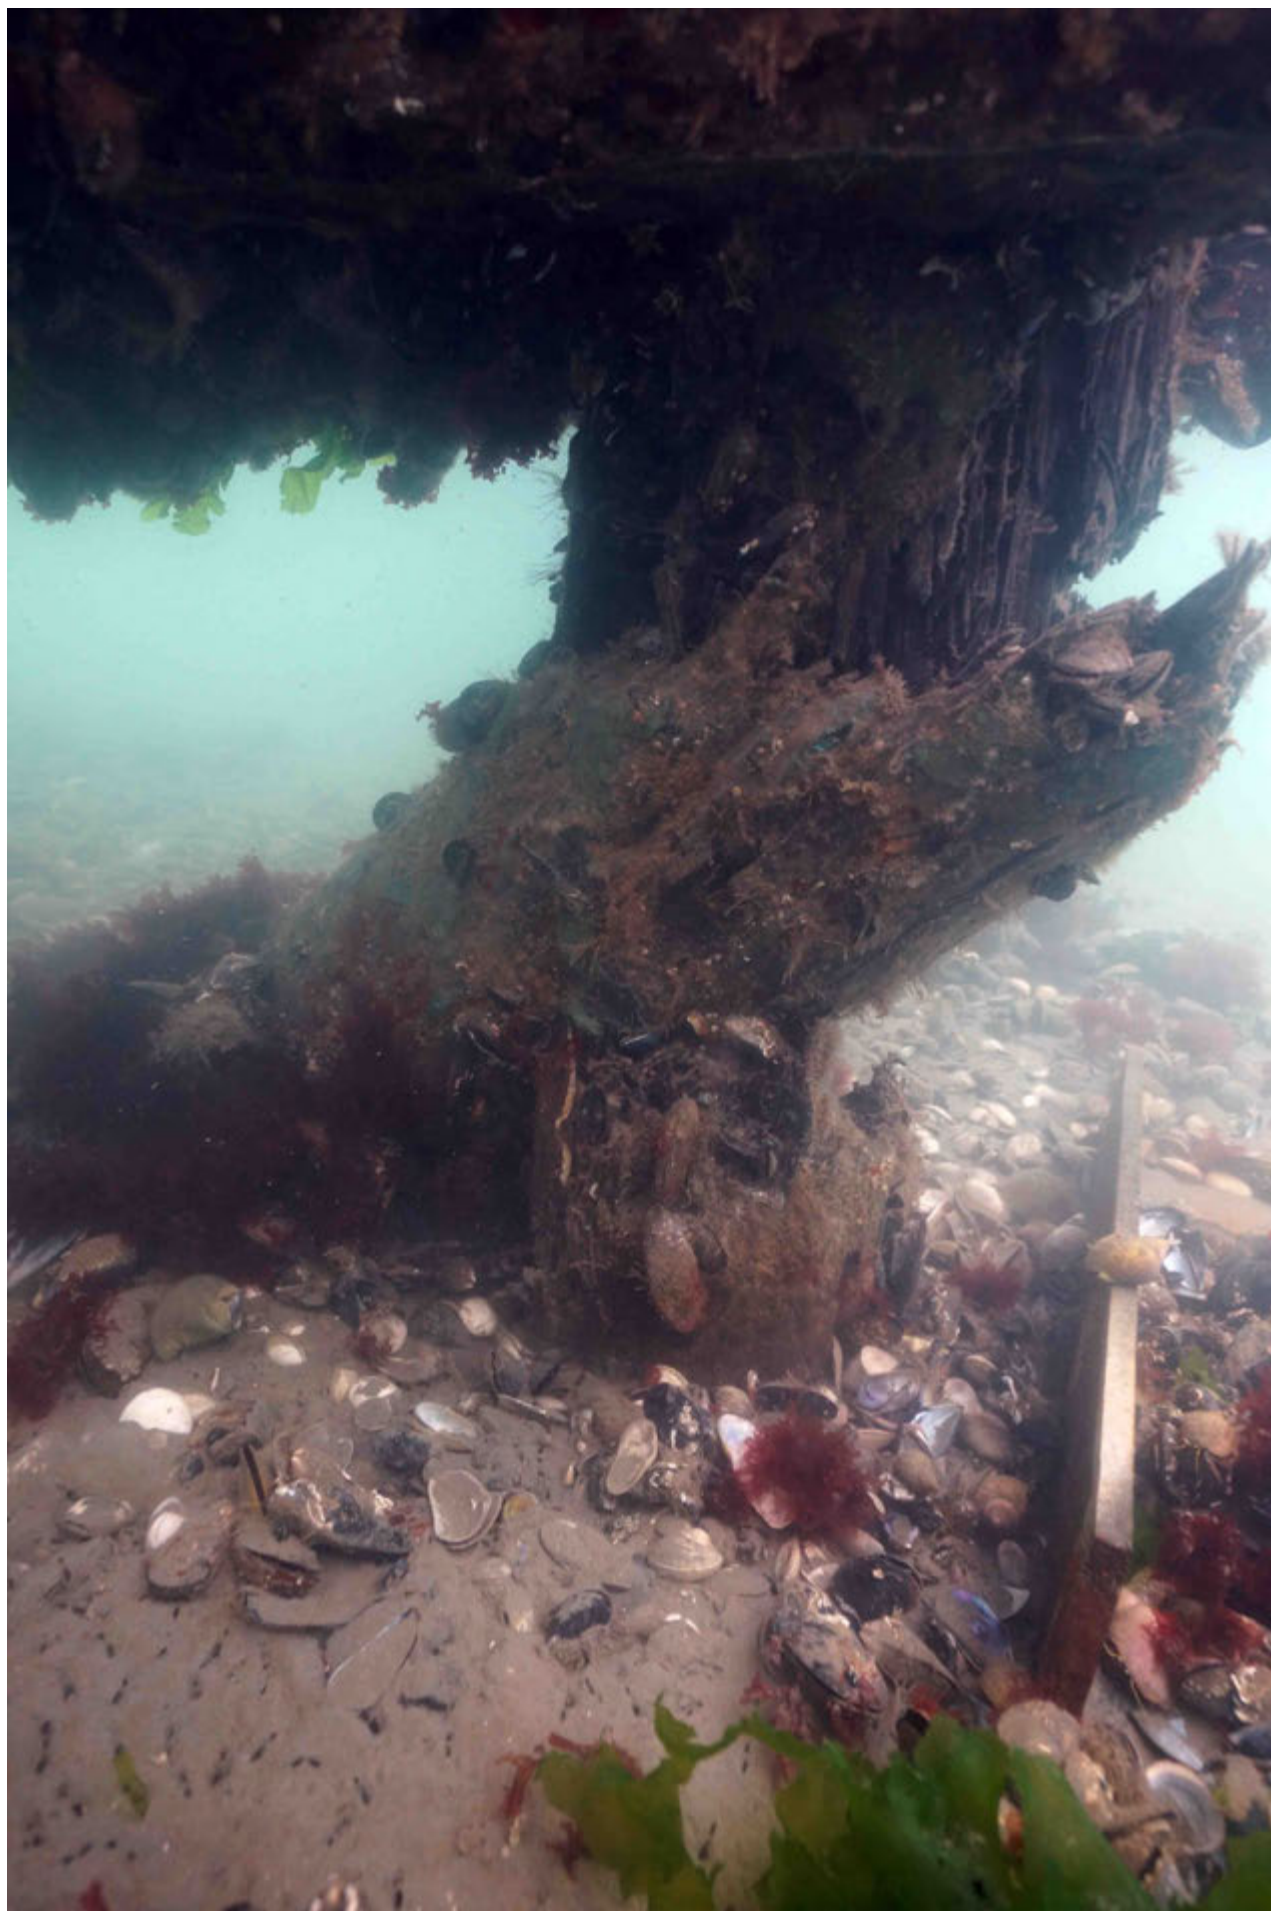
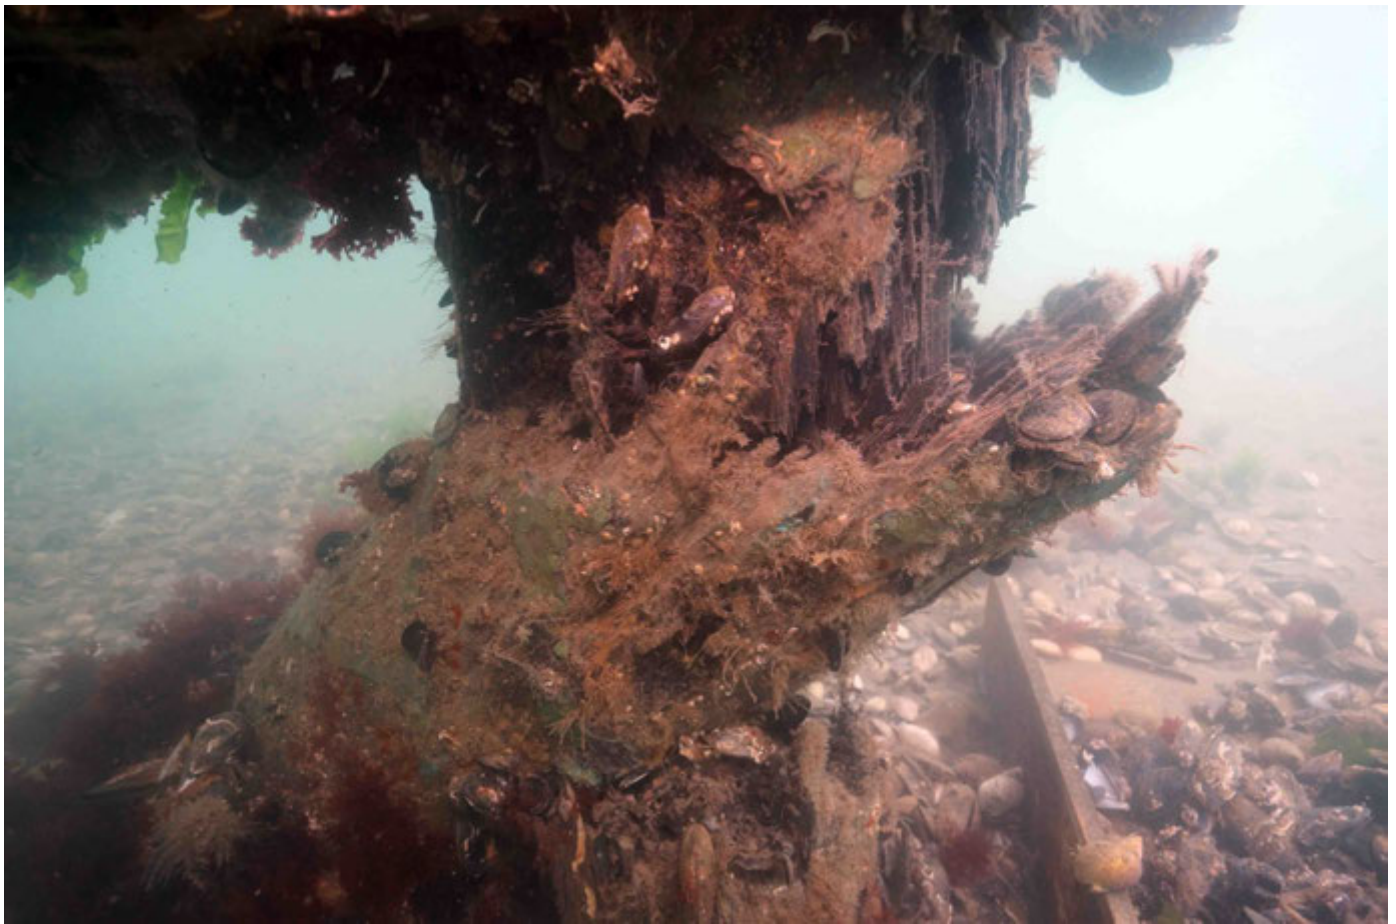
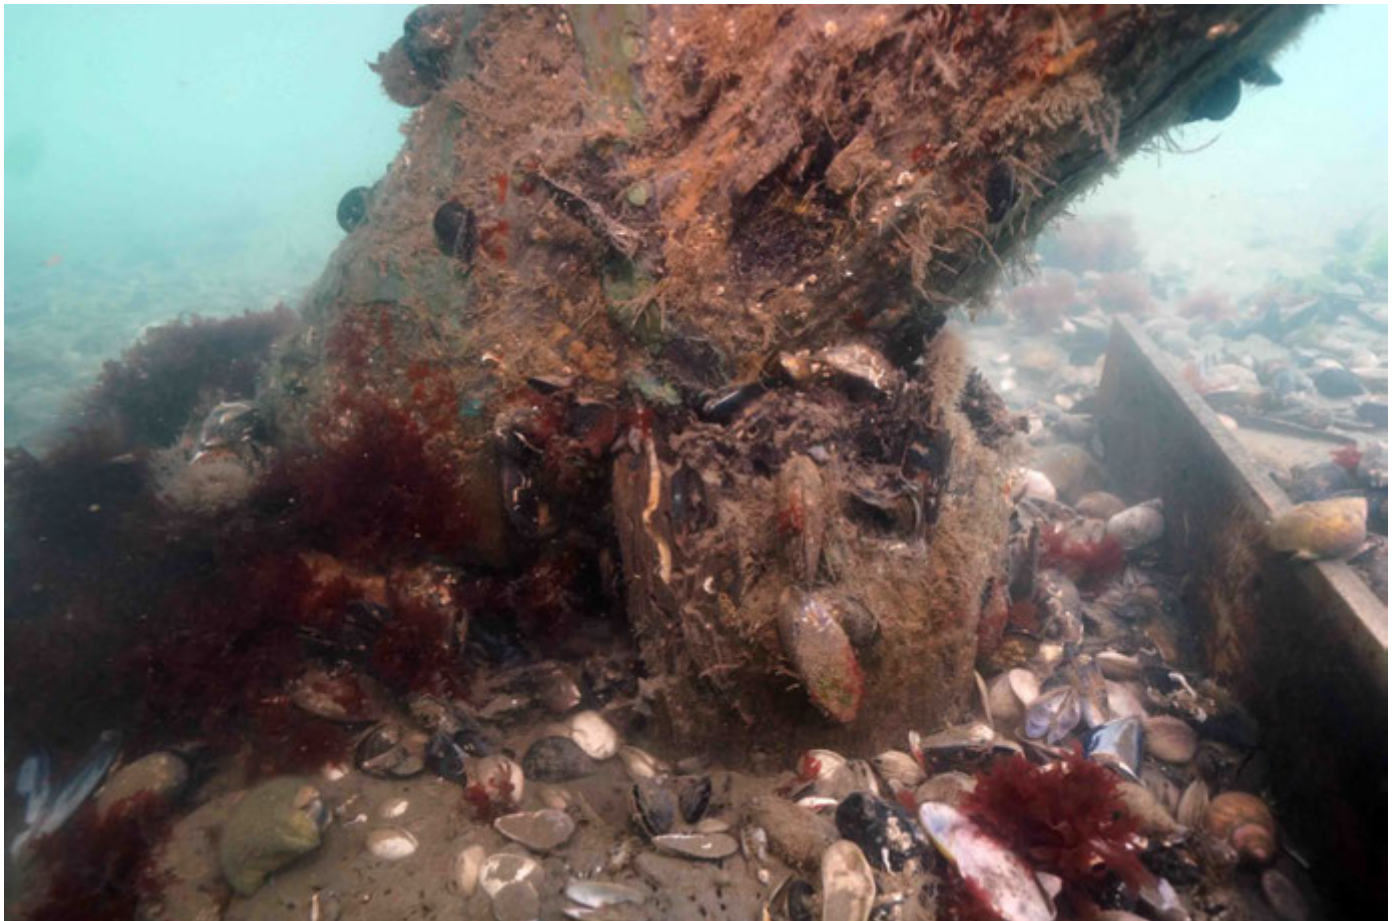
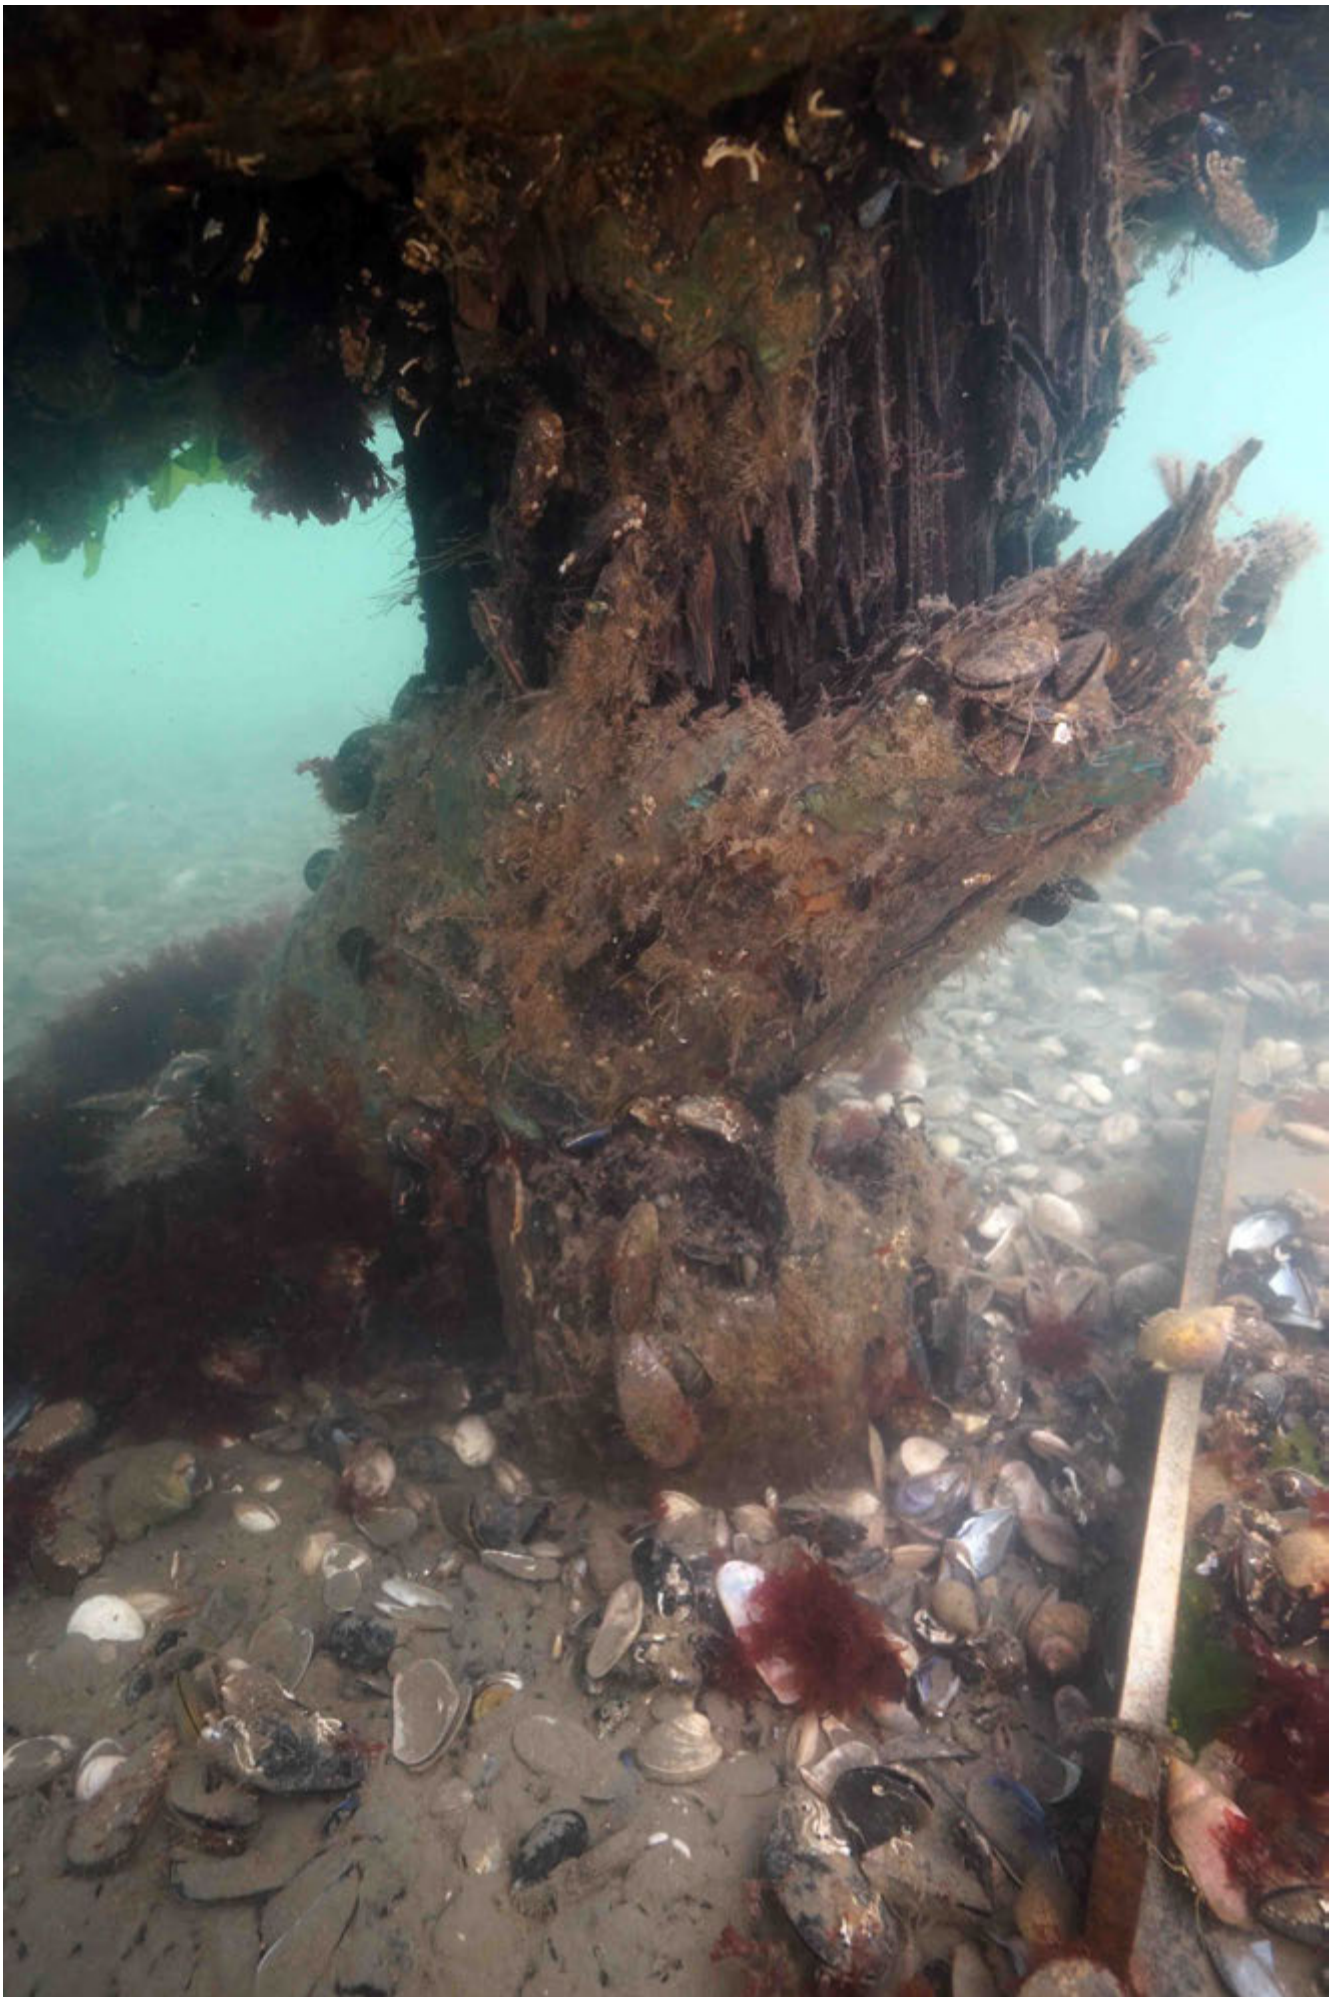
Pile 29C: Very Poor Condition – broken pile

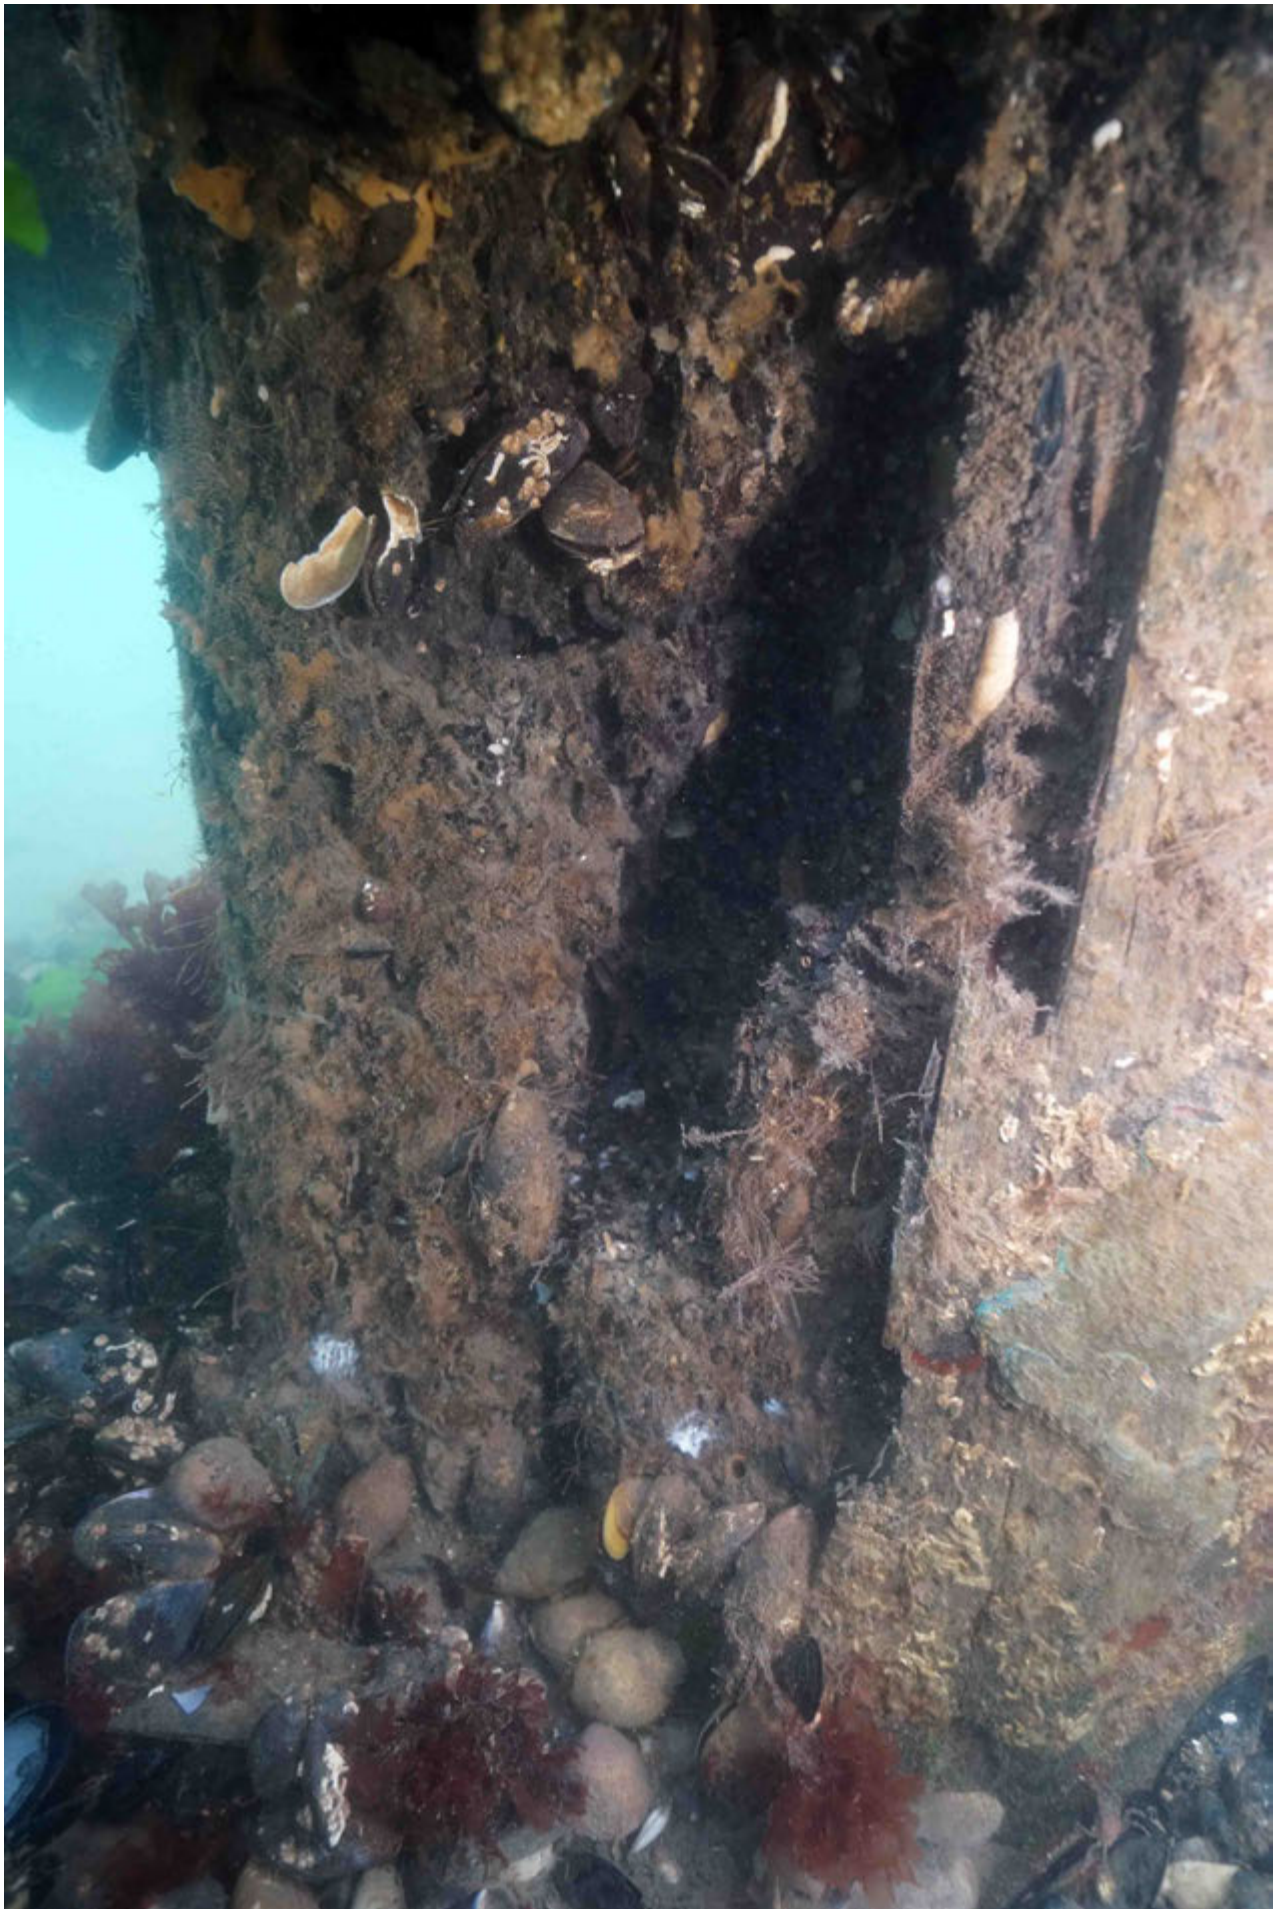
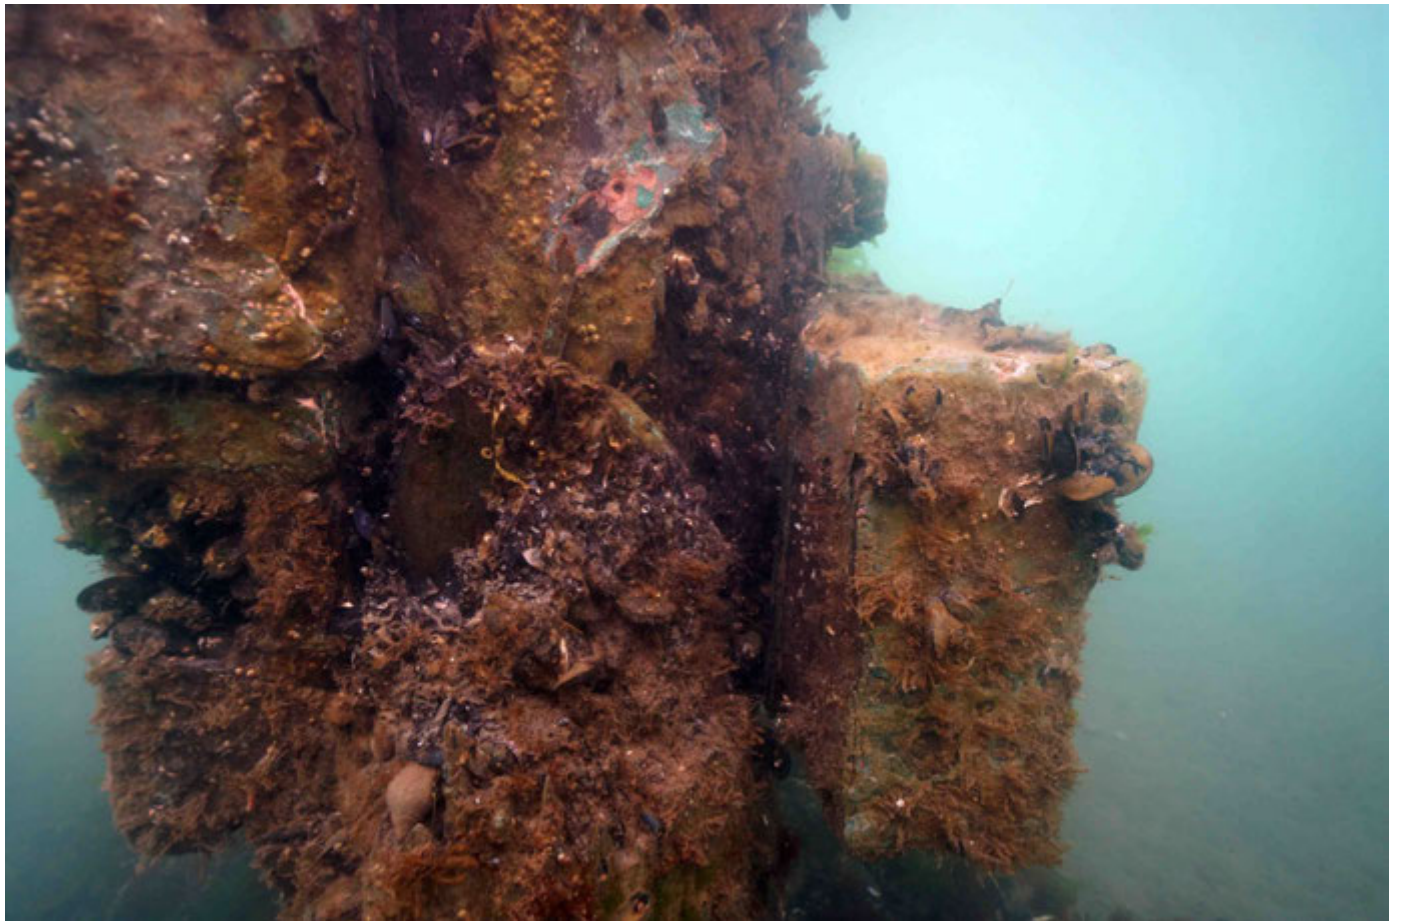
Pile 29D: Very Poor Condition – broken pile

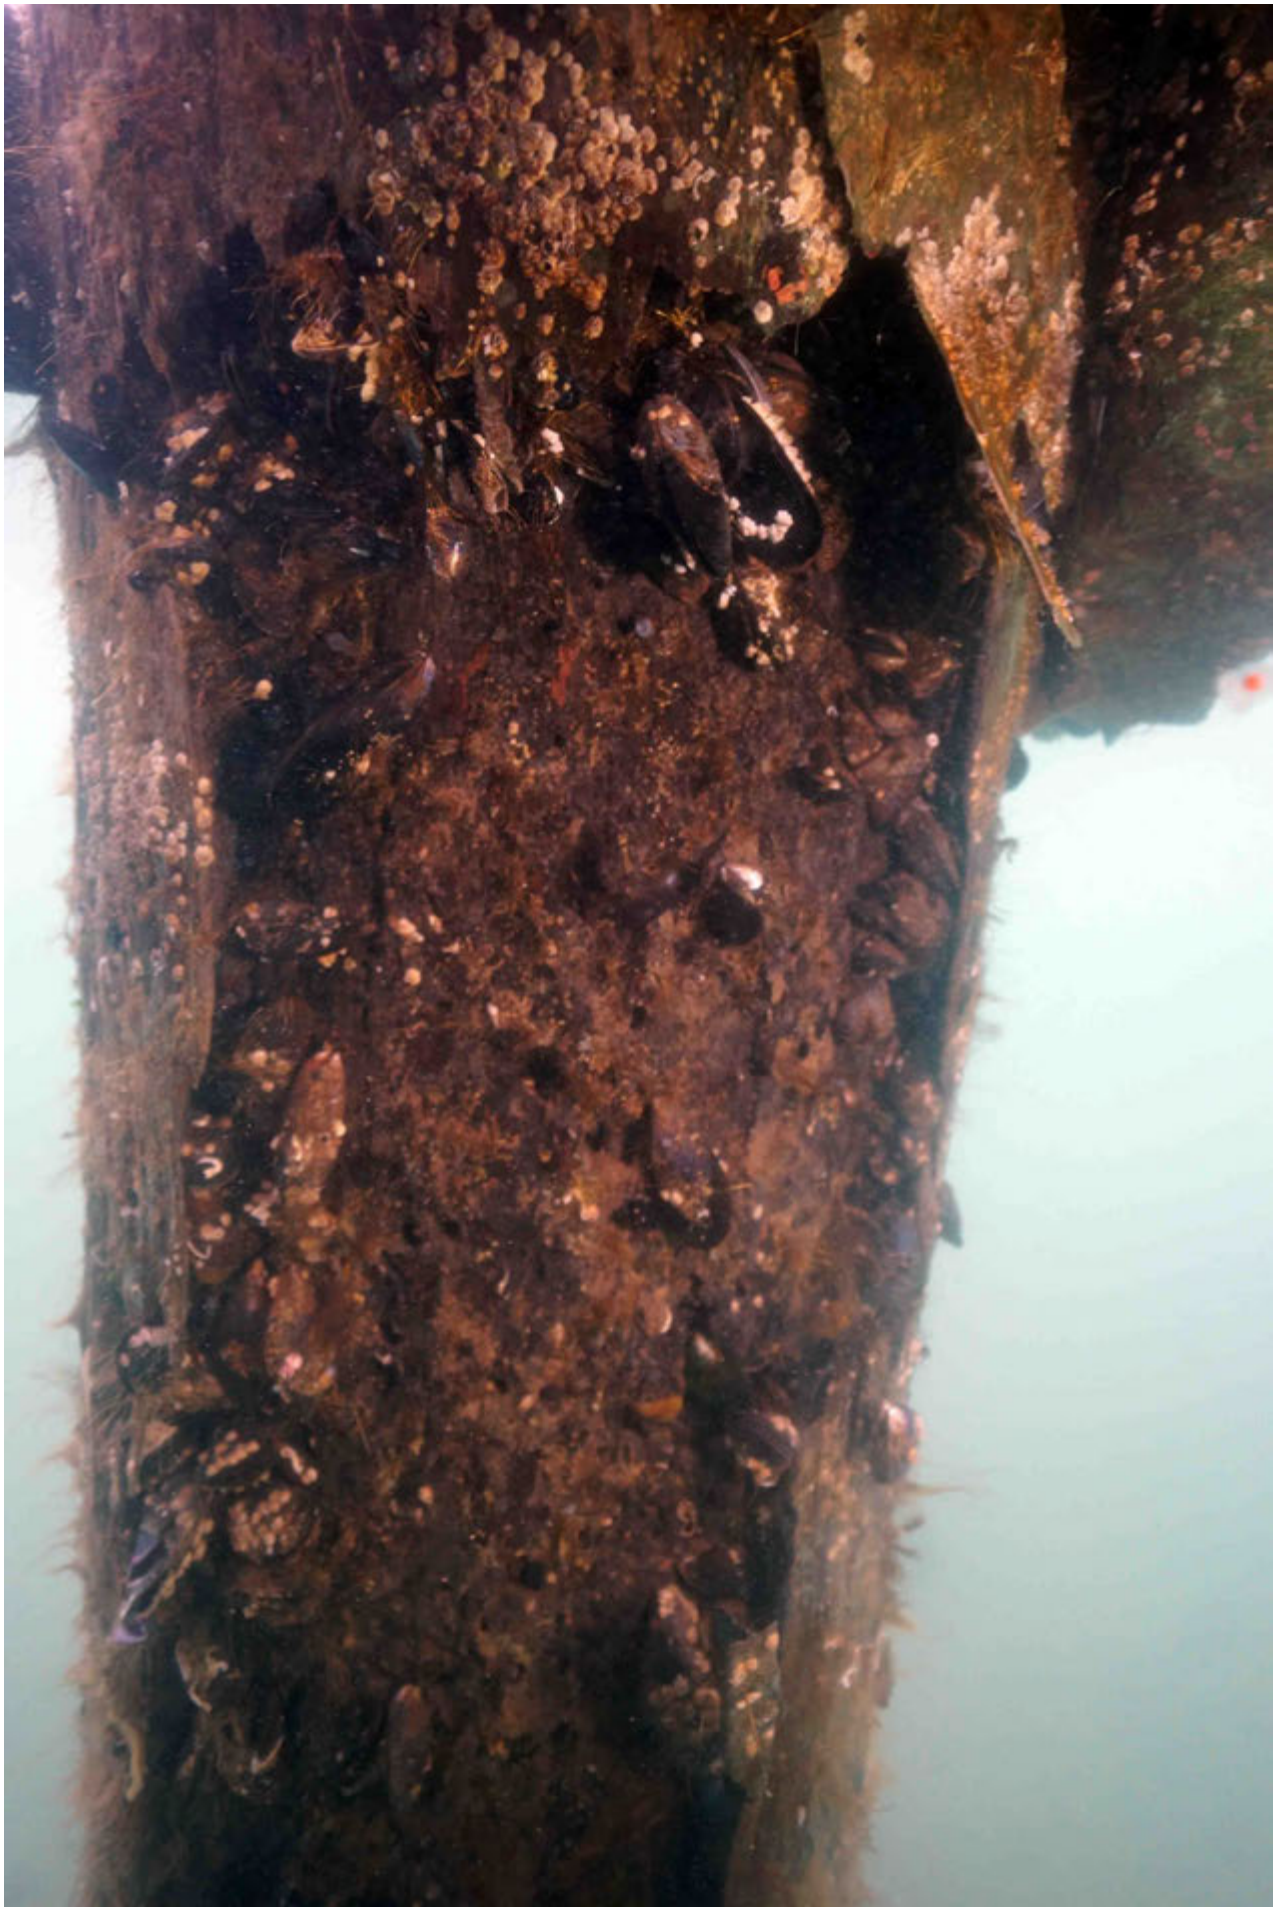
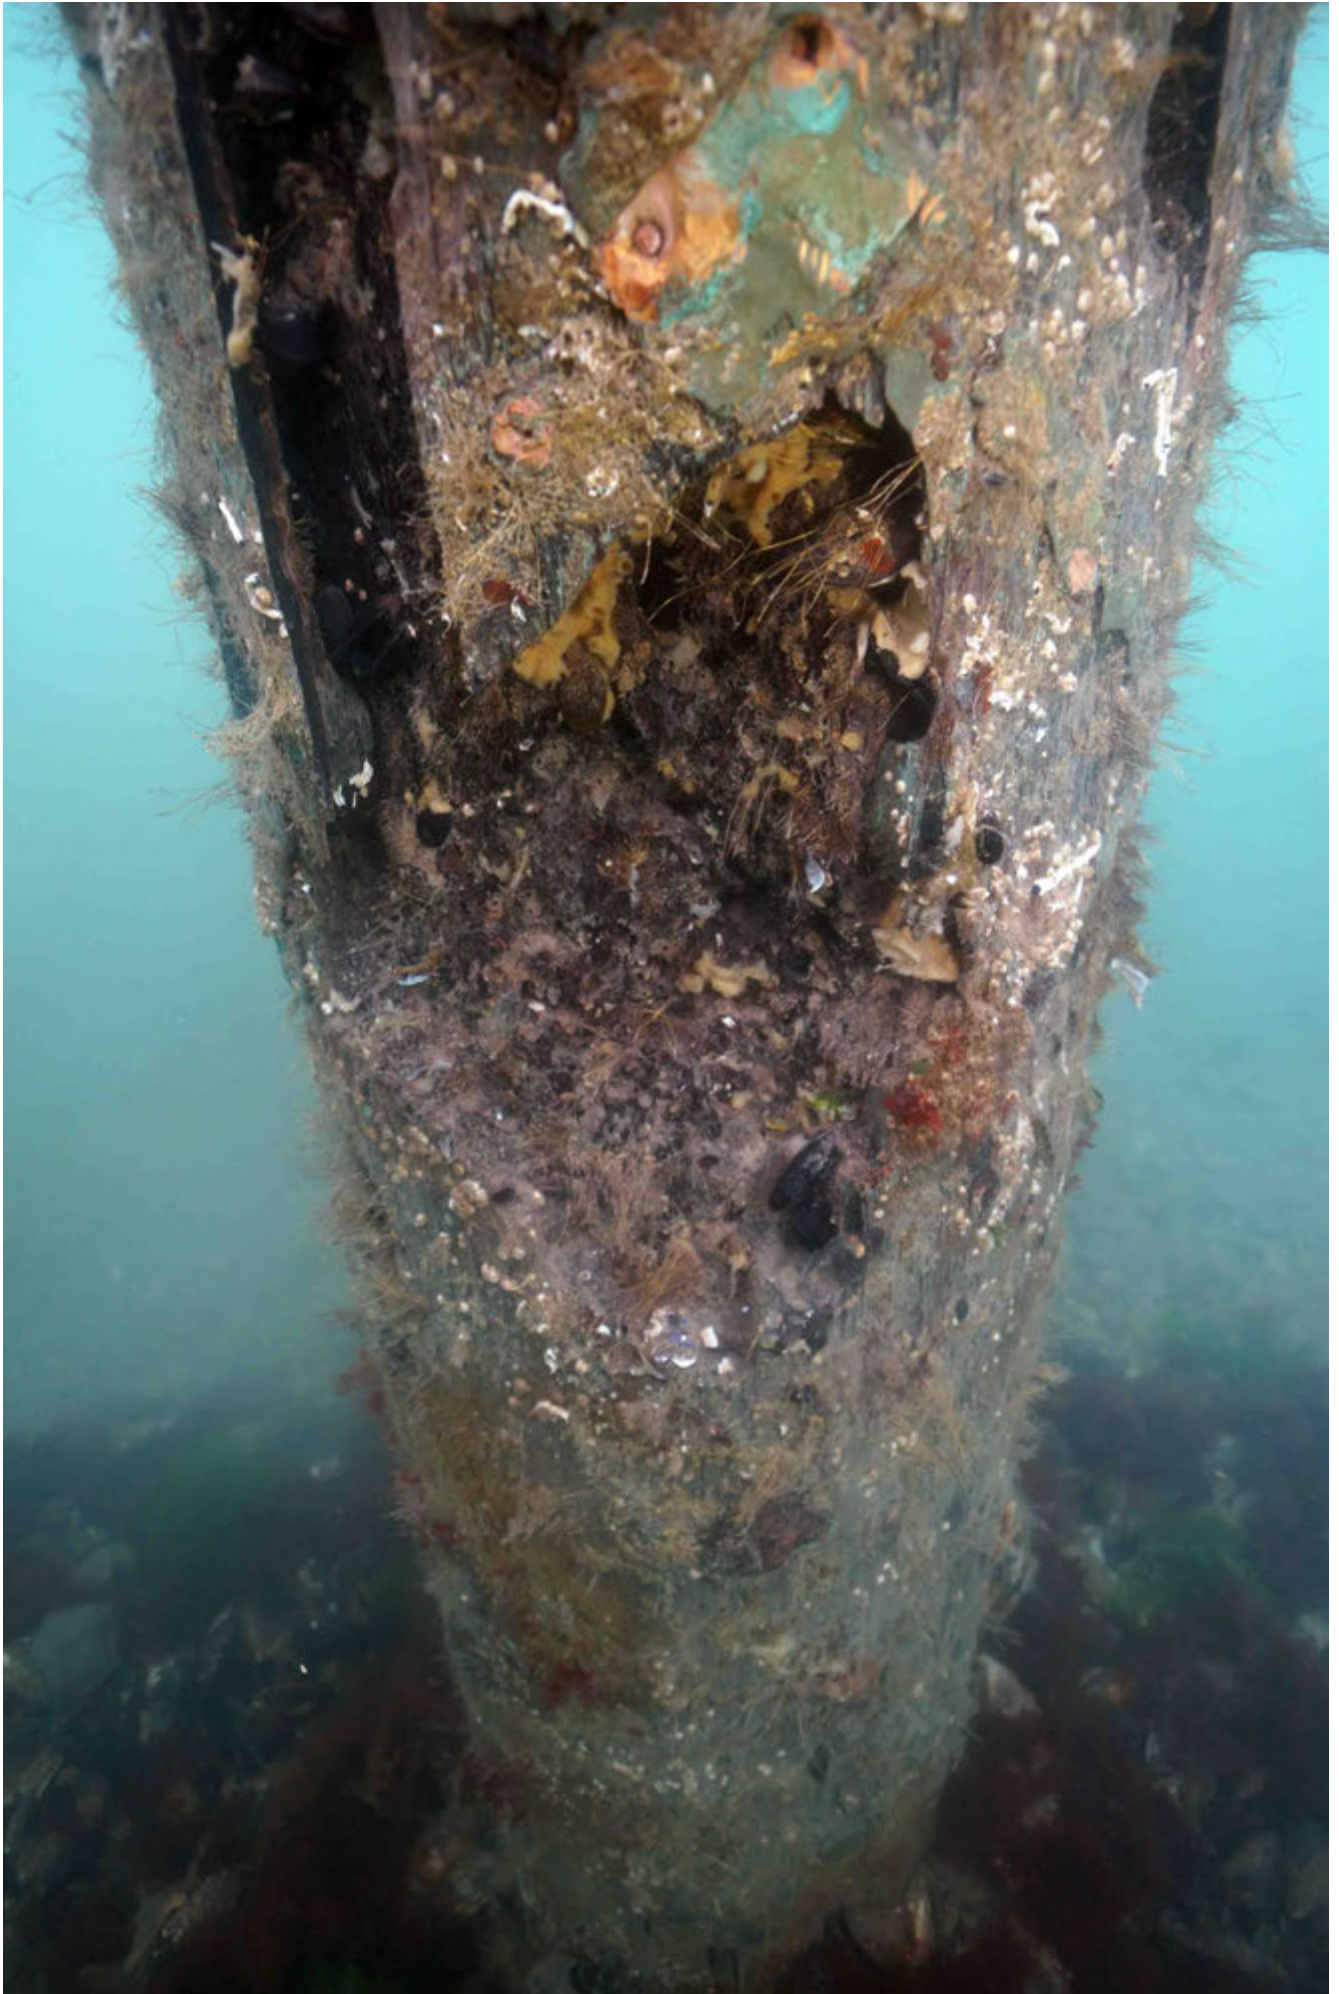
Pile 30C: Poor Condition – 40% loss of section – lower tidal zone

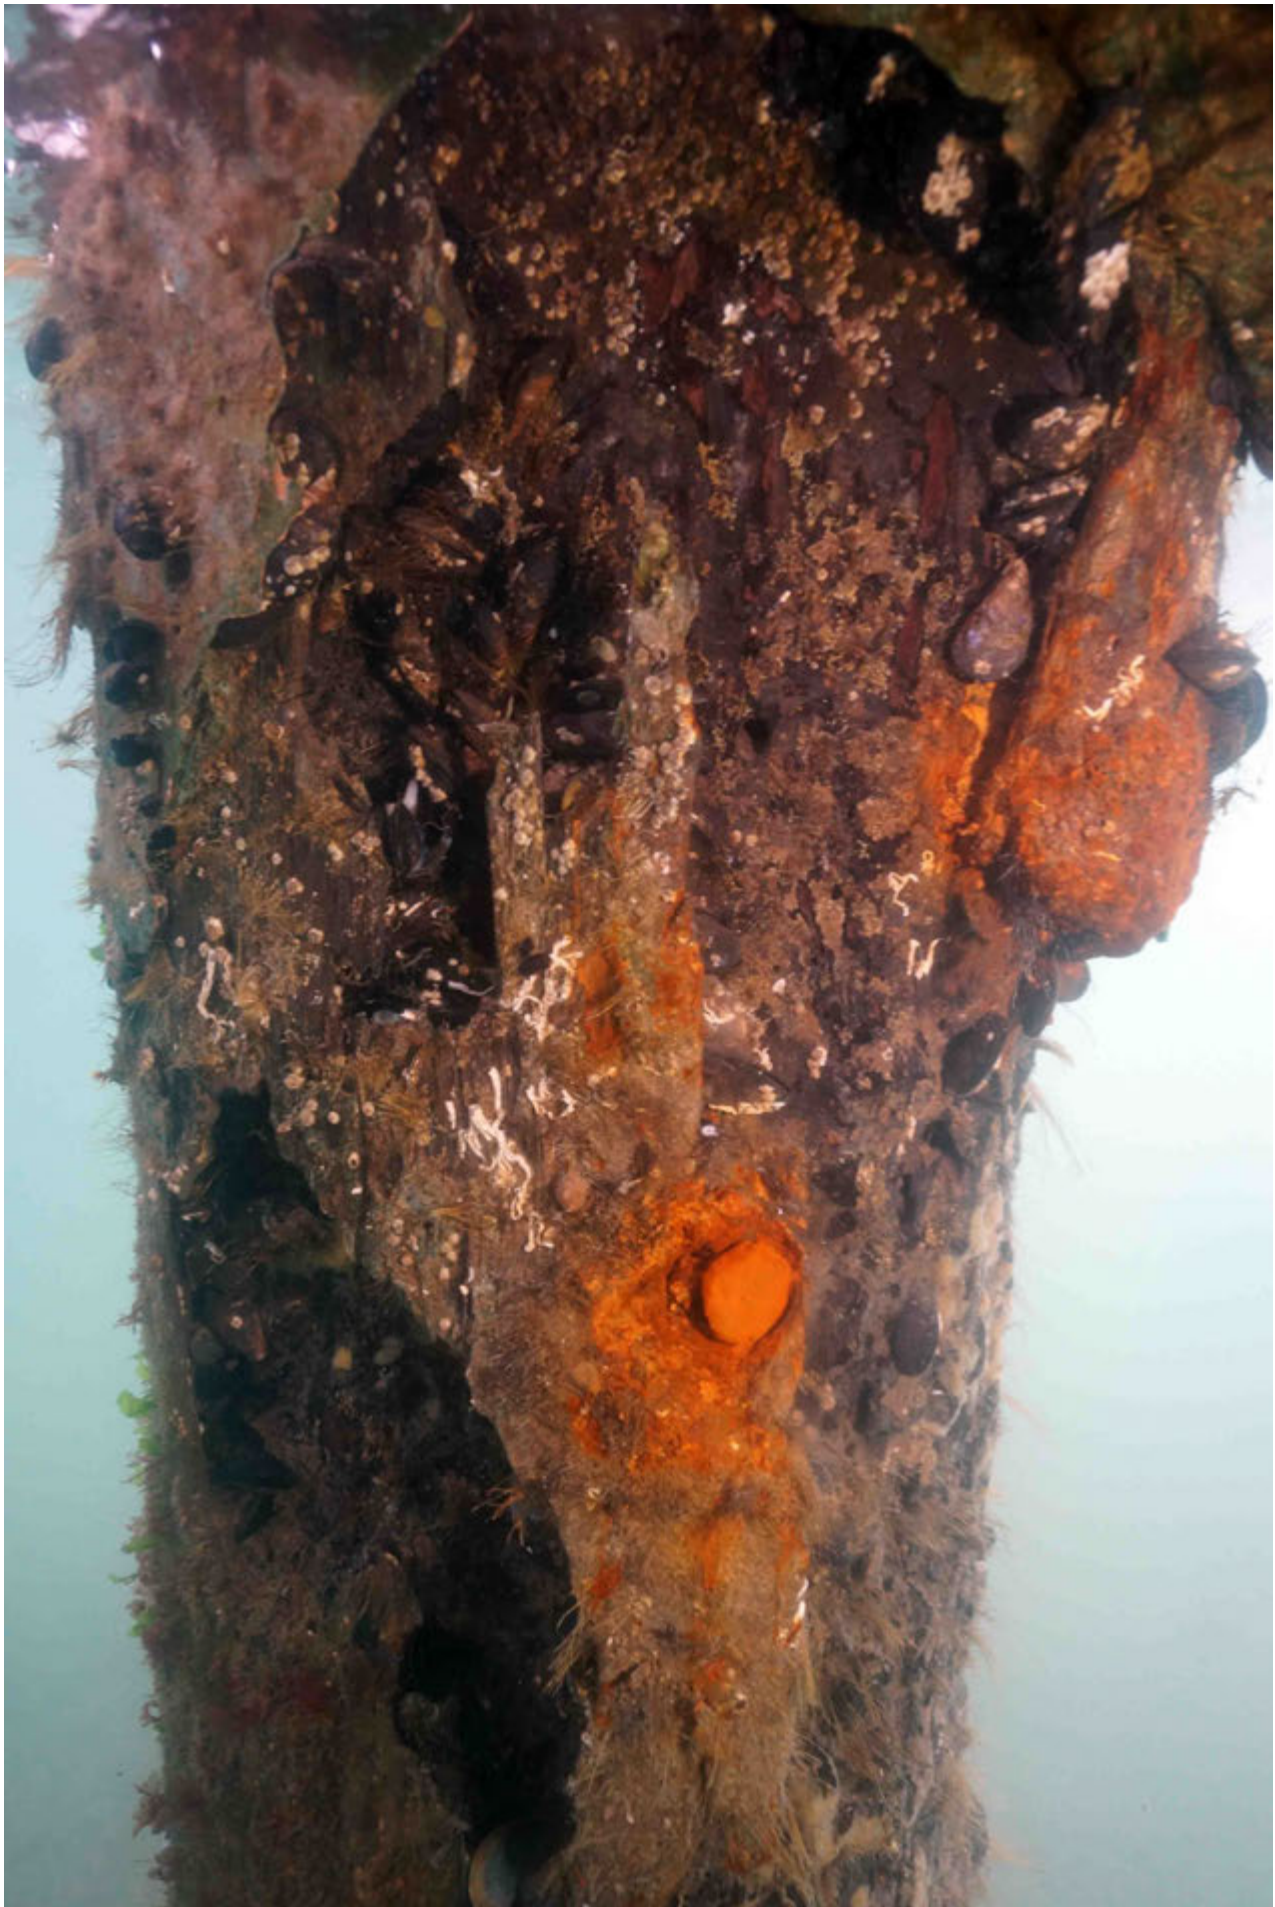
Pile 30D: Poor Condition – 50% loss of section – lower tidal zone
