Document Title:	HCC Petone Wharf – Approach Structure – Pile Condition Survey & Reporting
Document No.:	UCL – 2021.01 – HCC Wharf Approach PCS&R001 – V2
	Prepared for: Tom Arthur – Calibre Group Janet Lawson – Hutt City Council Francis O’Riley – G.K. Shaw Ltd.

Petone Wharf – Approach Structure

Pile Condition Survey & Reporting

January 2021

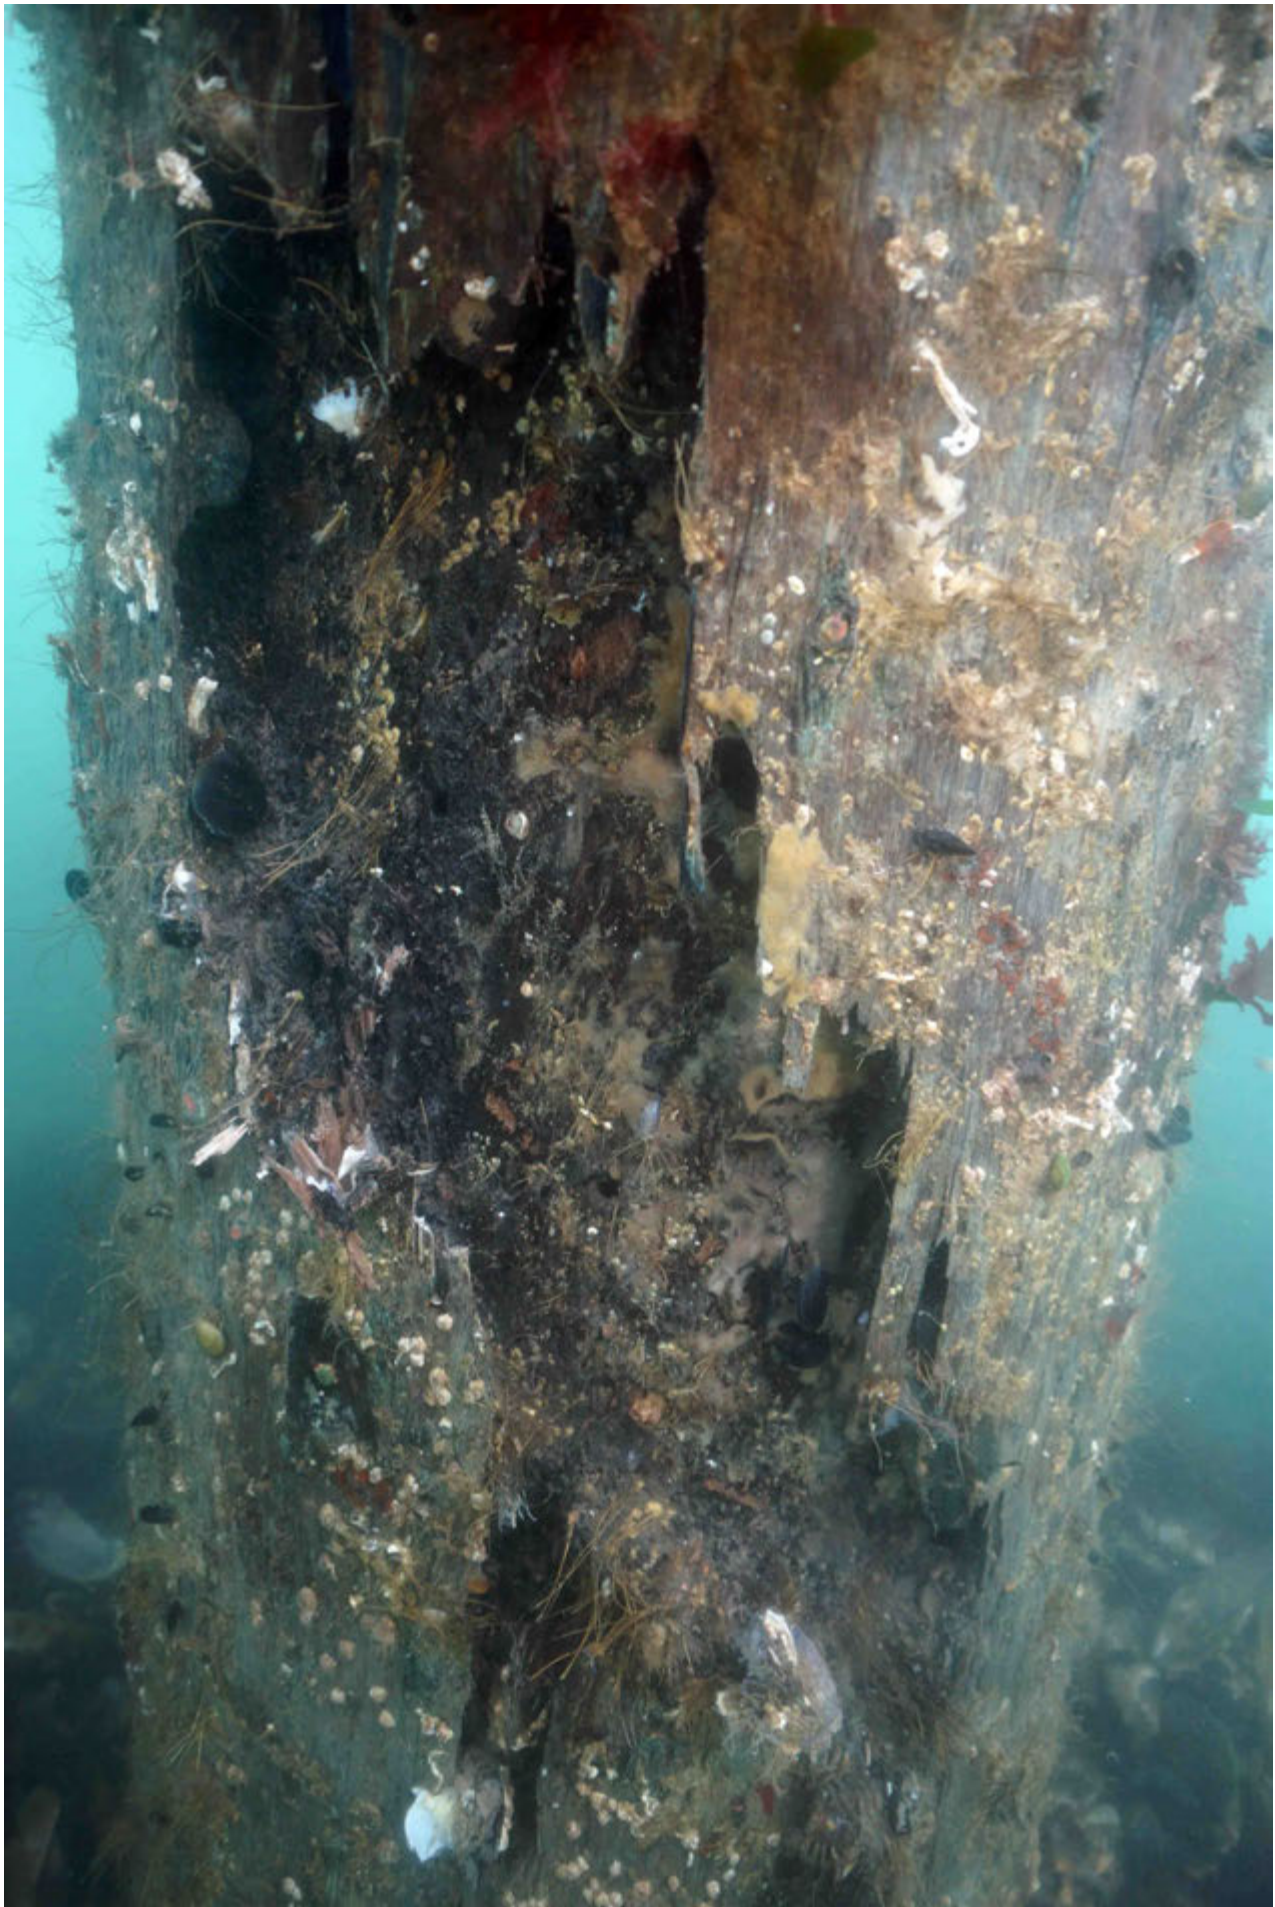
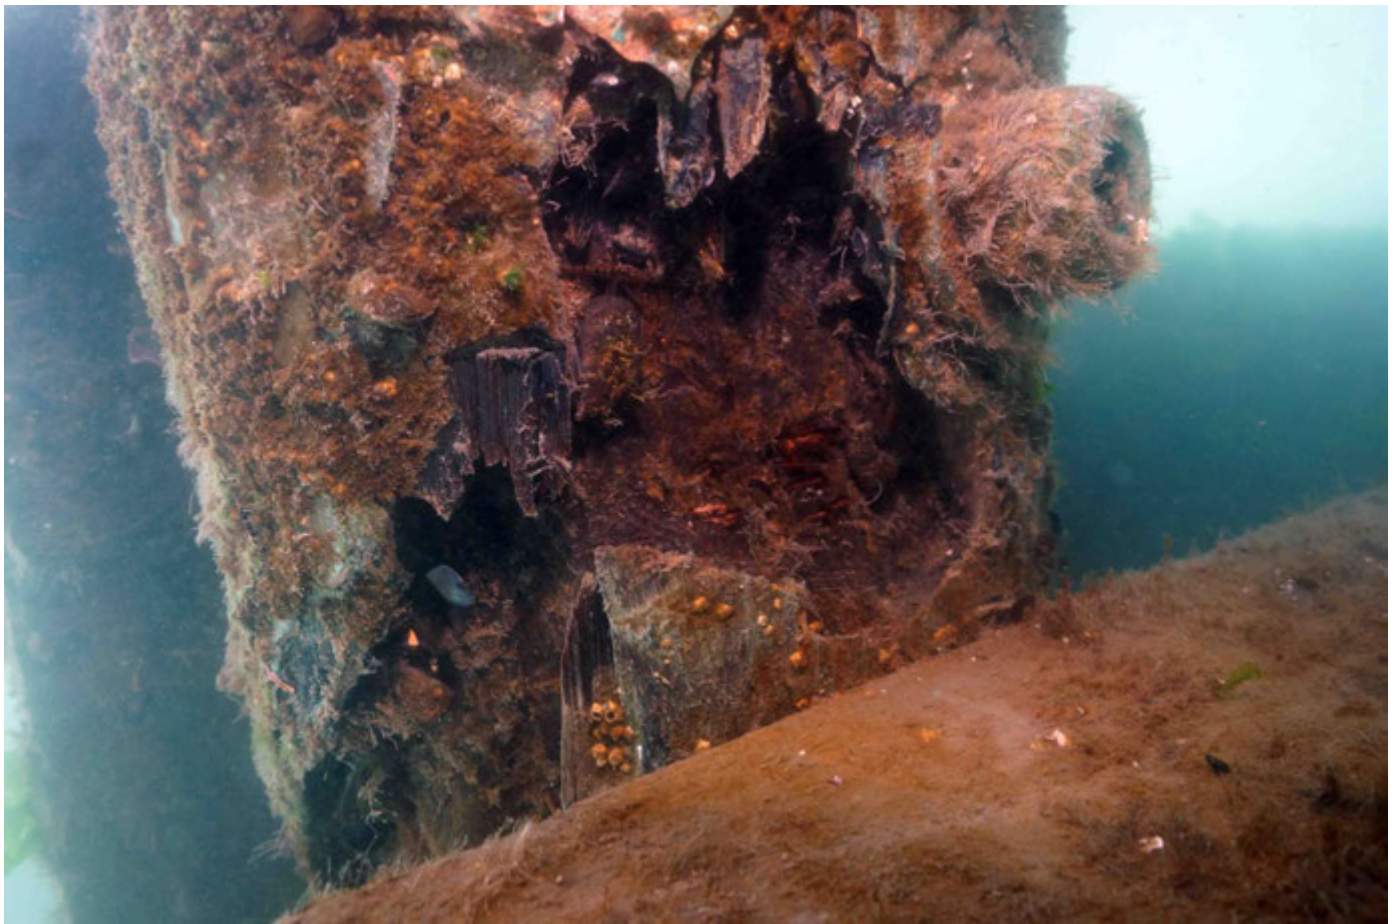
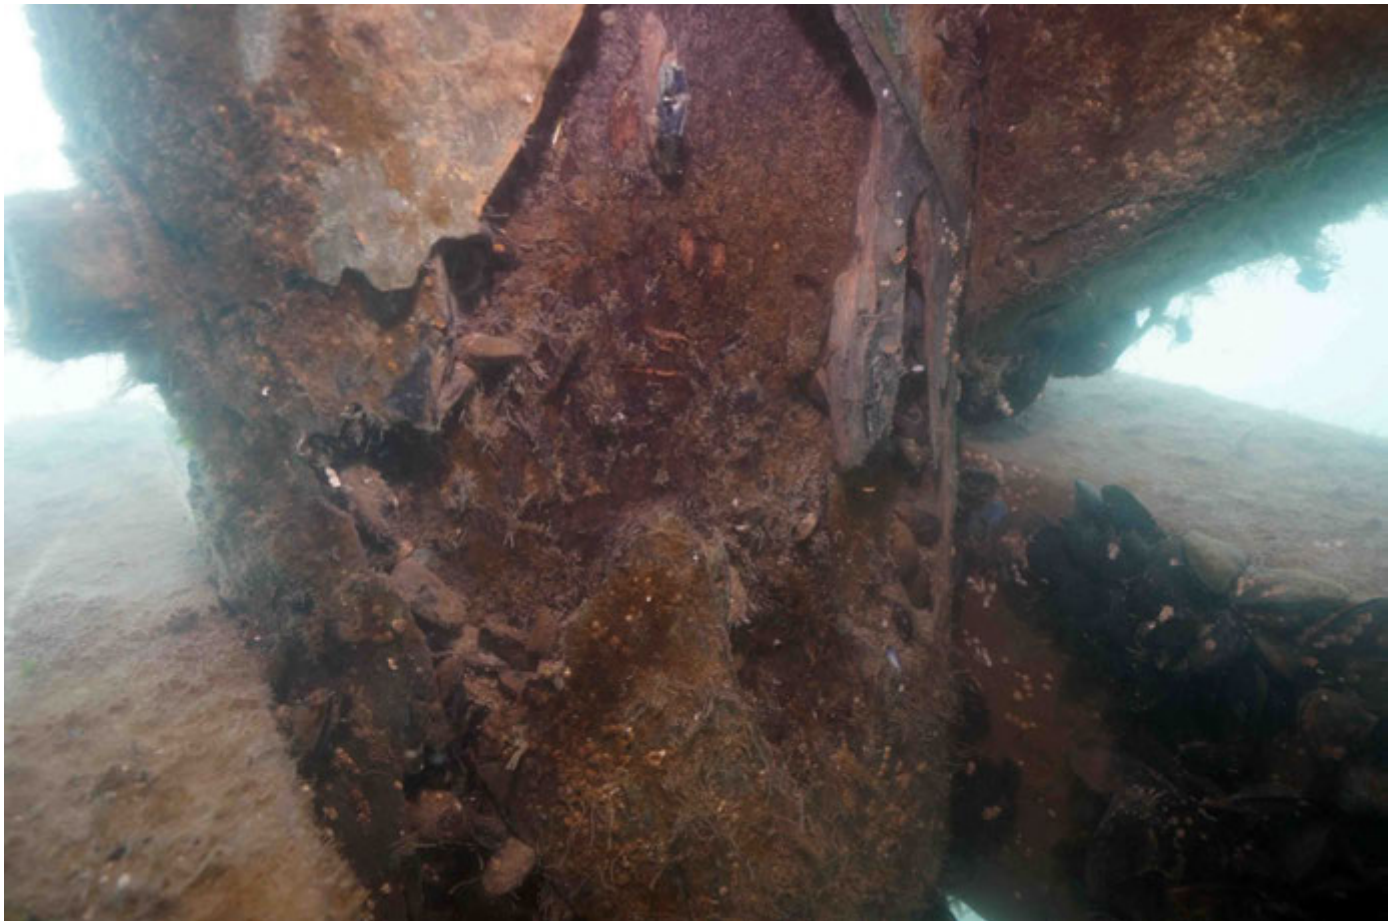
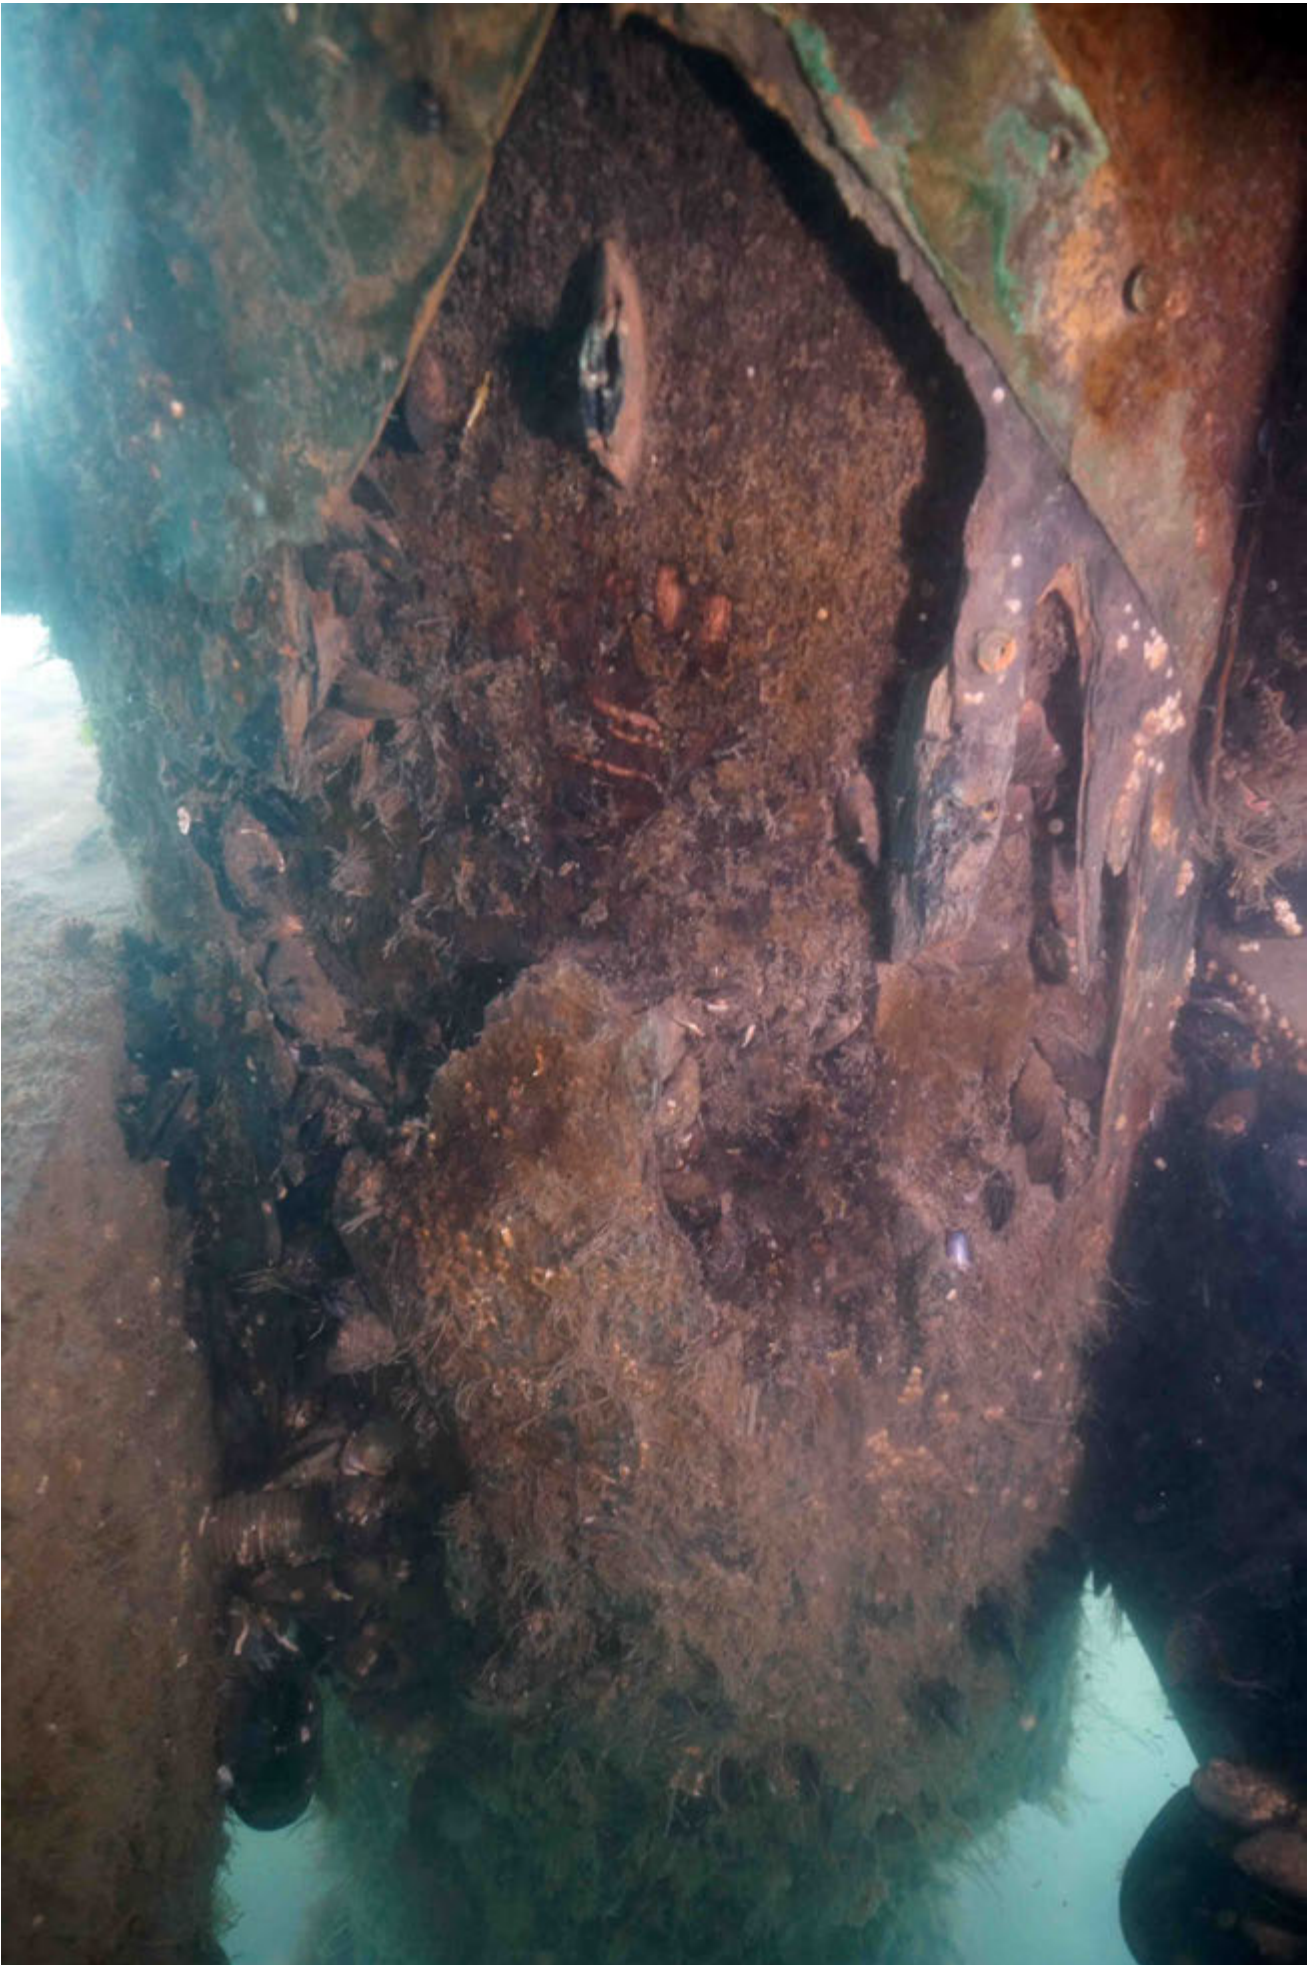
Pile 31C: Poor Condition – 40% loss of section – lower tidal zone to seabed

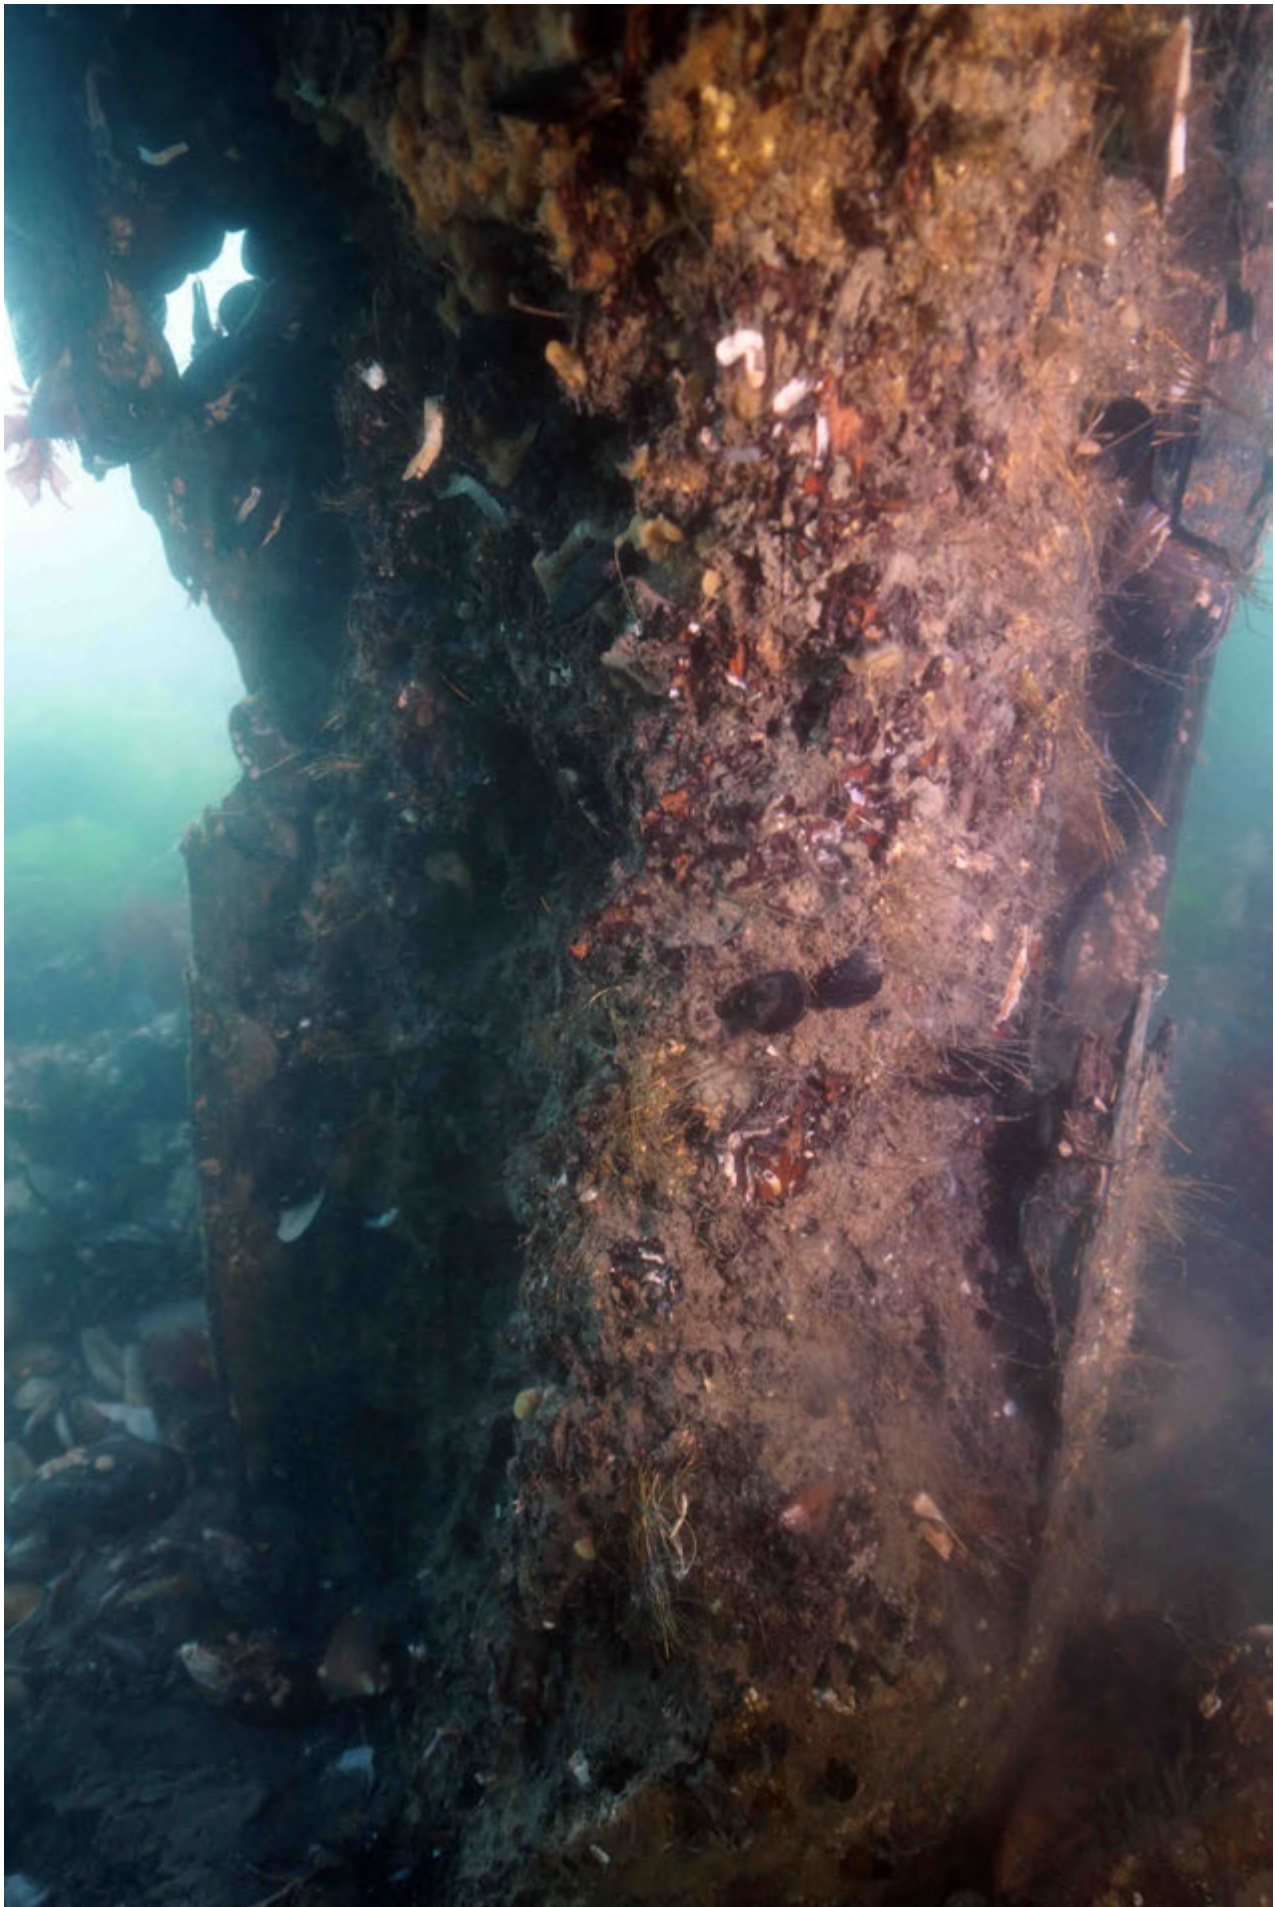
Pile 31D: Poor Condition – 60% loss of section – at seabed

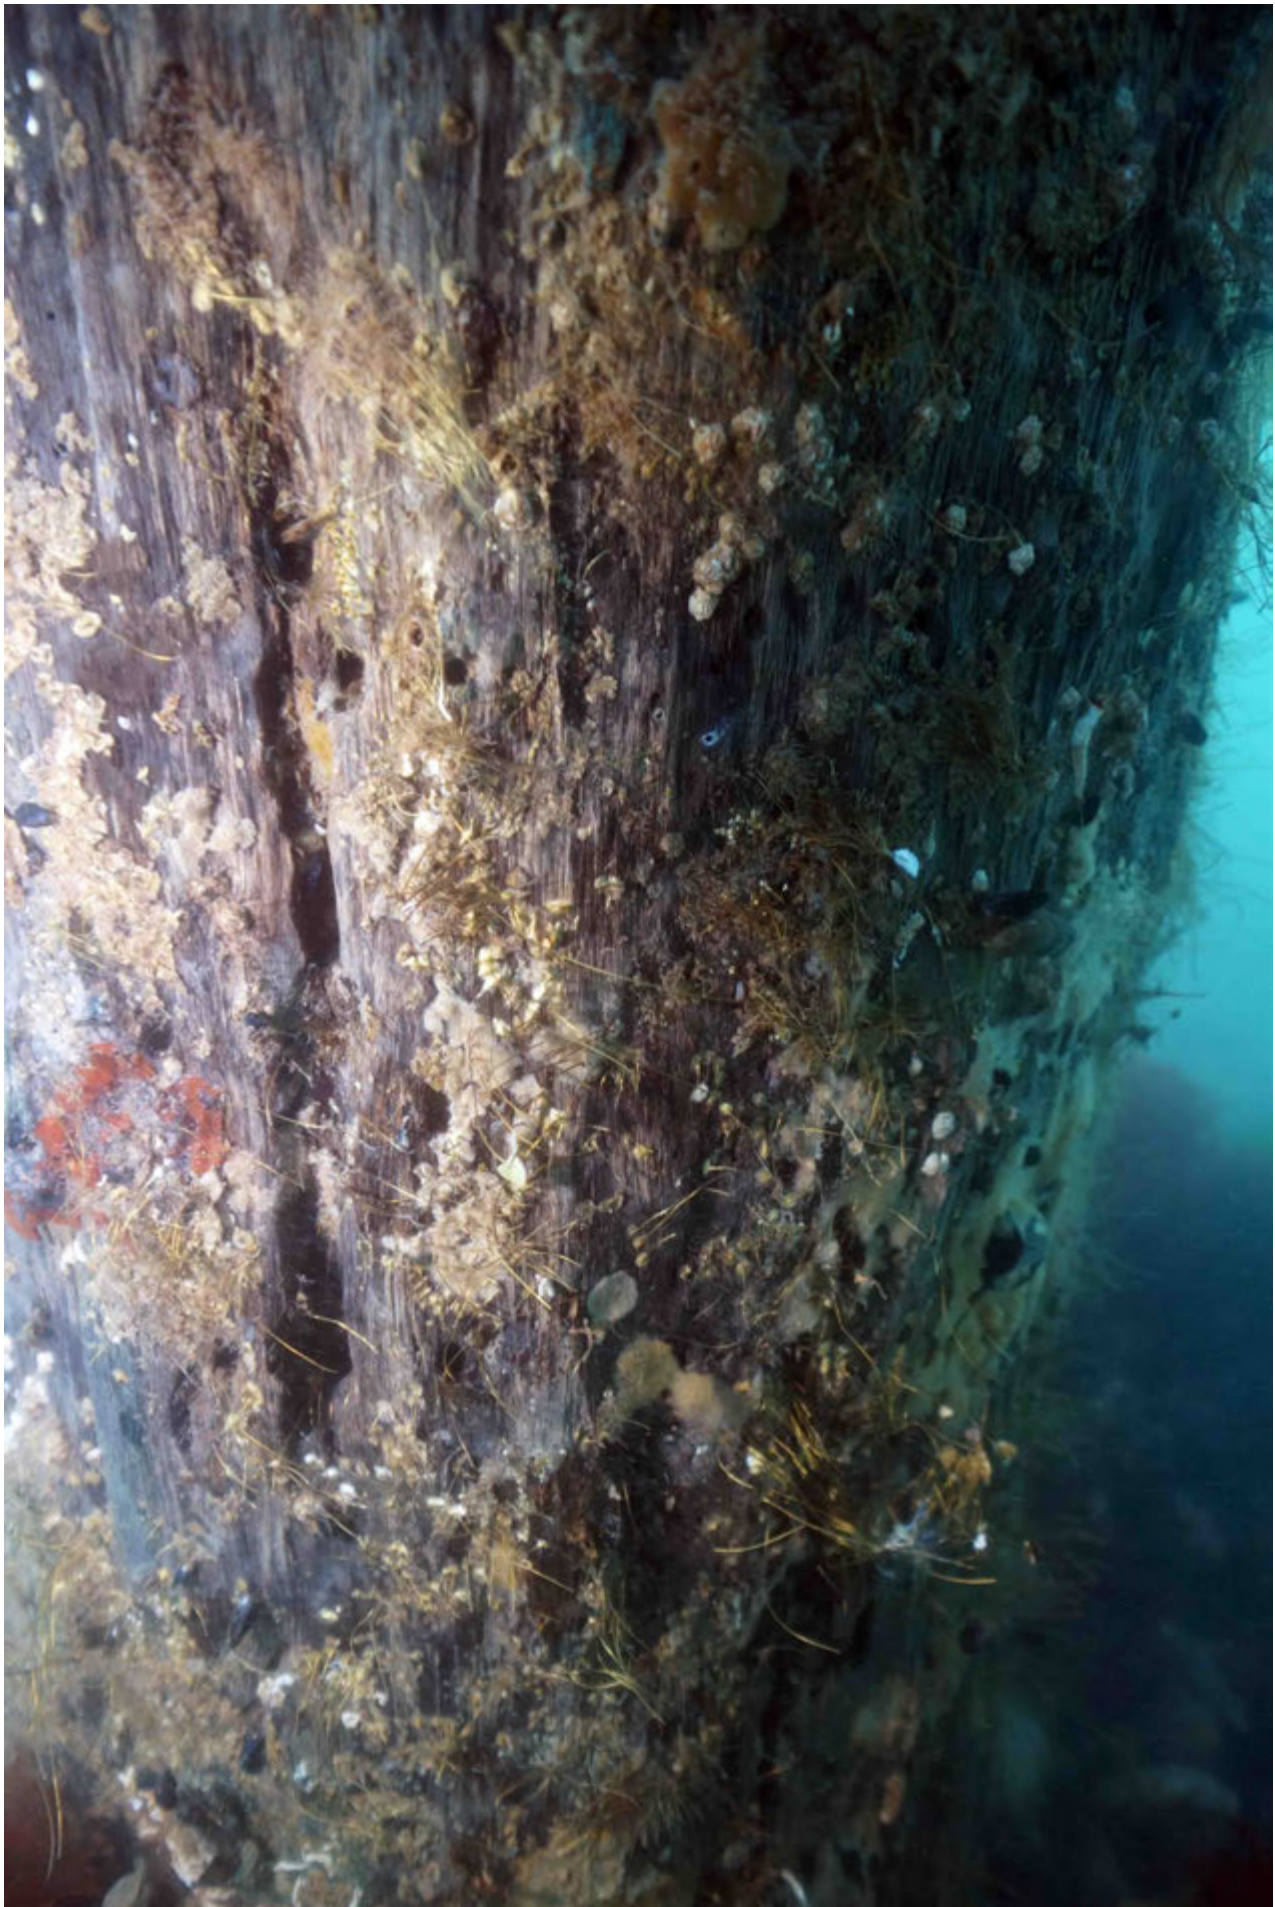
Pile 33D: Fair Condition – 20% loss of section – lower tidal zone

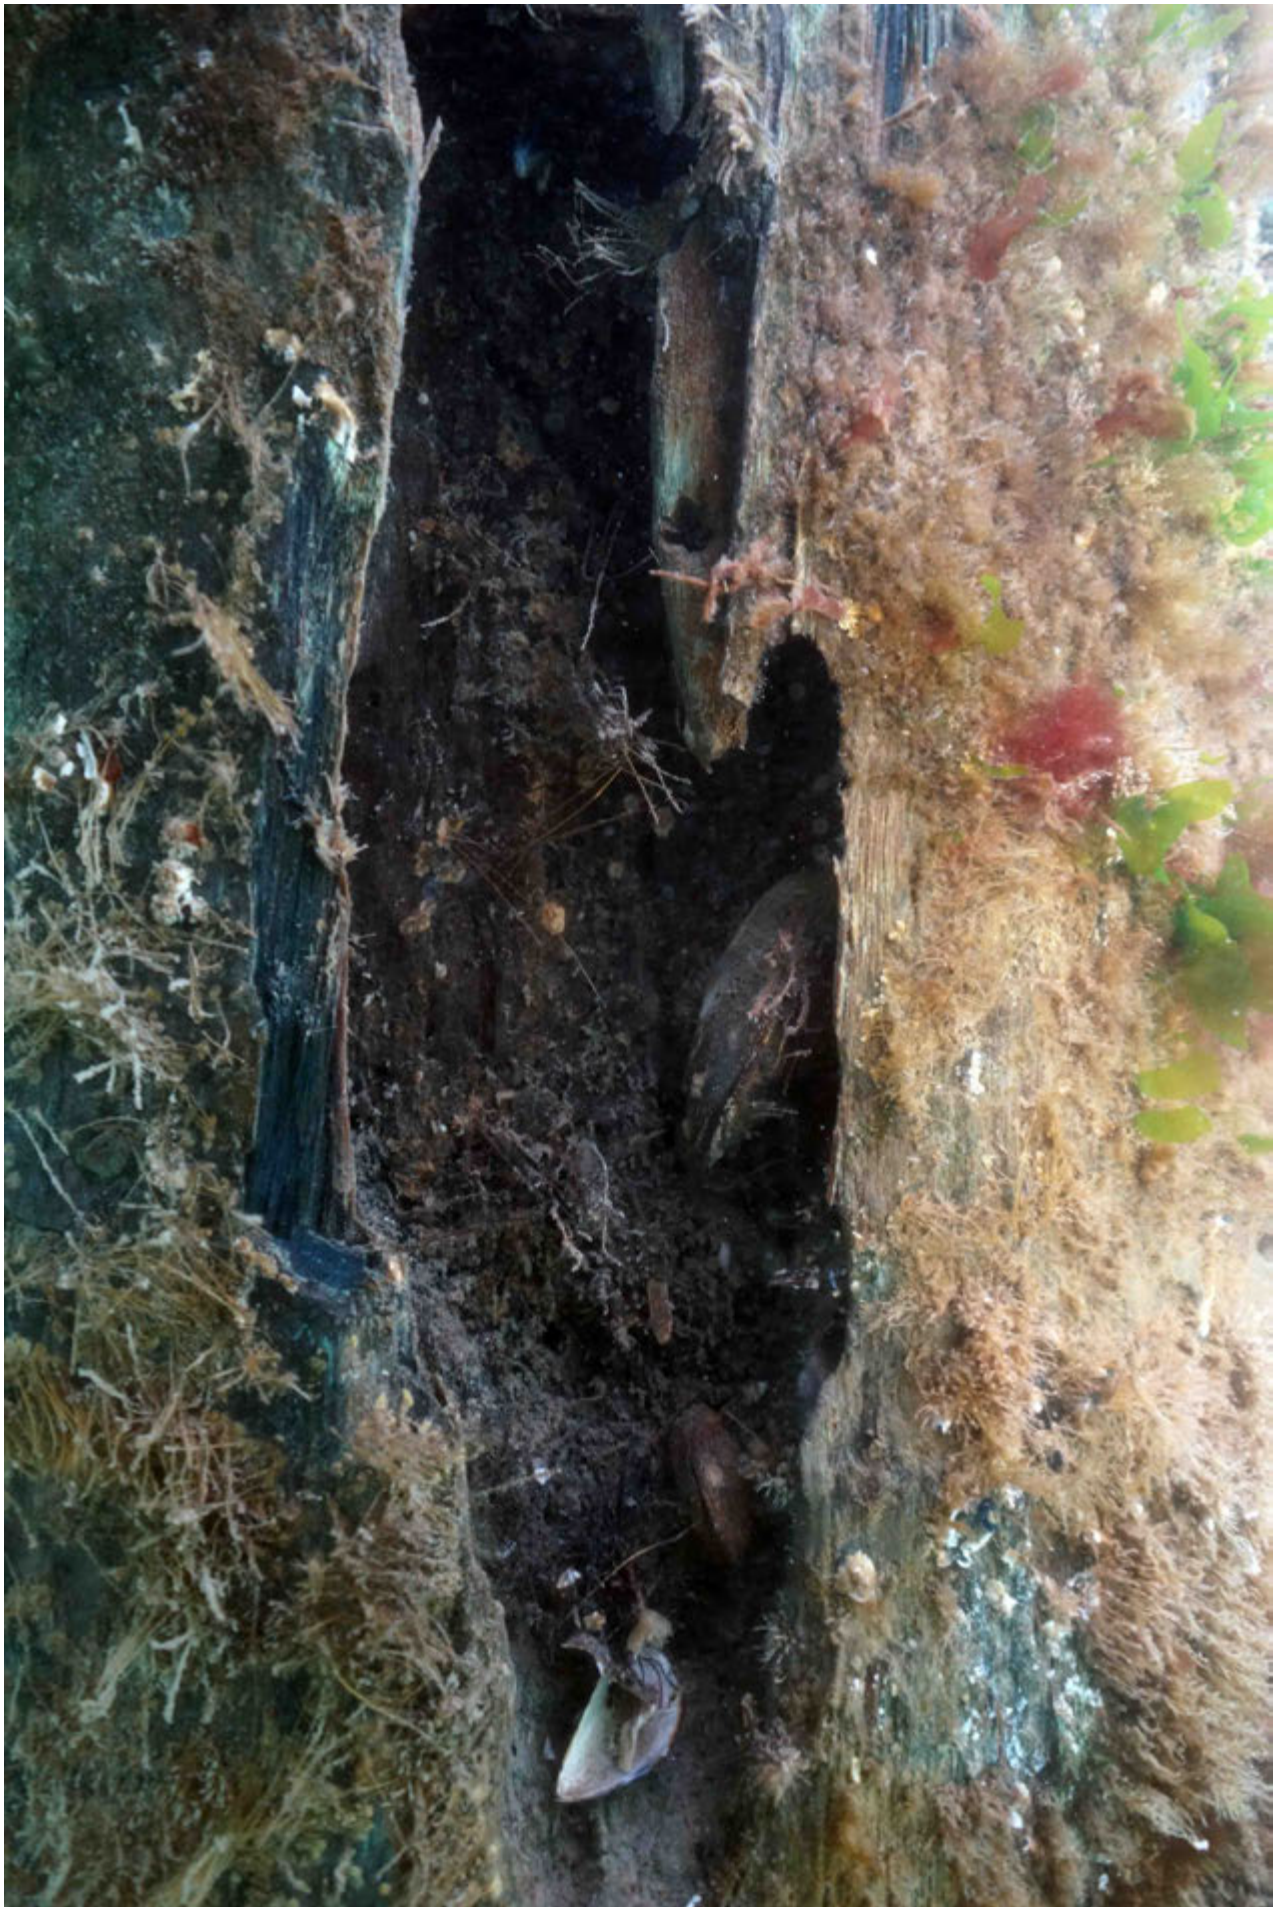
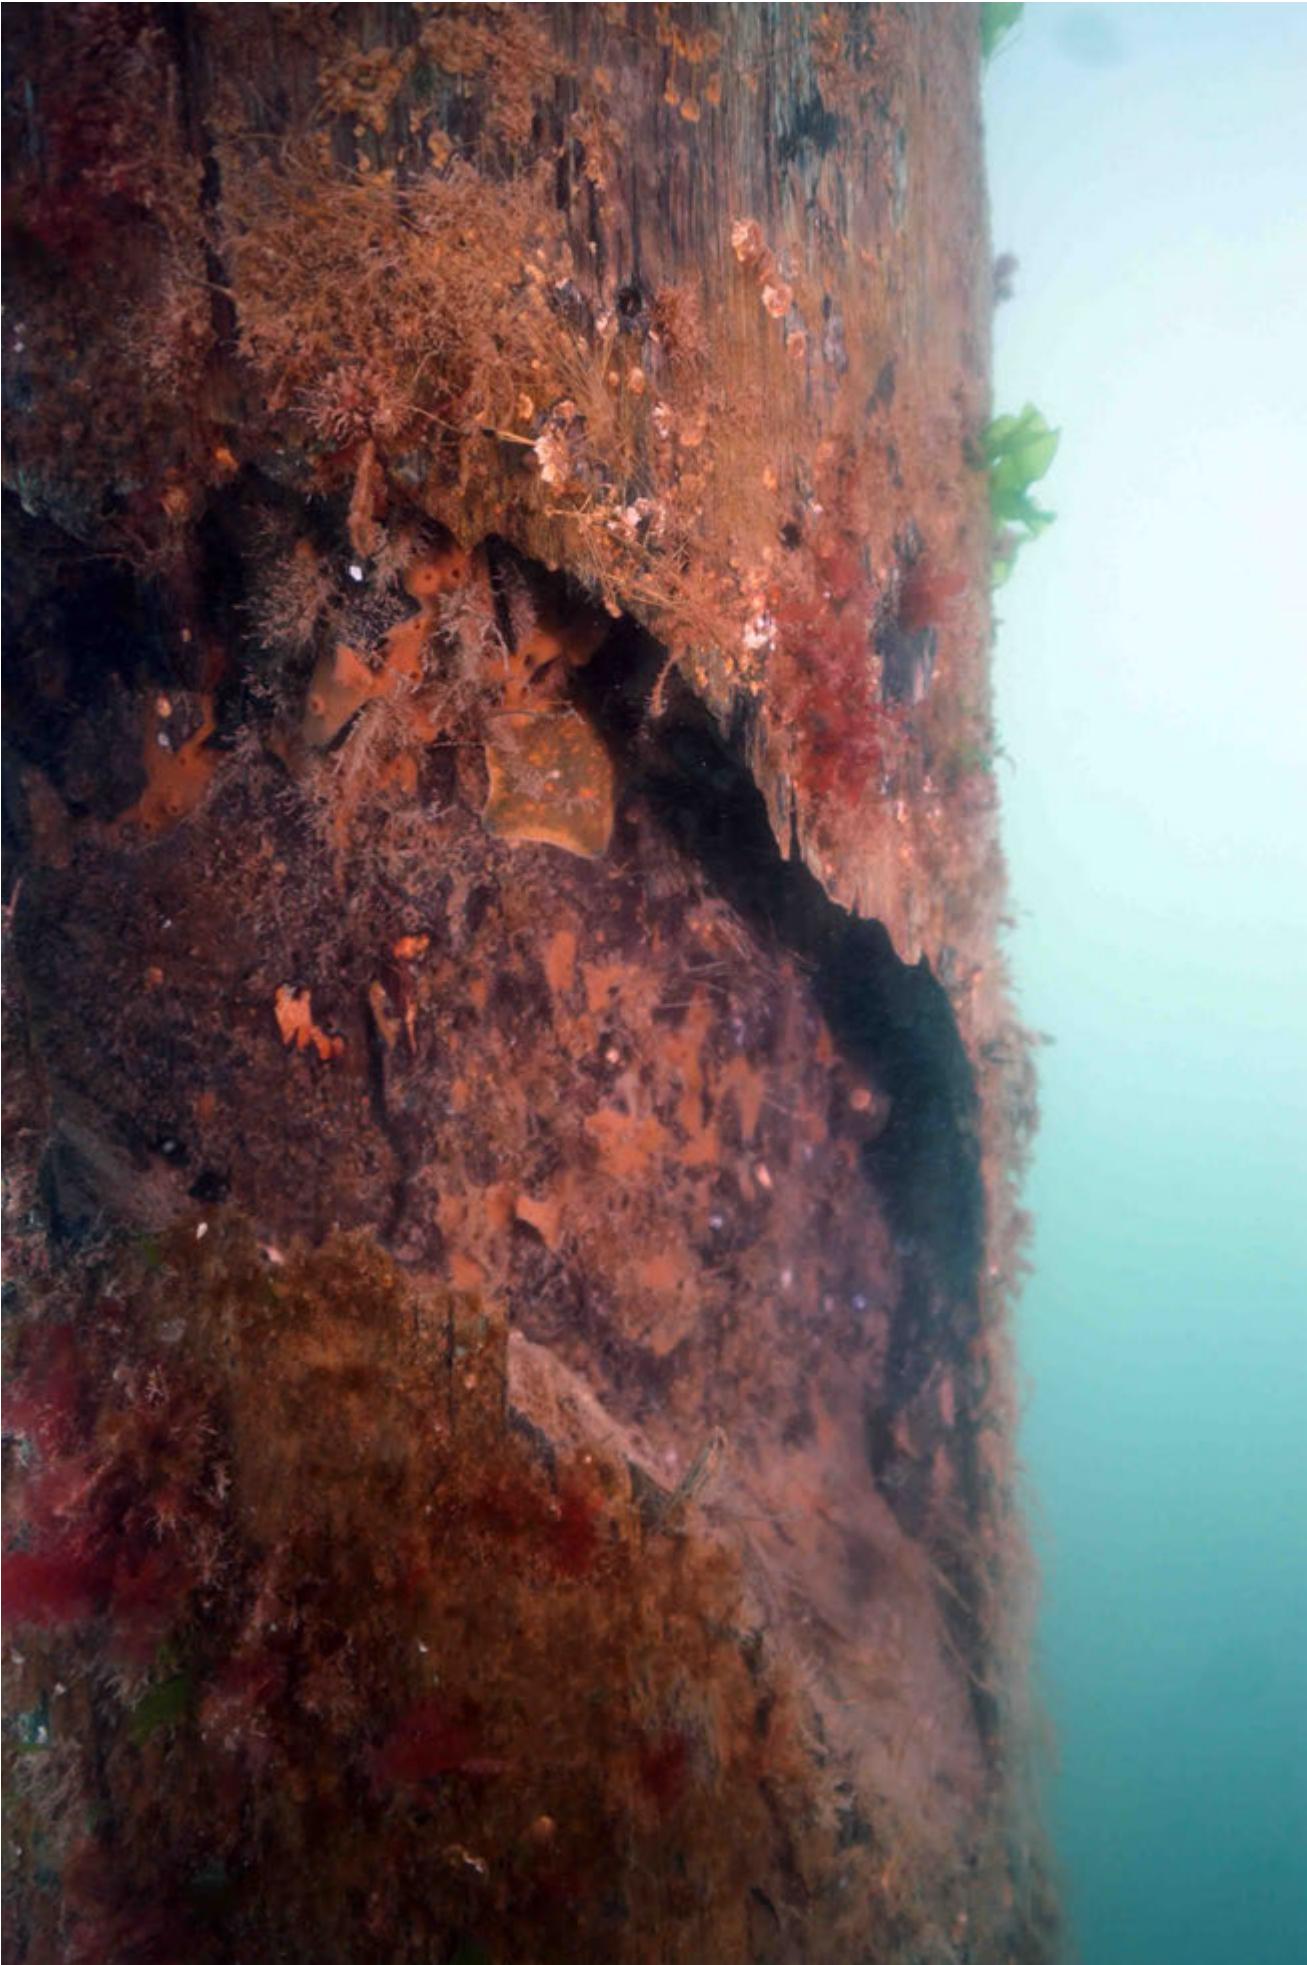
Pile 34C: Poor Condition – 35% loss of section – lower tidal zone to seabed

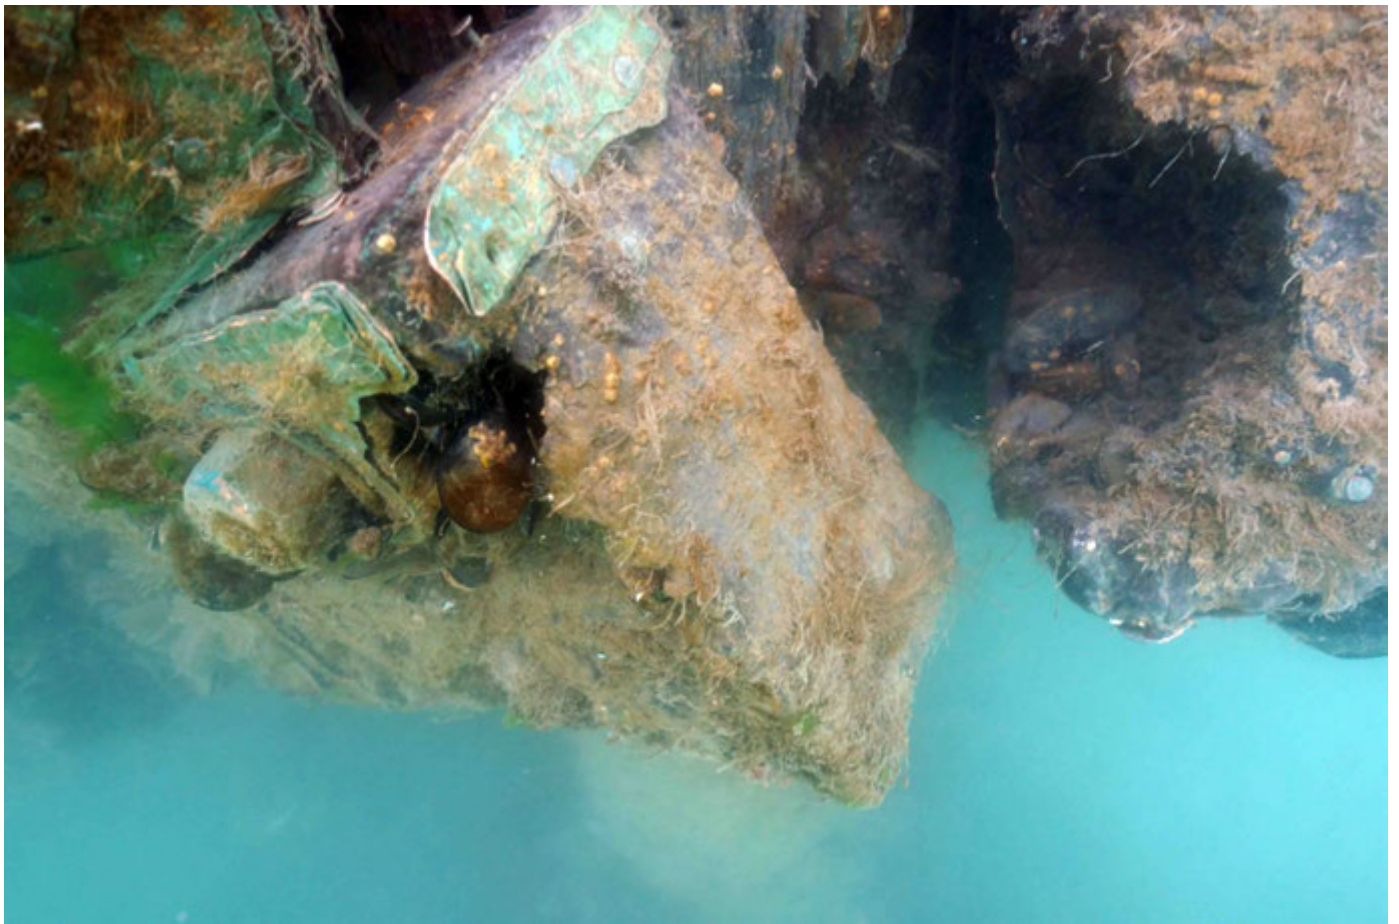
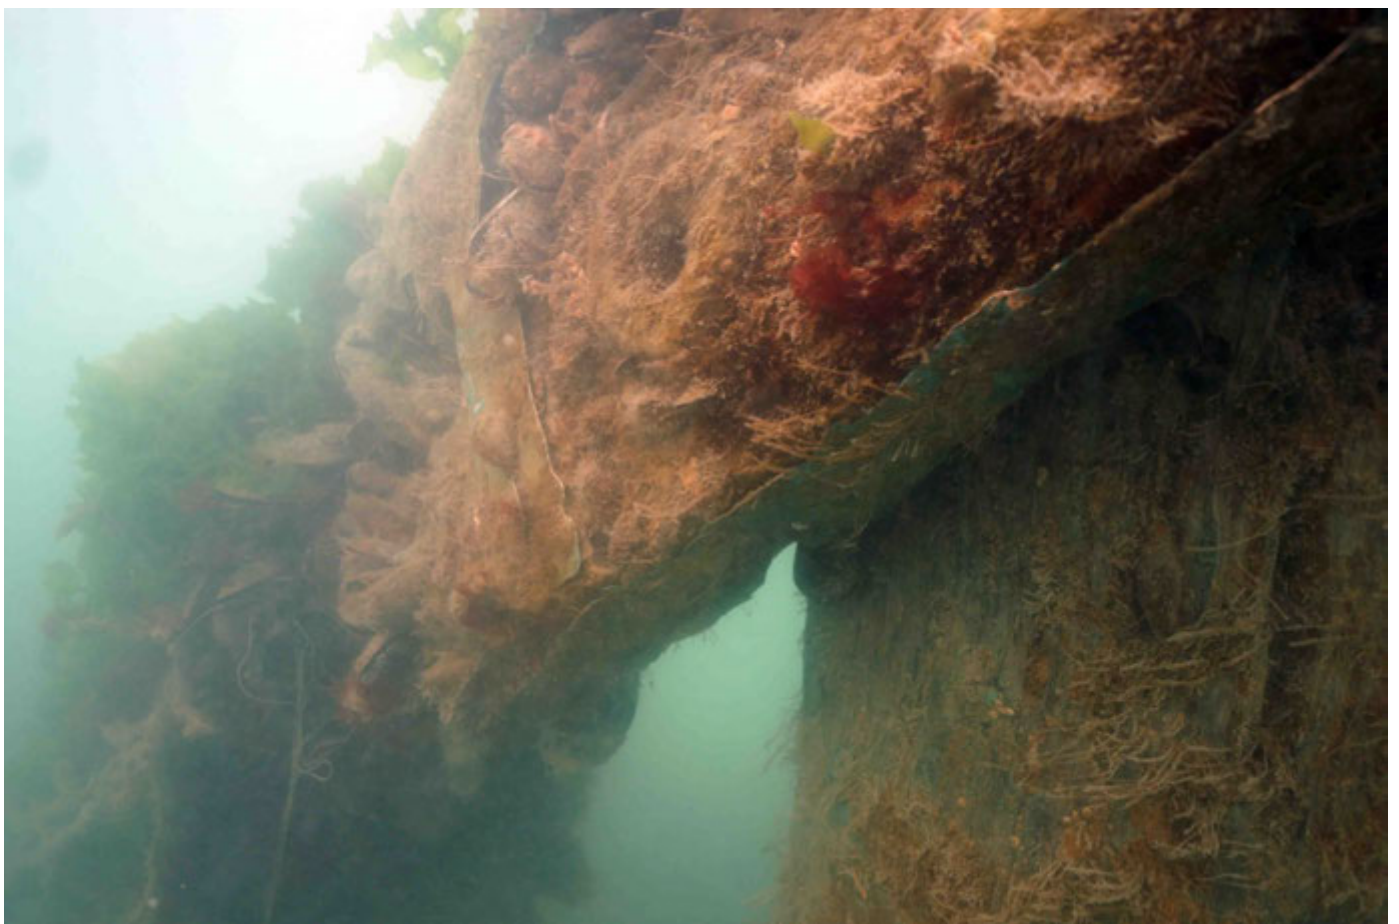
Pile 34D: Fair Condition – 30% loss of section – lower tidal zone
Note: Failed Wale Beams require removal

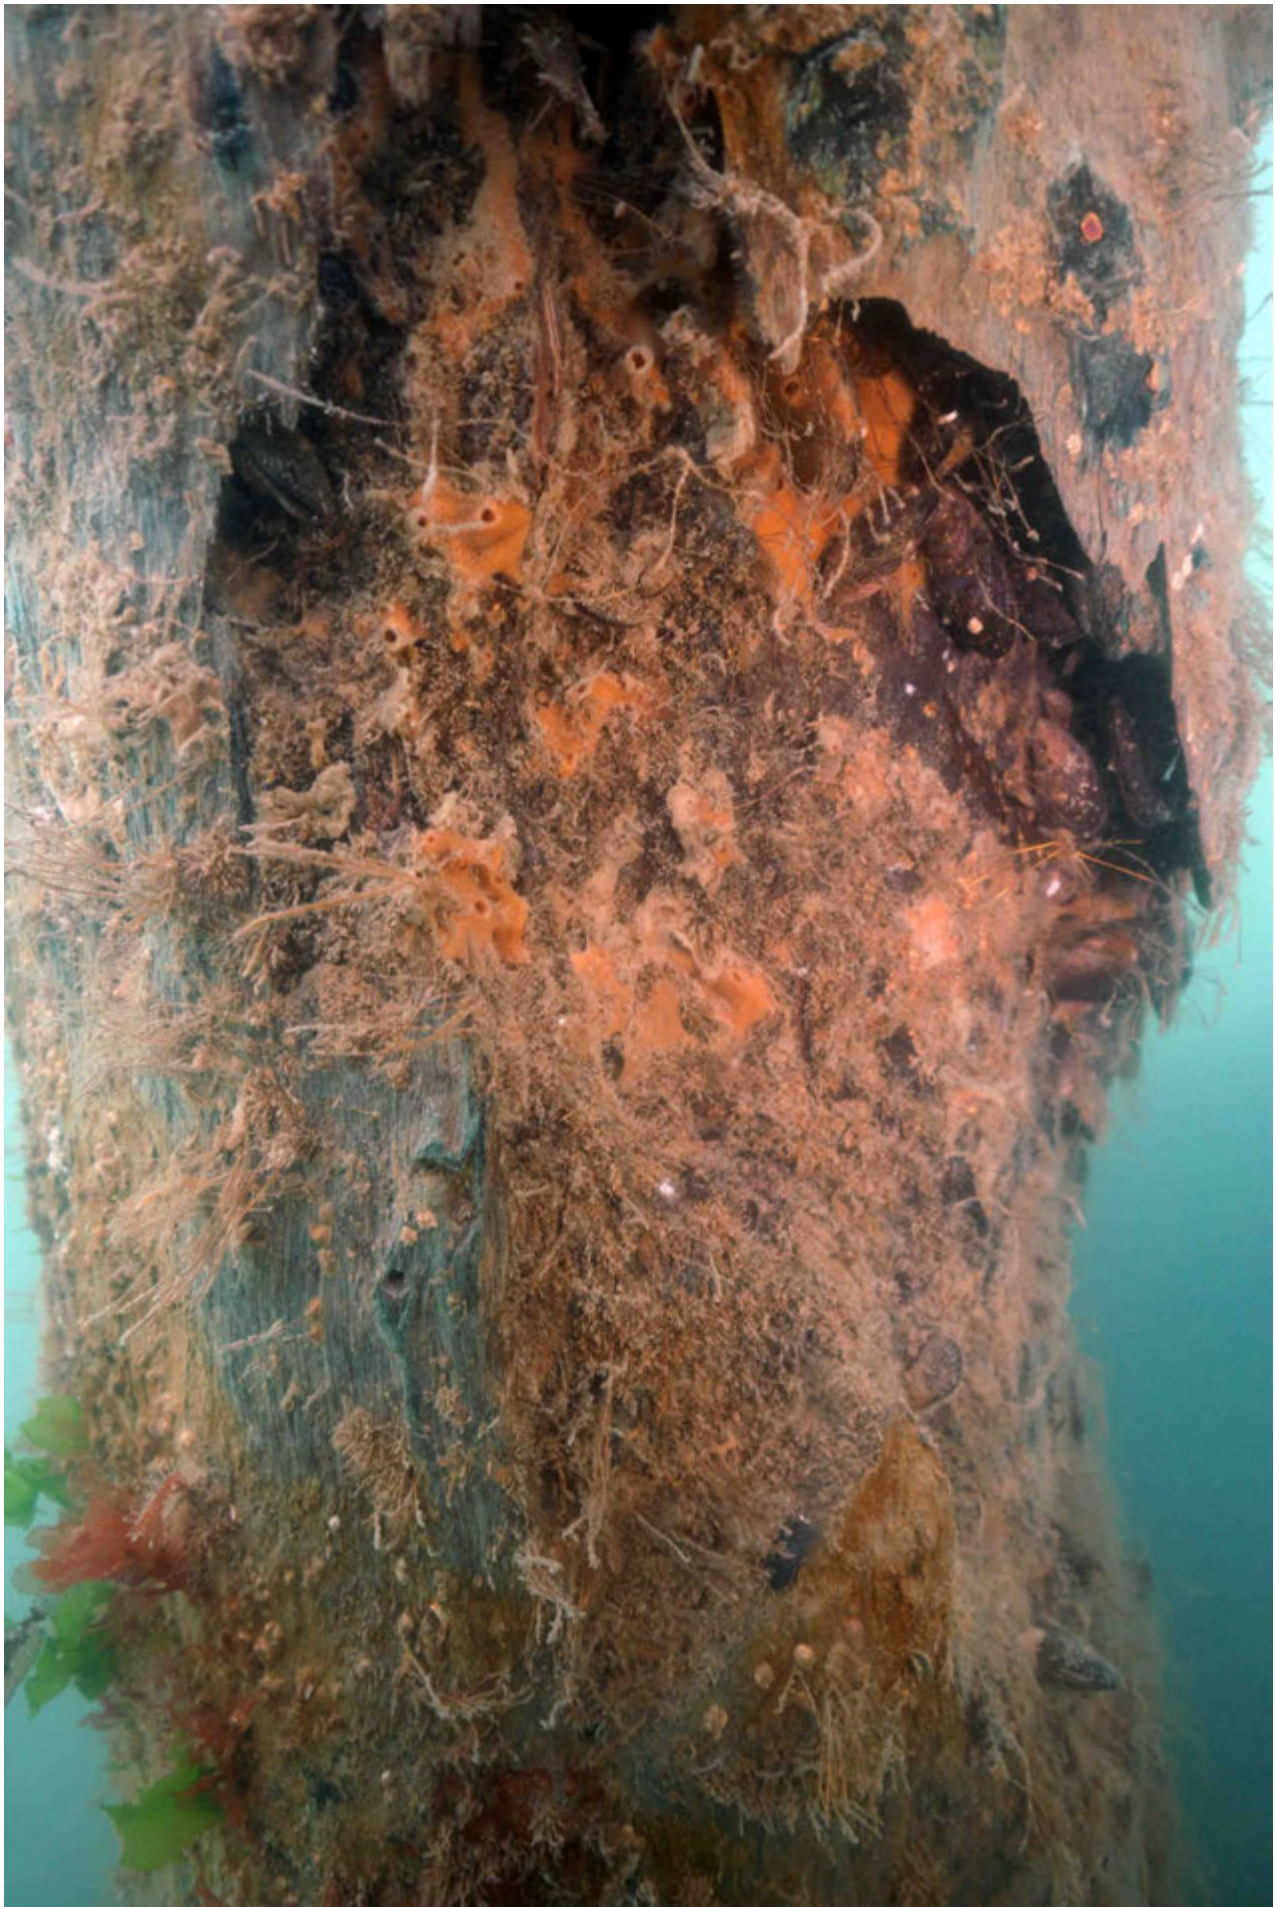
Pile 35C: Poor Condition – 40% loss of section – lower tidal zone
