Document Title:	HCC Petone Wharf – Approach Structure – Pile Condition Survey & Reporting
Document No.:	UCL – 2021.01 – HCC Wharf Approach PCS&R001 – V2
	Prepared for: Tom Arthur – Calibre Group Janet Lawson – Hutt City Council Francis O’Riley – G.K. Shaw Ltd.

Petone Wharf – Approach Structure

Pile Condition Survey & Reporting

January 2021

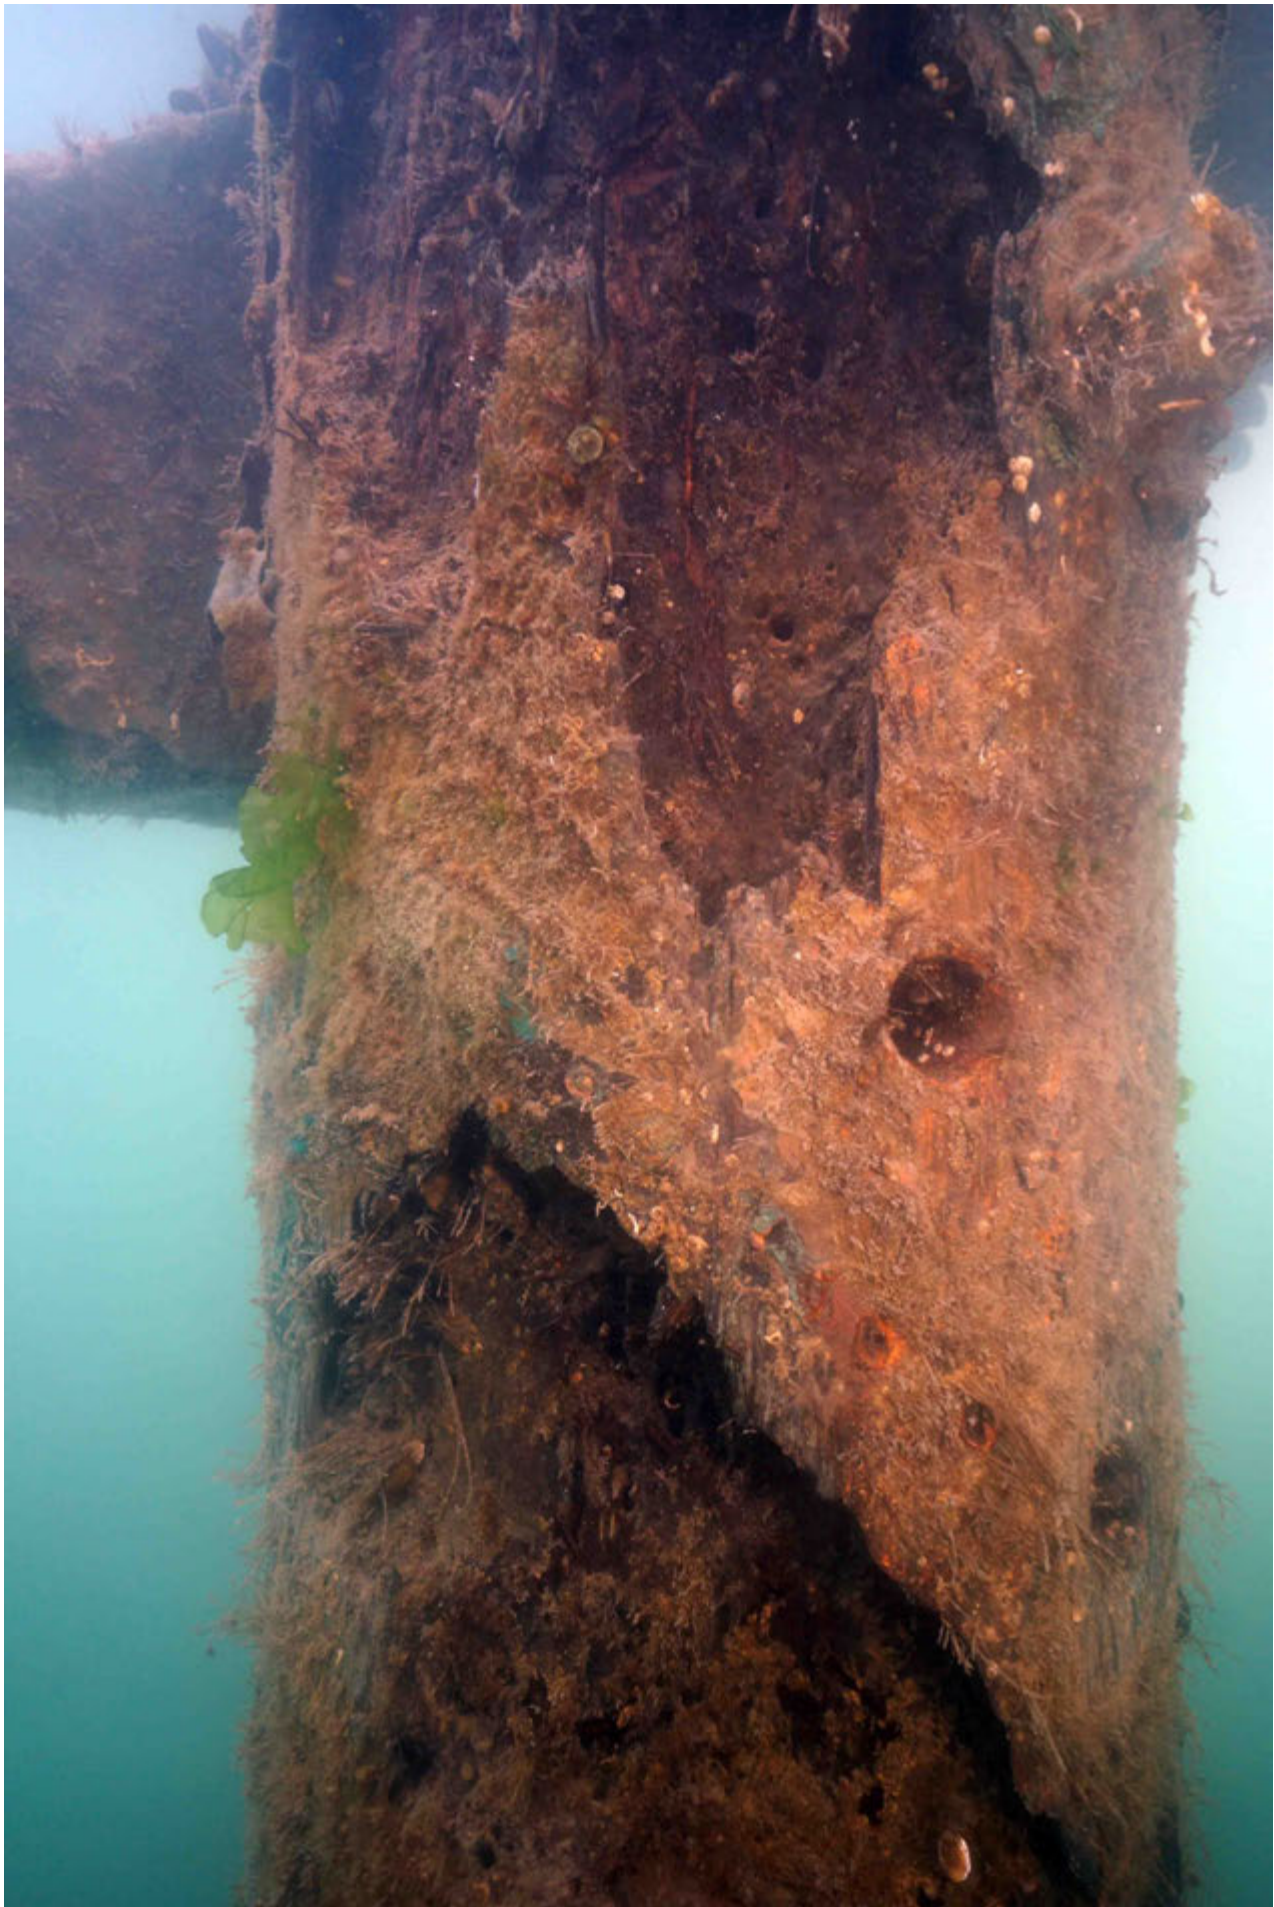
Pile 36C: Poor Condition – 35% loss of section – lower tidal zone. Moderate hollowing

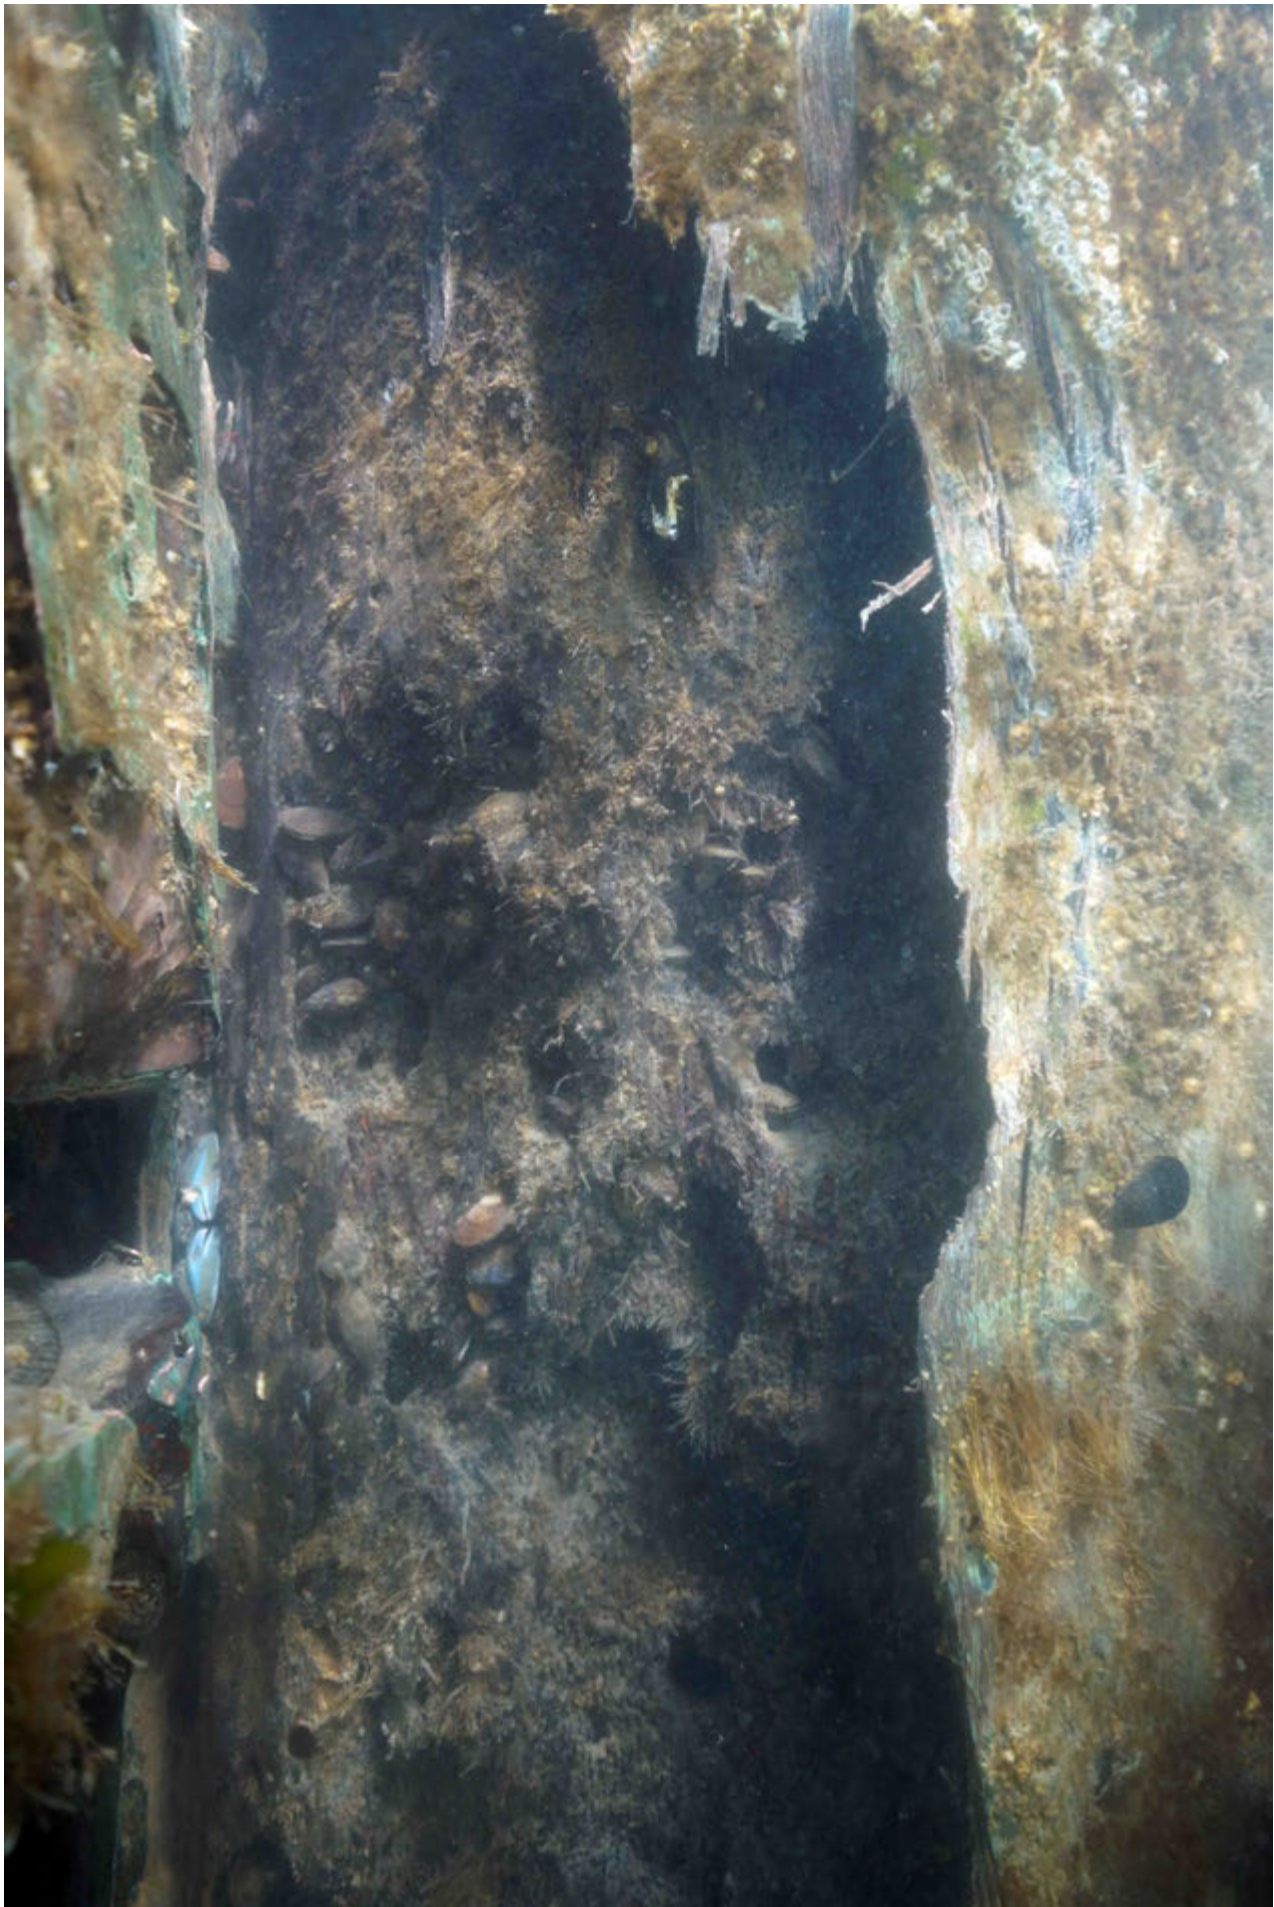
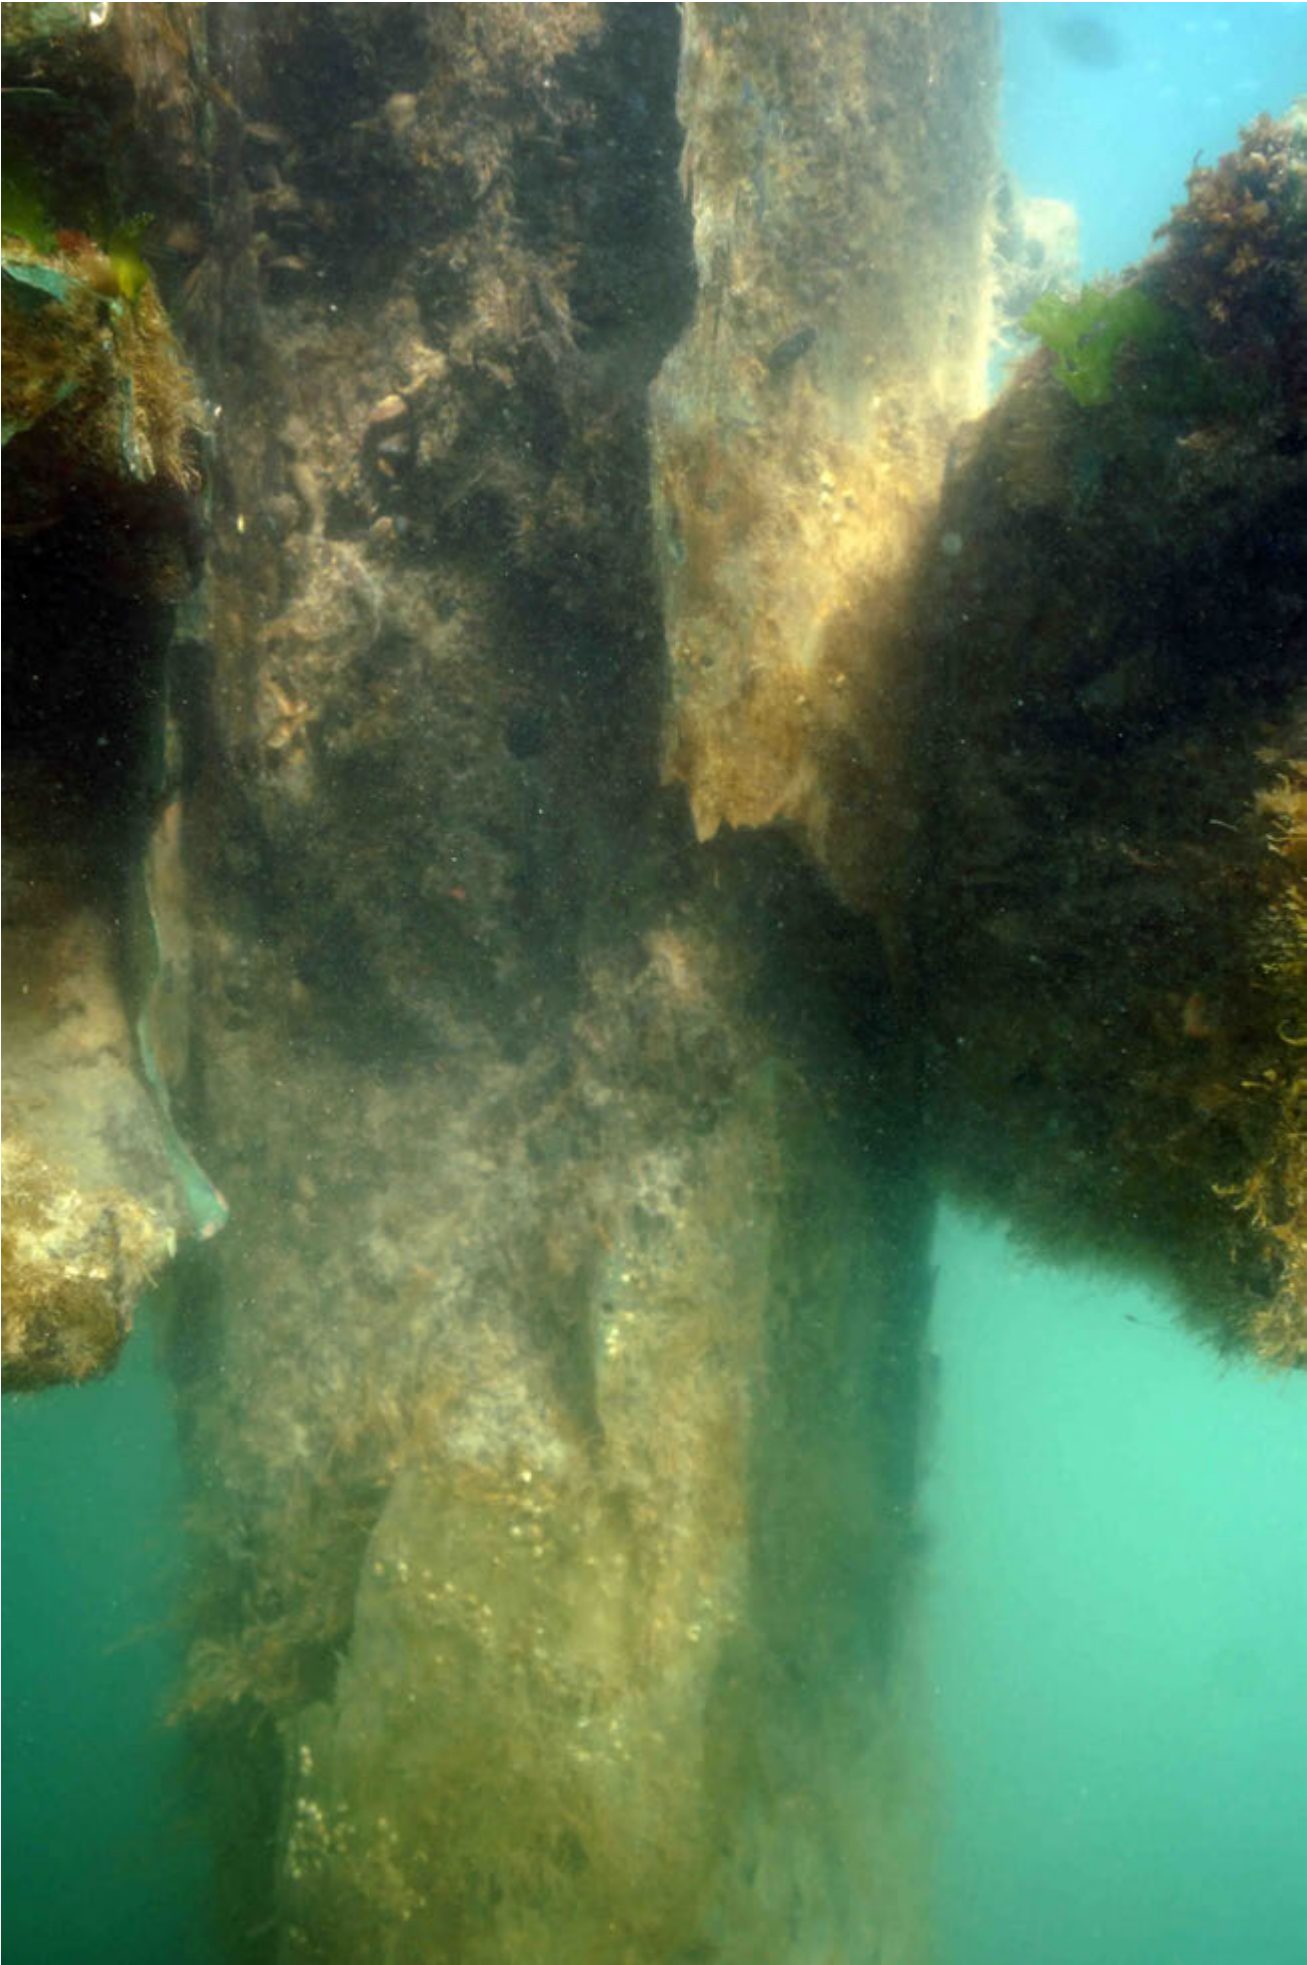
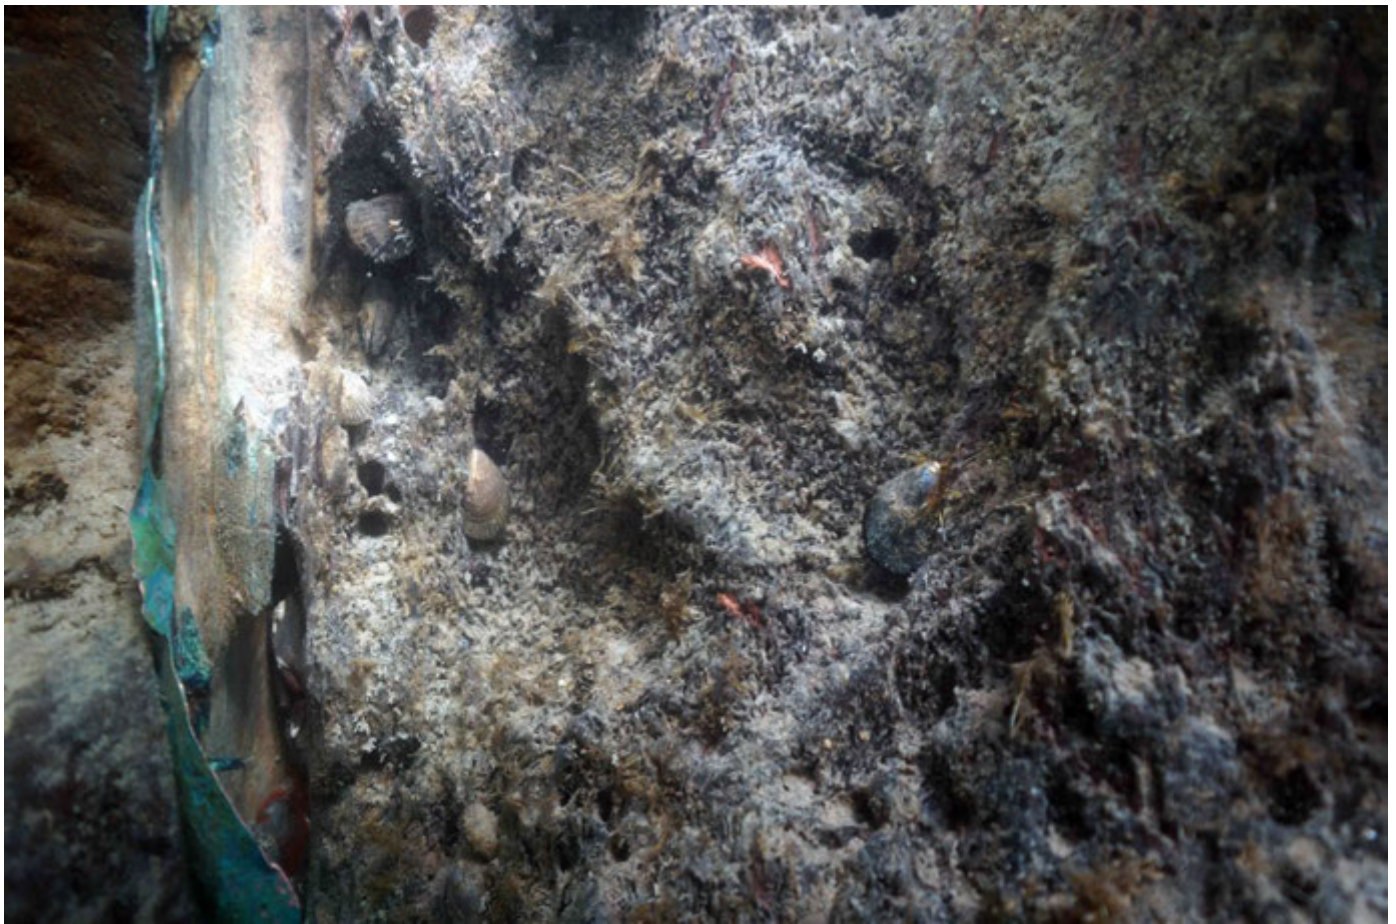
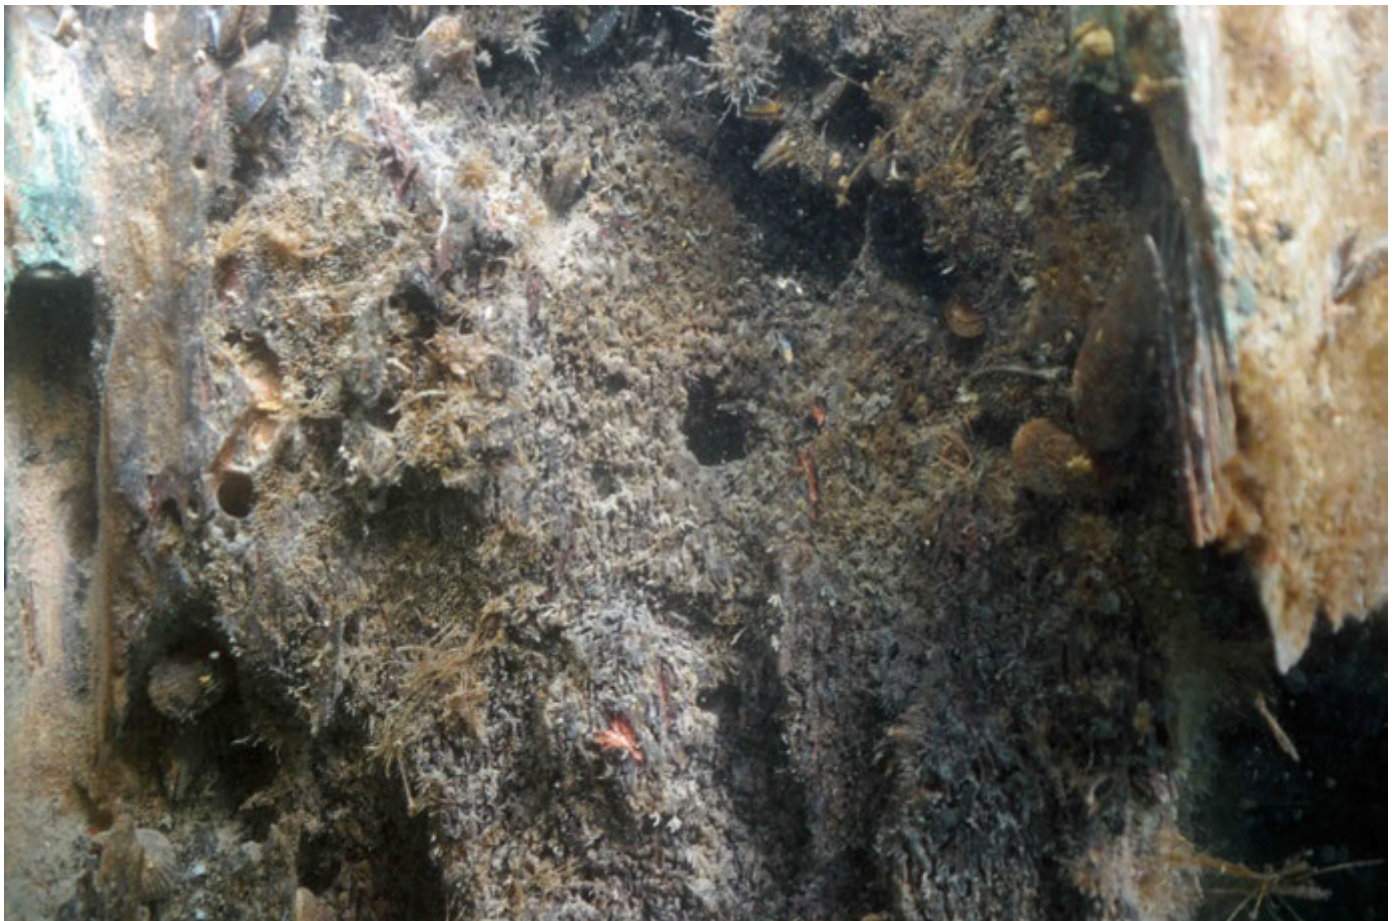
Pile 37C: Poor Condition – 45% loss of section – lower tidal zone to seabed

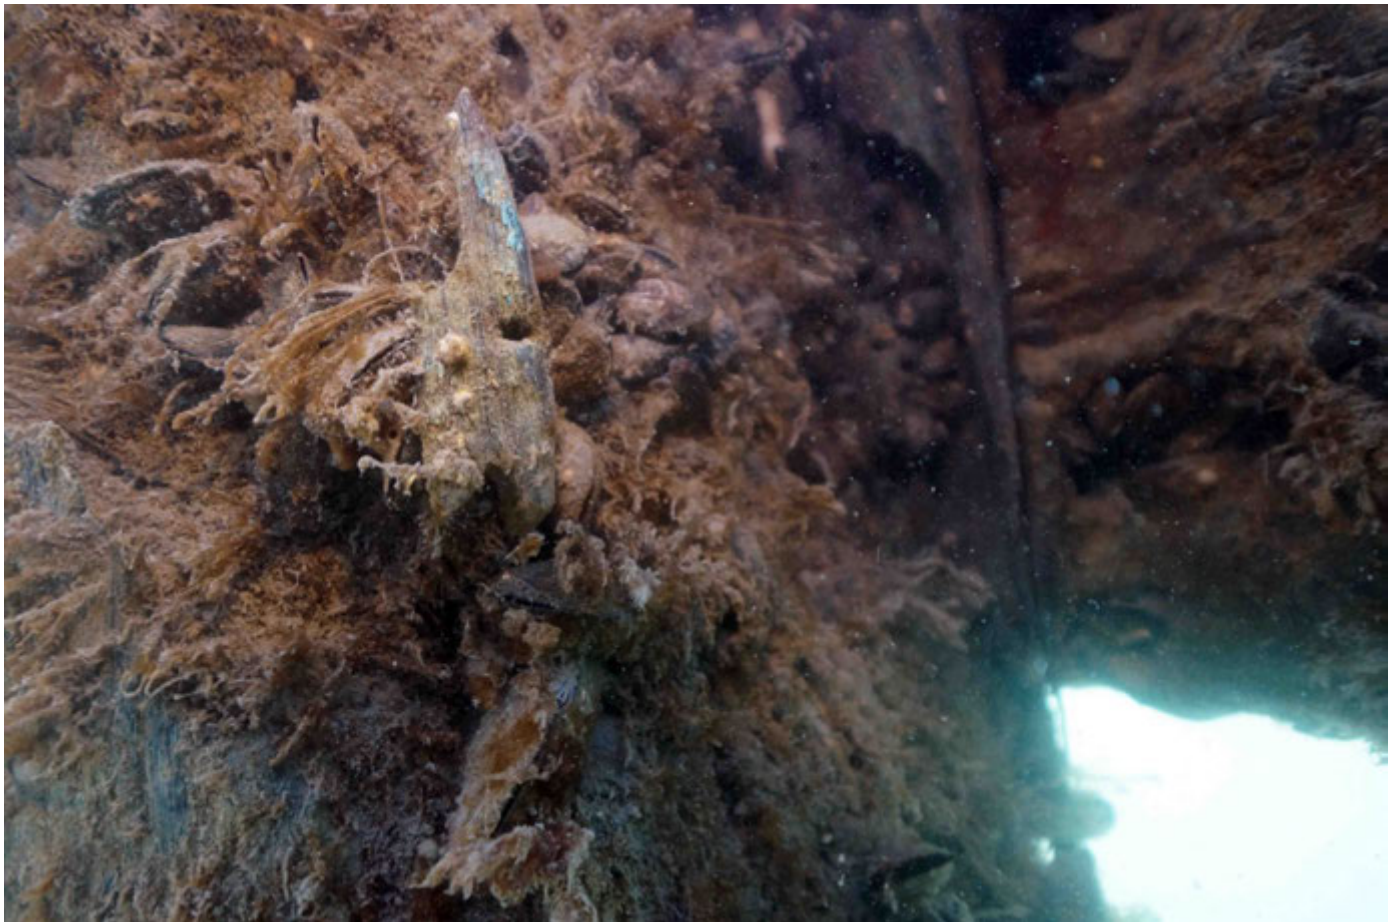
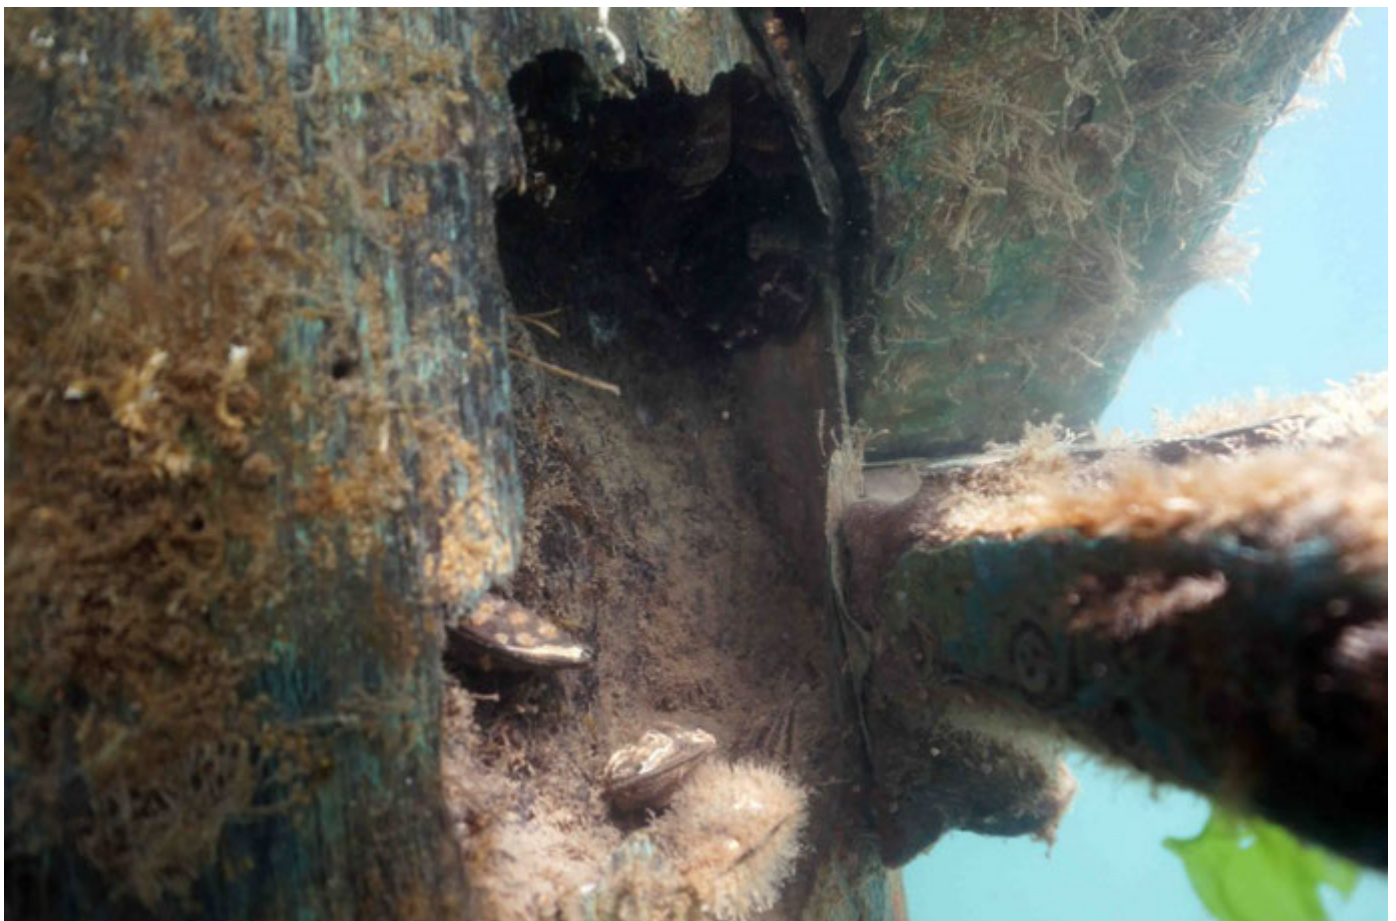
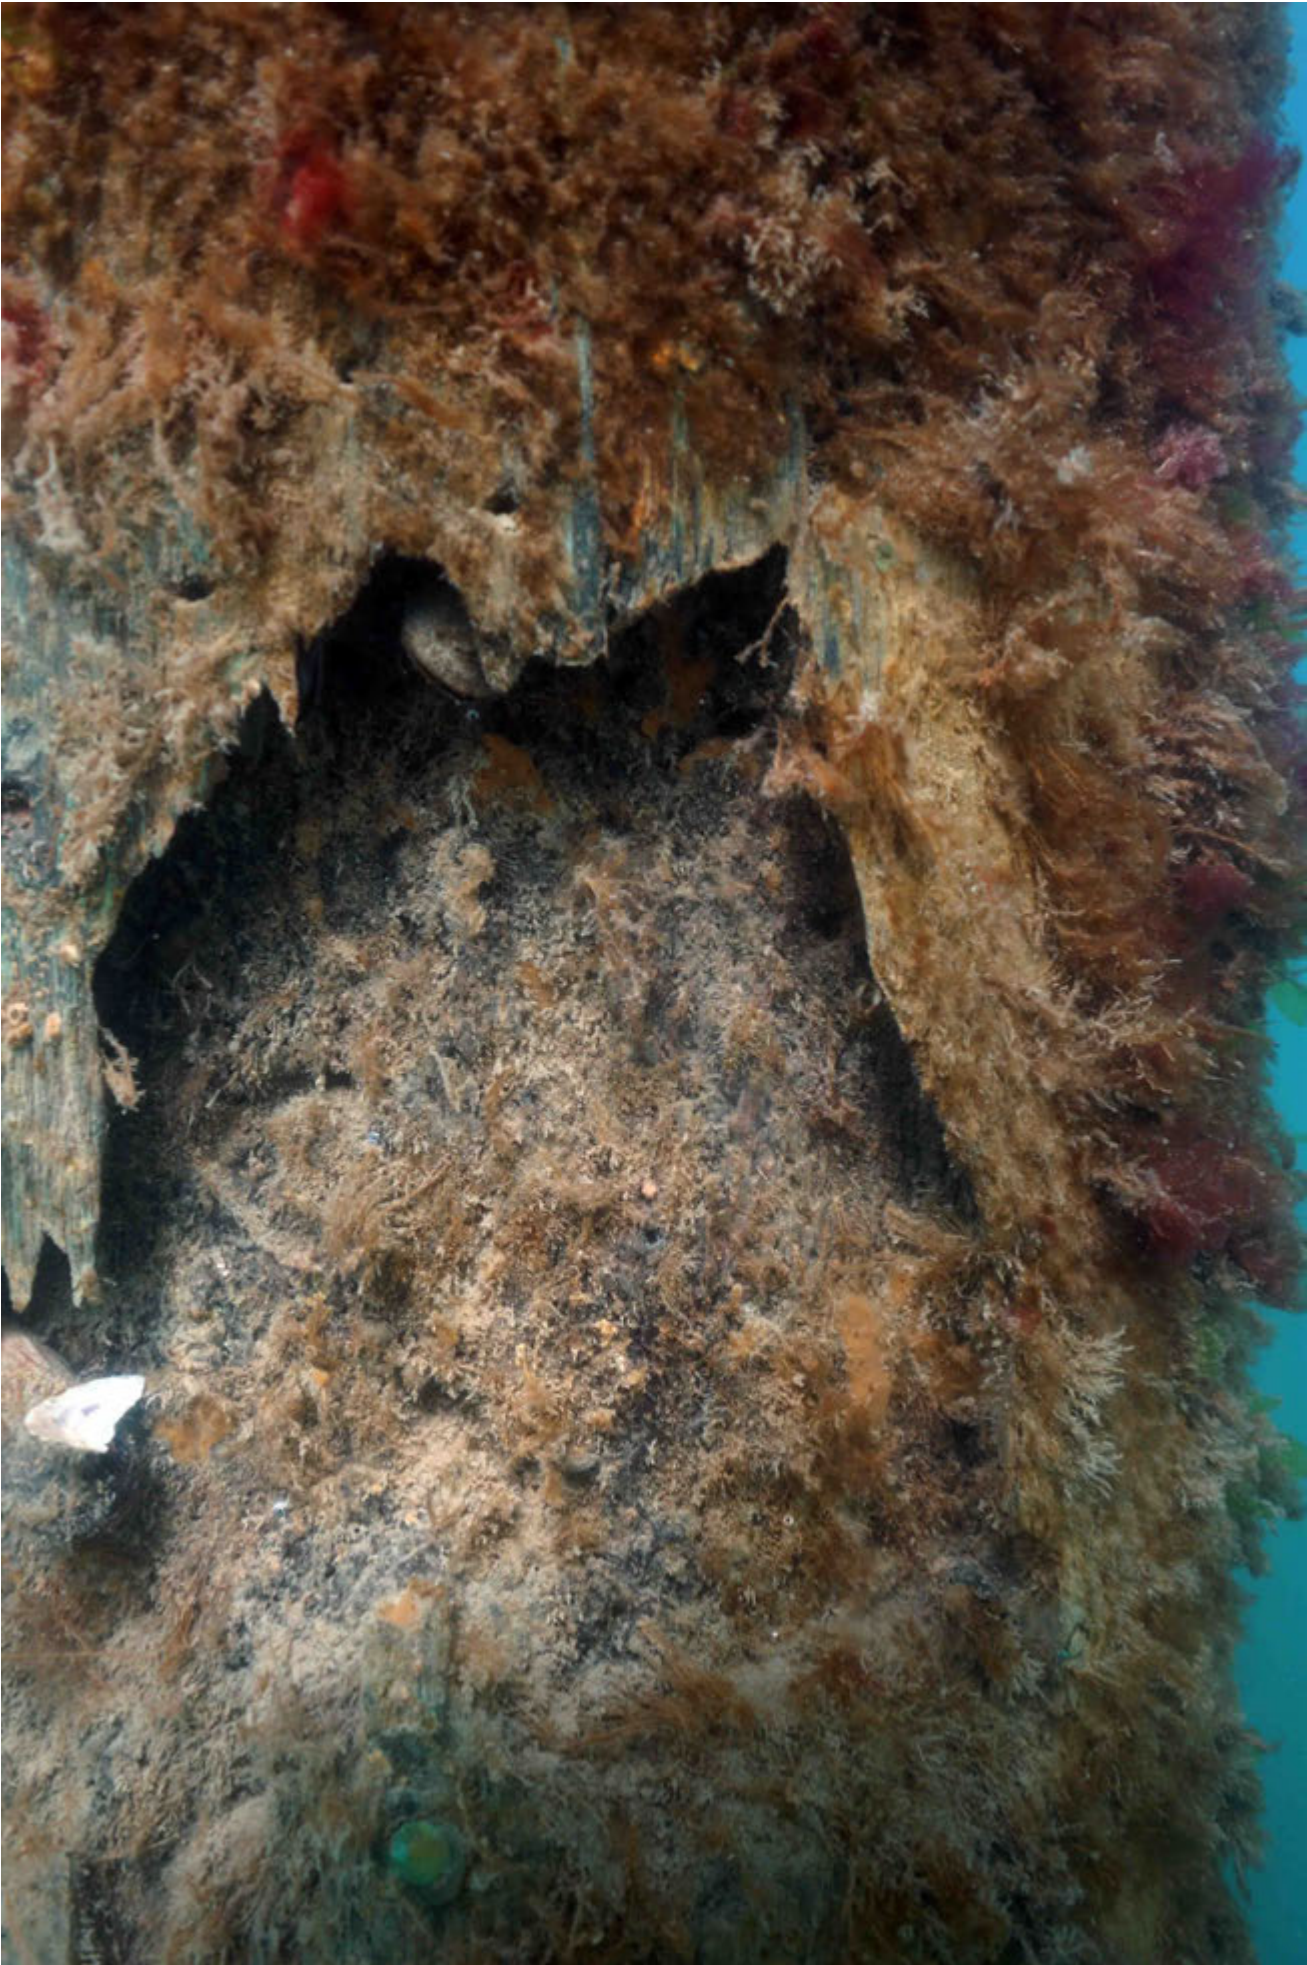
Pile 37D: Poor Condition – 35% loss of section – lower tidal zone

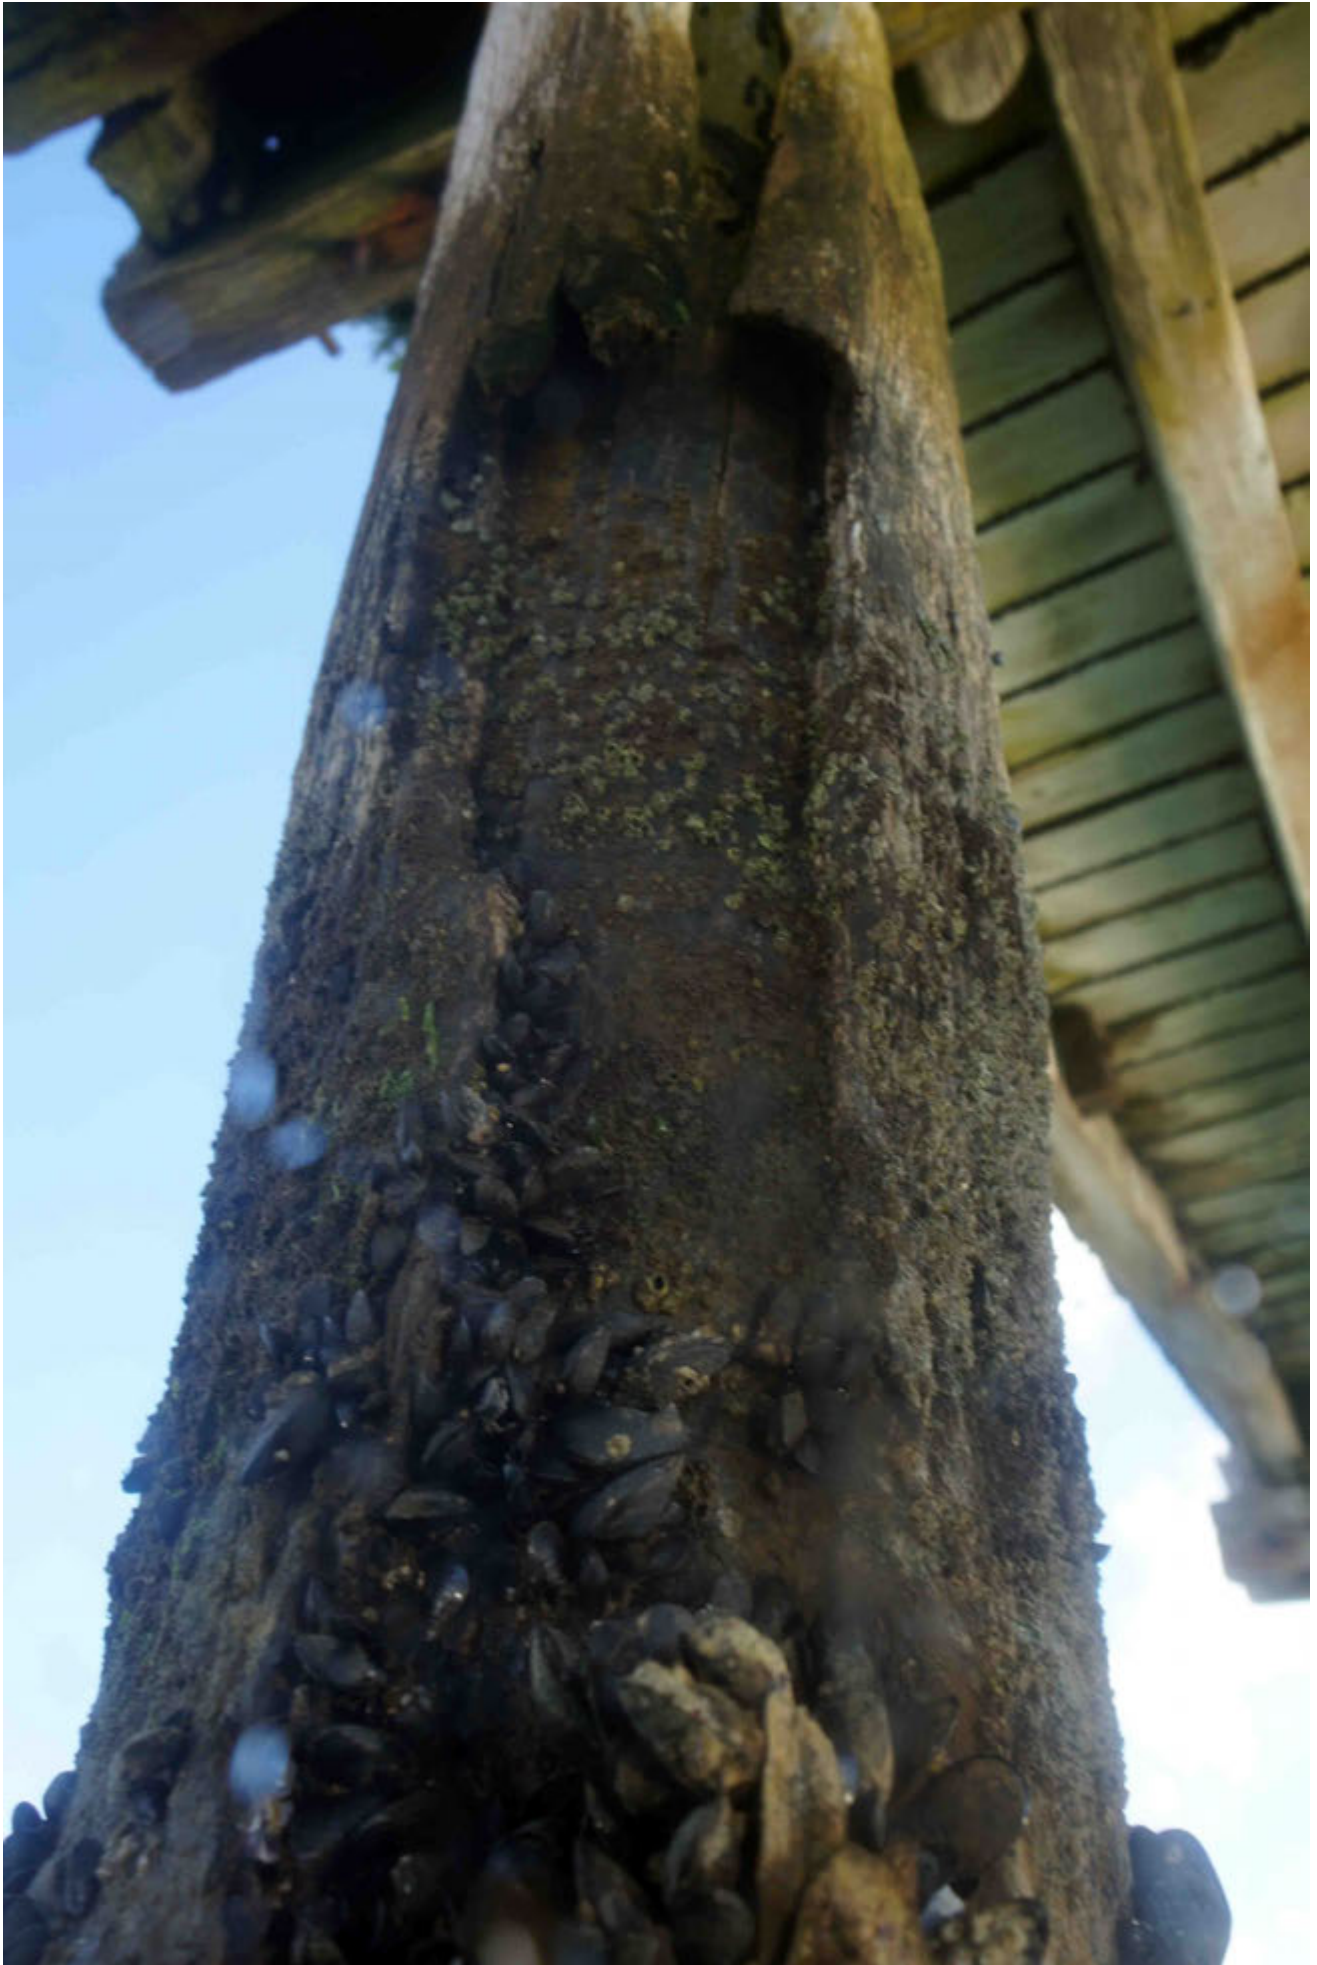
Pile 38D: Poor Condition – 35% loss of section – above tidal zone. Moderate hollowing & decay

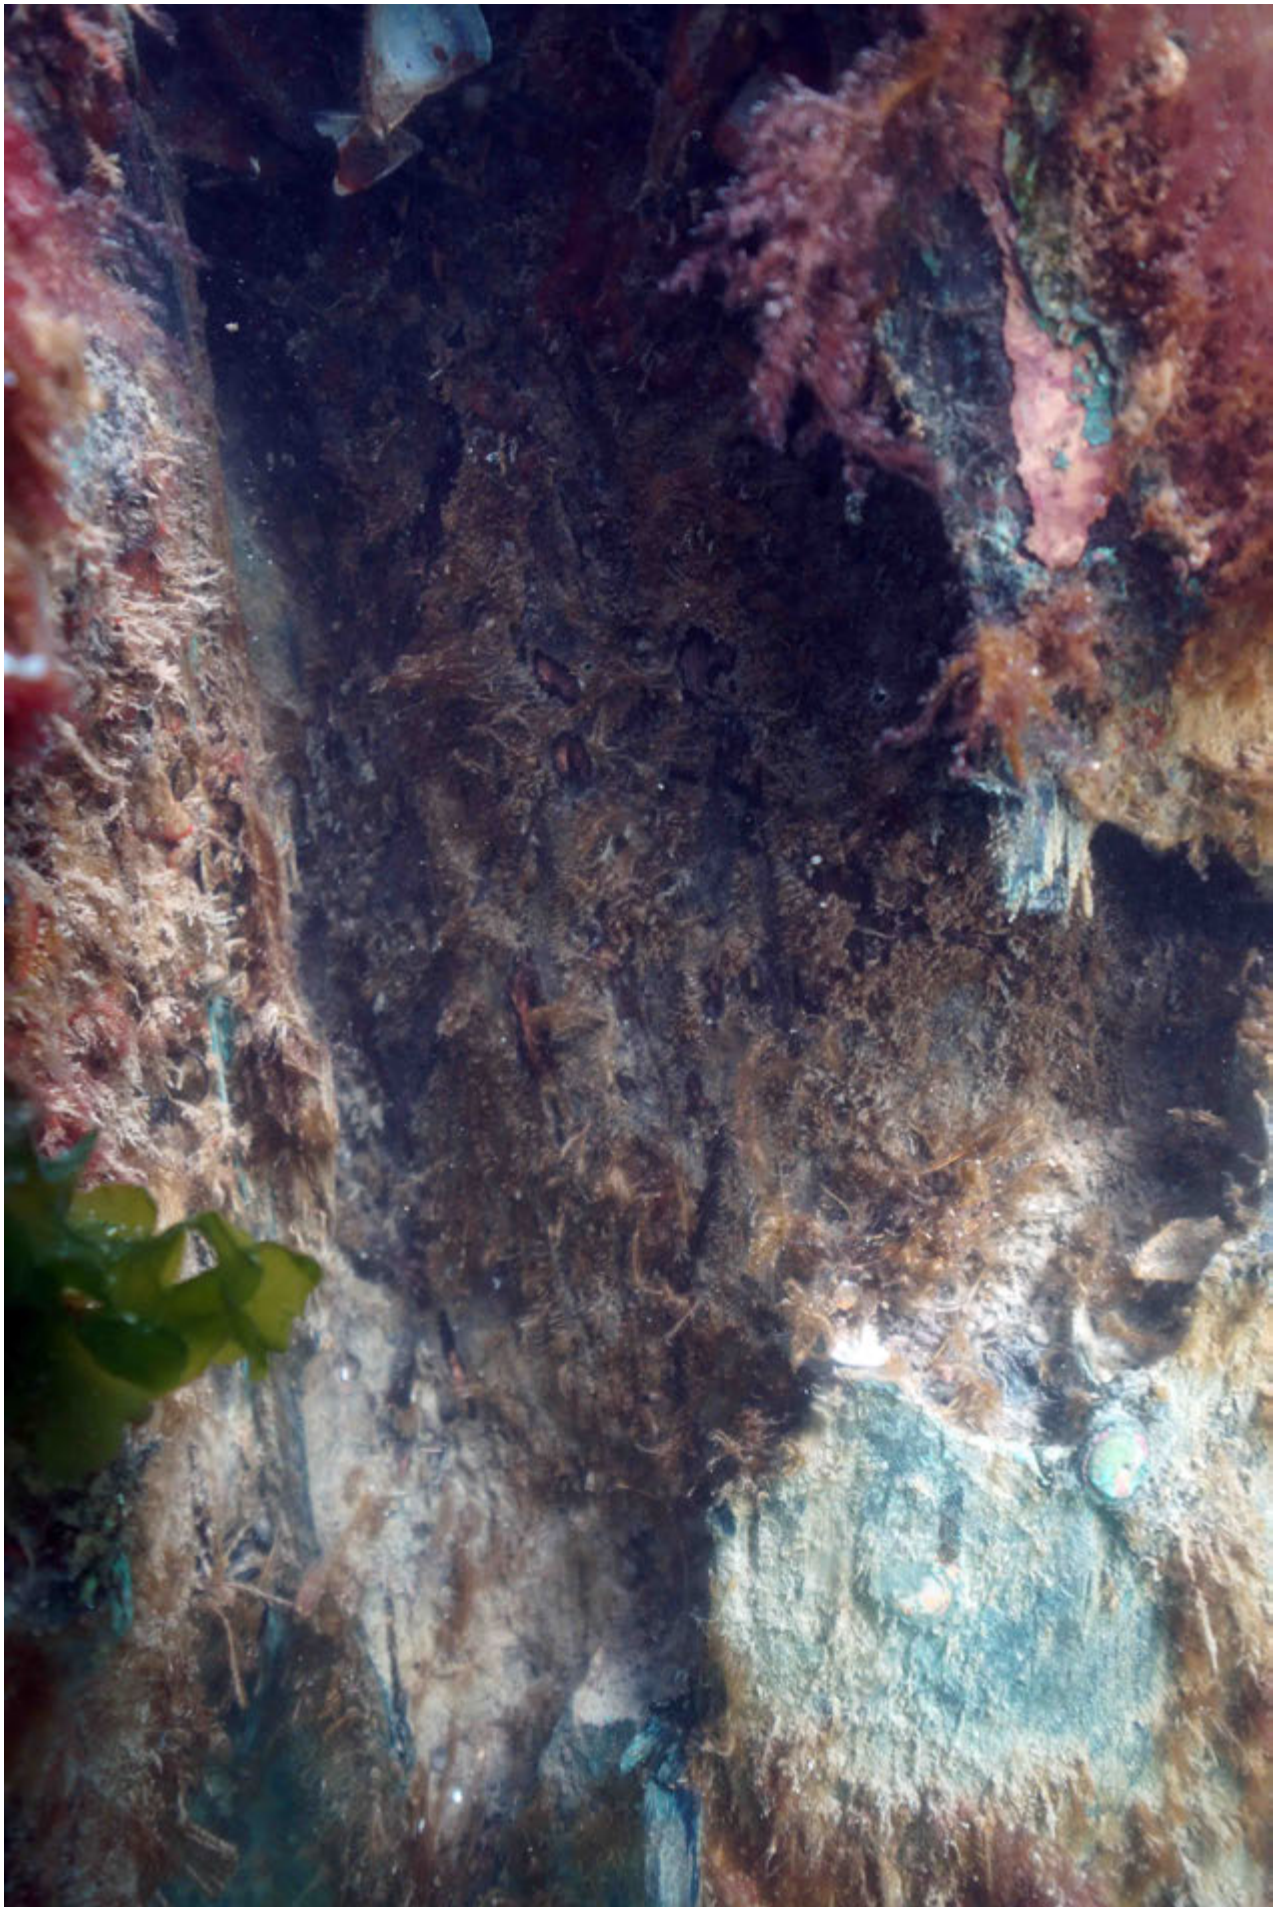
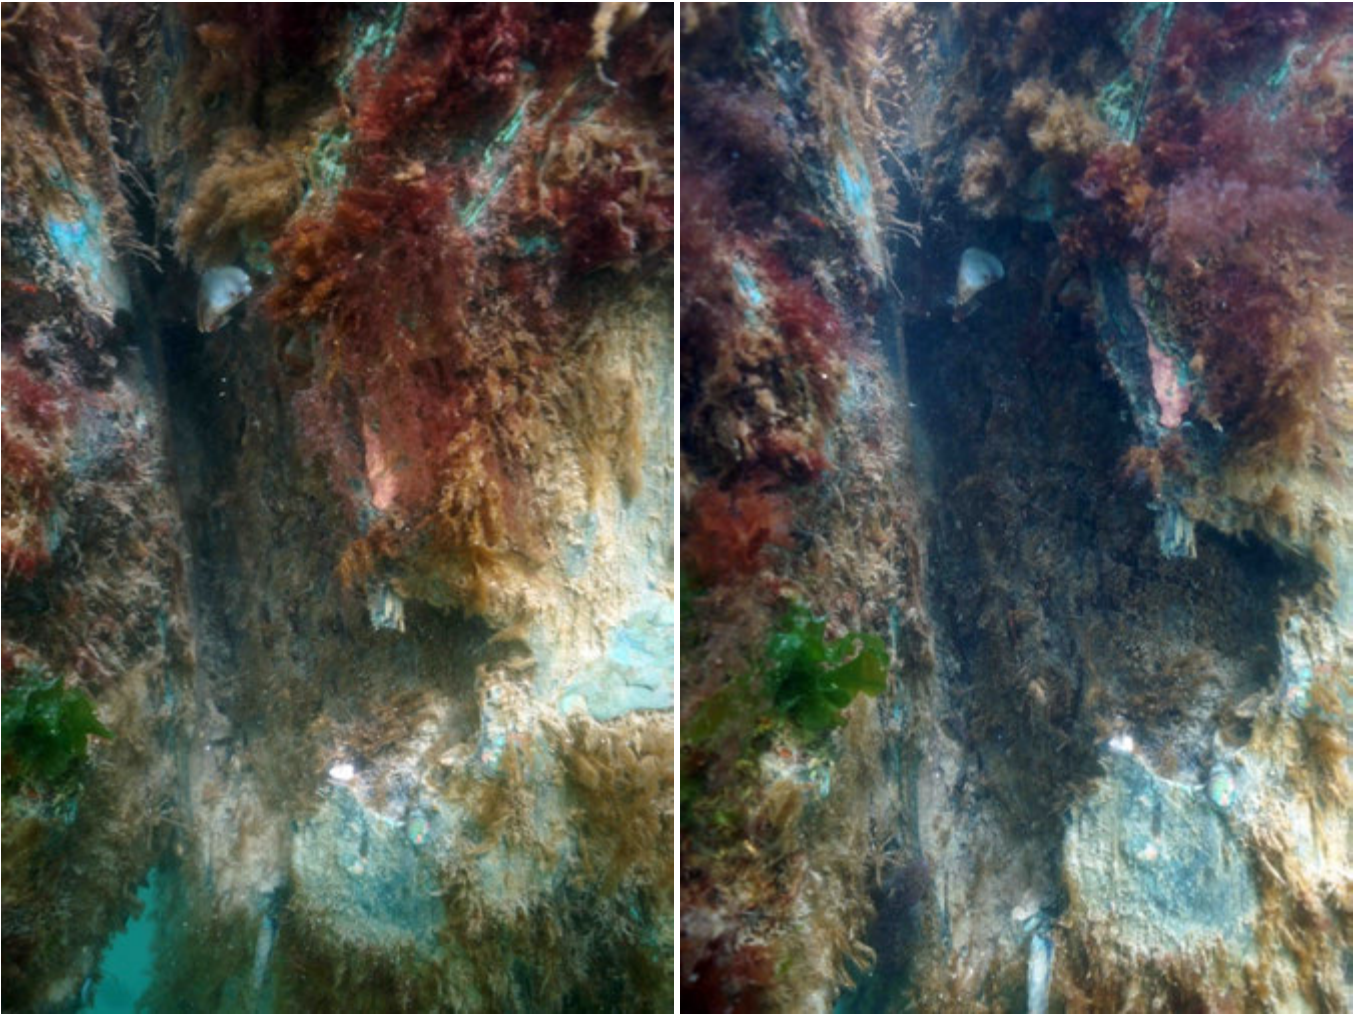
Pile 43C: Poor Condition – 35% loss of section – lower tidal zone
