Document Title:	HCC Petone Wharf – Approach Structure – Pile Condition Survey & Reporting
Document No.:	UCL – 2021.01 – HCC Wharf Approach PCS&R001 – V2
	Prepared for: Tom Arthur – Calibre Group Janet Lawson – Hutt City Council Francis O’Riley – G.K. Shaw Ltd.

Petone Wharf – Approach Structure

Pile Condition Survey & Reporting

January 2021

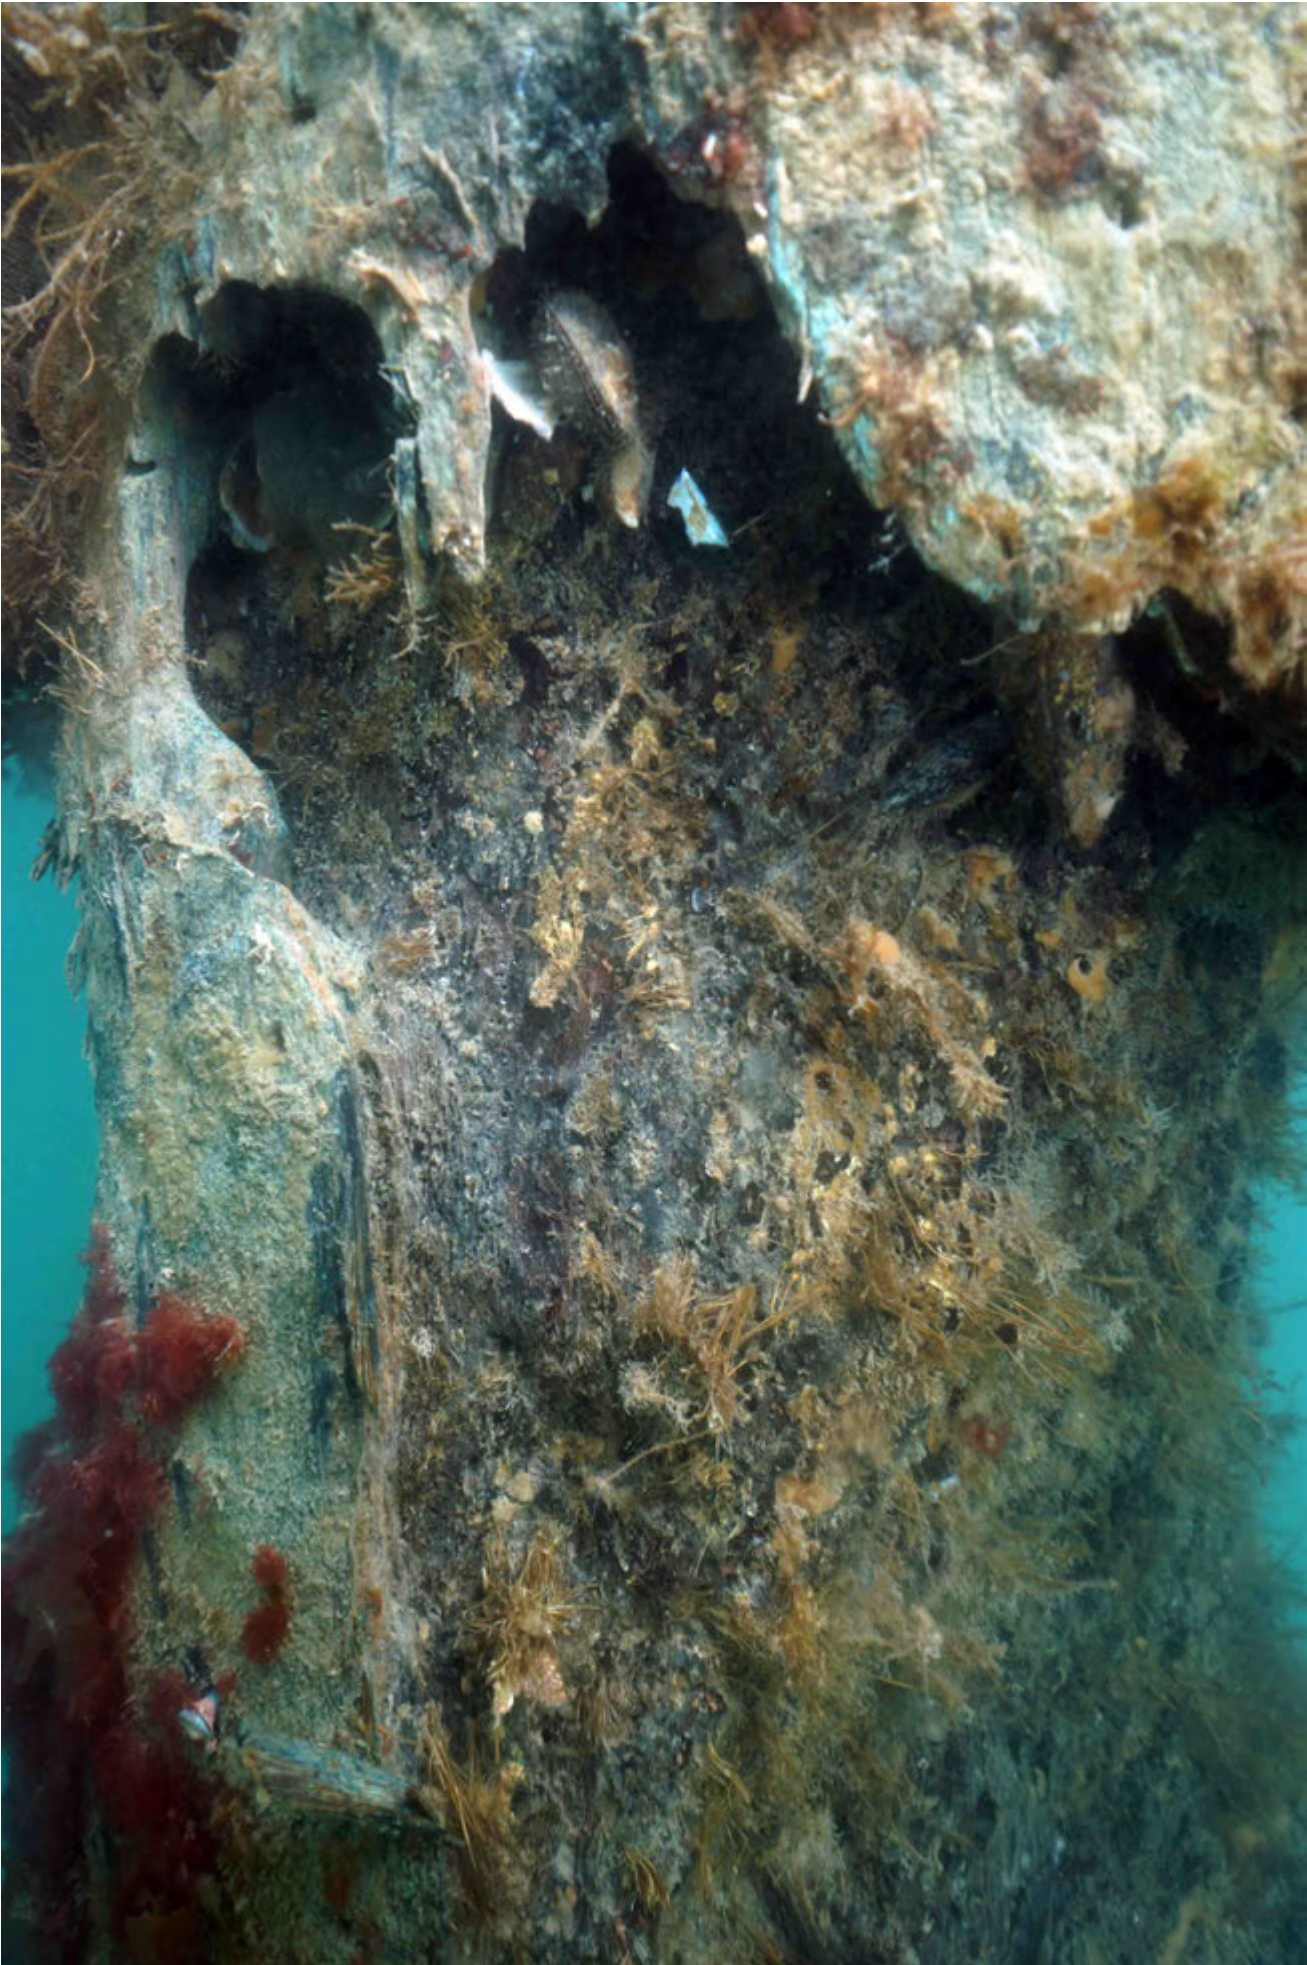
Pile 44C: Poor Condition – 40% loss of section – lower tidal zone. Top-end splitting
