Hutt Hospital – Detailed Seismic Assessments

Clock Tower Building DSA

Hutt Valley District Health Board

Reference: 520602

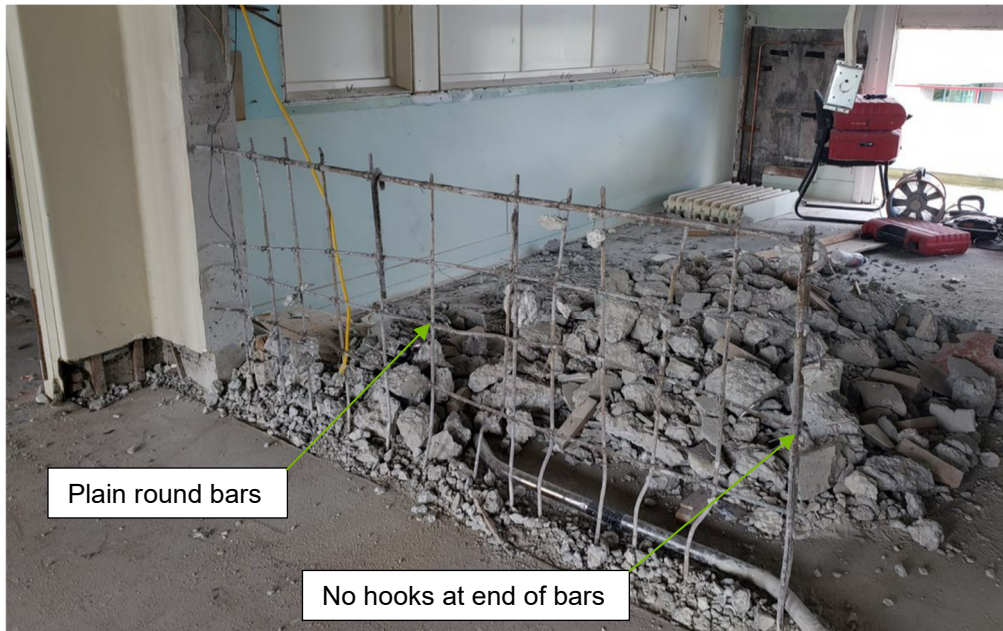
Figure 1-4 Demolished wall example showing plain round bars with no hooks at the ends of the wall

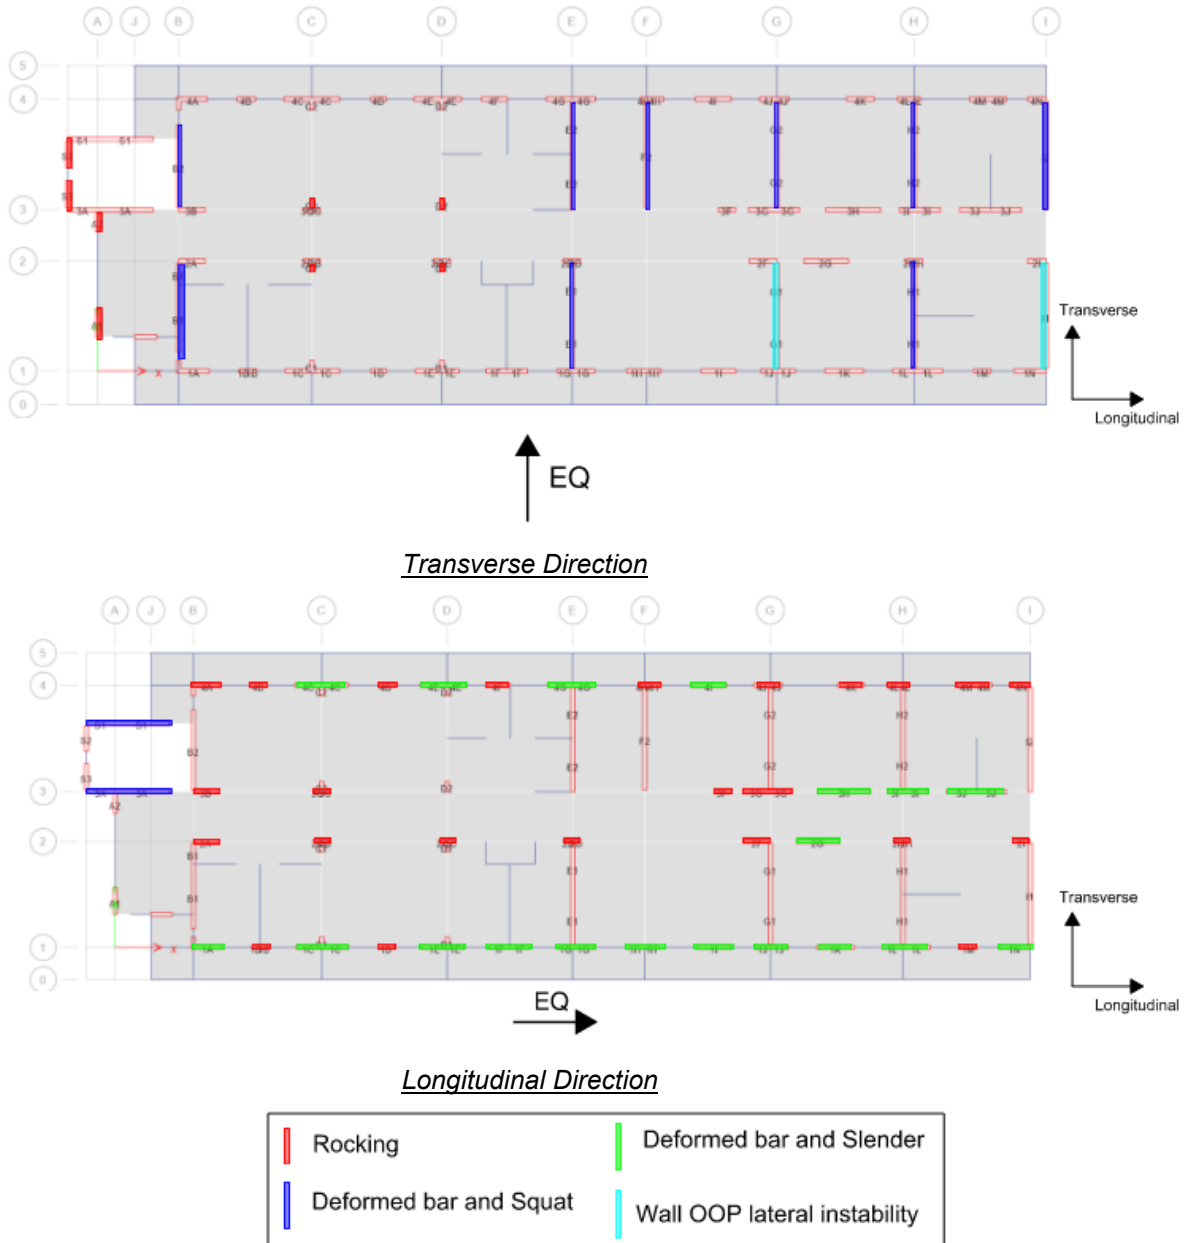
The RC walls have insufficient flexural and/or shear capacities to withstand a global system ductility ranging from 1.25 to 2 under 100% ULS shaking (representing the earthquake rating of 100%NBS). In both directions, the lap lengths of the plain round bars at the base of the walls are inadequate to yield the bars. The required development length was taken as twice that required for an equivalent deformed bar as determined by NZS 3101:2006. Consequently, during an ULS earthquake, the bars are expected to slip, leading to the formation of a single diagonal crack. Once this crack appears, the walls may experience a rocking response and potentially lead to sliding shear failure. Some walls are also susceptible to out-of-plane lateral instability and shear failure during a design-level earthquake. Refer to Figure 6-1 and Figure 6-2 that shows the governing RC post-elastic rotation mechanism for each of the buildings in each direction.

When rocking, shear failure and/or out-of-plane instability occur, significant spalling of concrete cover on the RC walls may transpire, contributing to increased building displacements. As the displacements increase, non-structural elements such as doors, windows, and building services are anticipated to sustain significant damage. Additionally, the gap between adjacent buildings may result in collision and cause local crushing of the slab and wall edges. Once substantial shear sliding occurs in the walls, their capacity to carry gravity loads may be compromised.

Figure 6-1 East and West Wing RC walls governing post-elastic rotation mechanism

- Increase the buildings vertical lateral resisting capacity by installing new RC walls or steel braces
- Increase the foundations capacity by installing new RC jackets around the existing foundations/add new piles
- Increase the diaphragms tension capacity by recessing steel plates into the concrete floor
- Increase the roofs lateral capacity by installing additional braces and struts

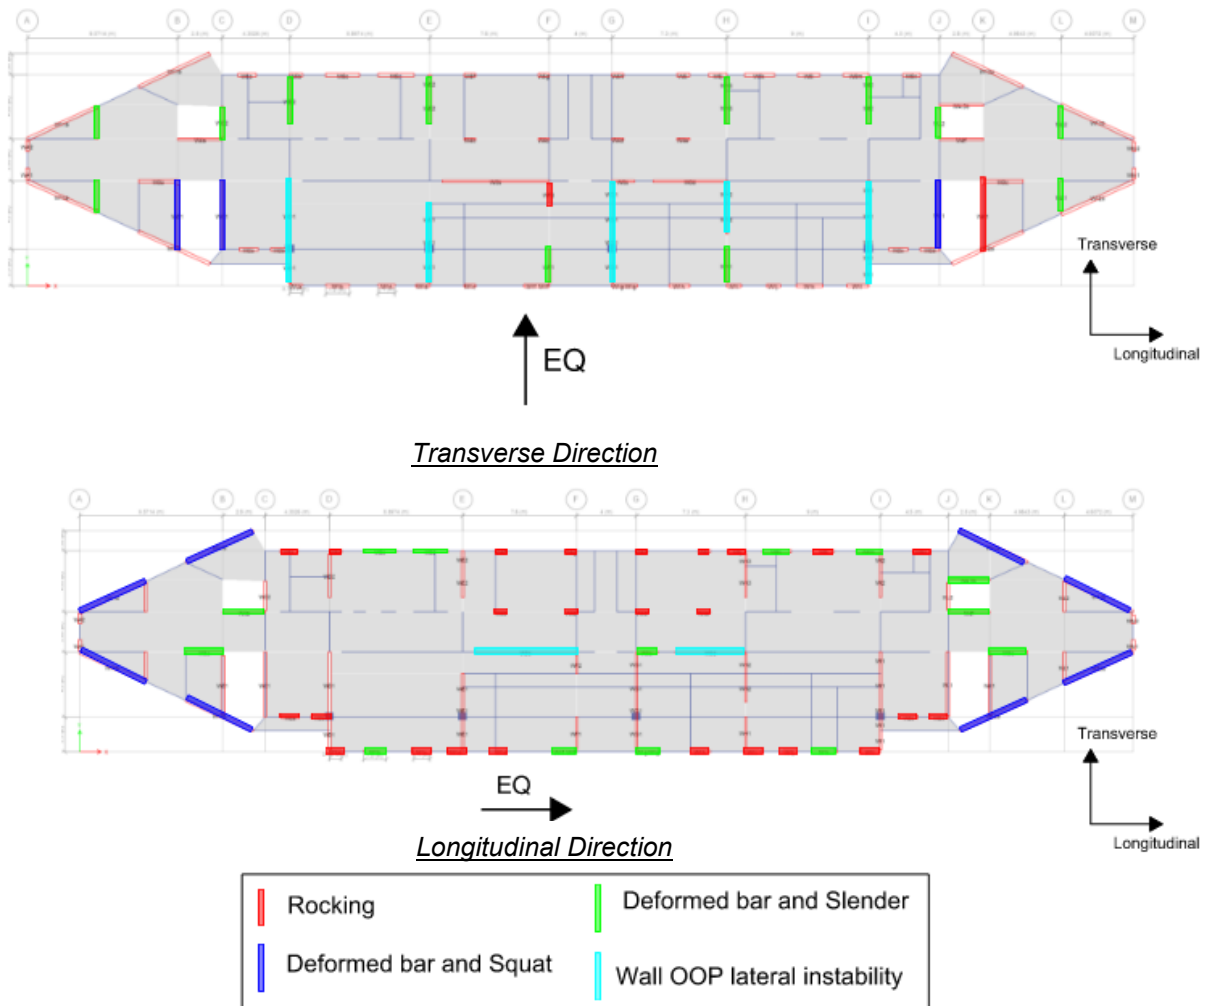
Figure 6-2 Central Wing RC walls governing post-elastic rotation mechanism

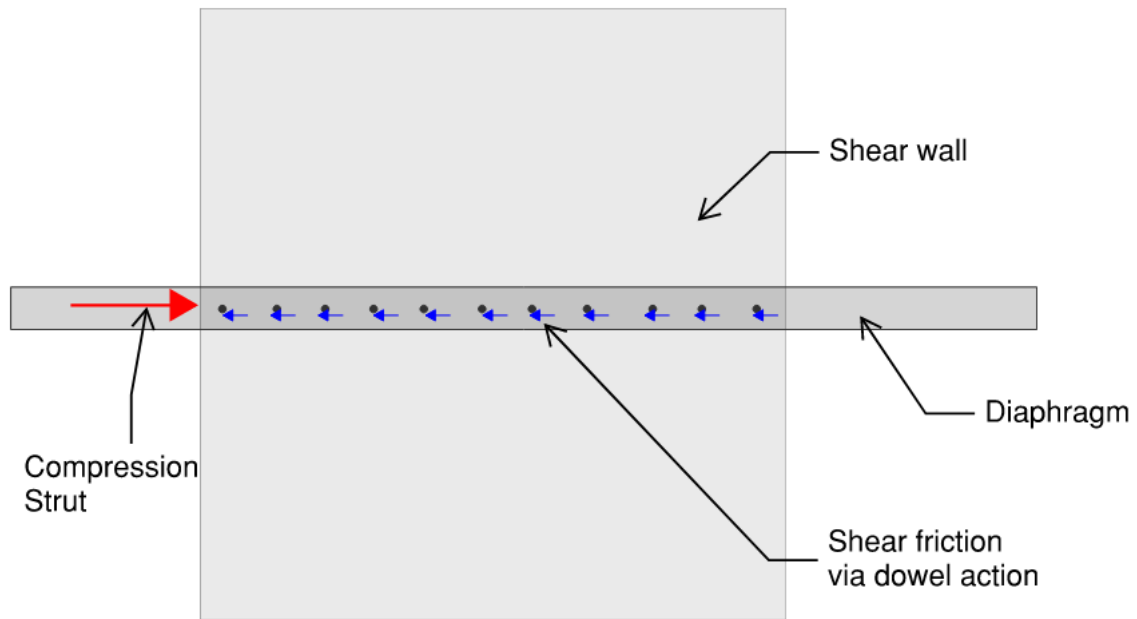
Once the diaphragm connection is exceeded, the diaphragm may detach from the RC walls. Seismic load may then redistribute to the other in-plane shear walls and overload them. RC walls out-of-plane may also provide an alternative load path.

Figure 6-3 Shear wall elevation showing the load transfer mechanism
