Hutt Hospital – Detailed Seismic Assessments

Clock Tower Building DSA

Hutt Valley District Health Board

Reference: 520602

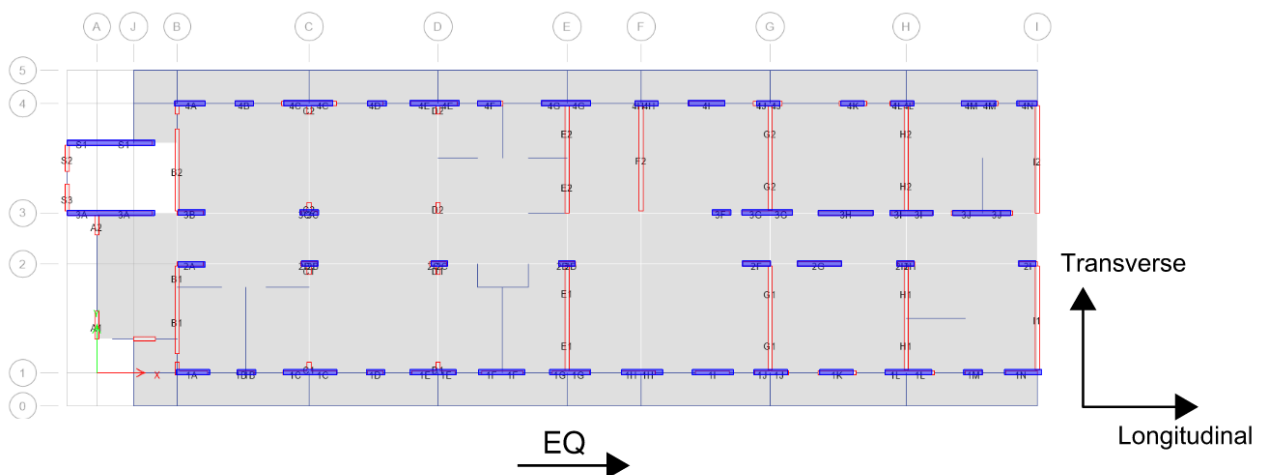
Figure 3-1 East Wing and West Wing lateral resisting elements in the longitudinal direction

- RC shear walls that extend the full height of the buildings
- The concrete wall thickness and wall reinforcement was measured in several locations during the demolition works. The walls were measured as approximately 200mm thick. The wall reinforcement was observed as one layer of 9.5mm diameter plain round bars at approximately 150mm centres in each direction.
- Refer to Figure 3-1, Figure 3-2, Figure 3-3 and Figure 3-4 for the location of the RC shear walls.

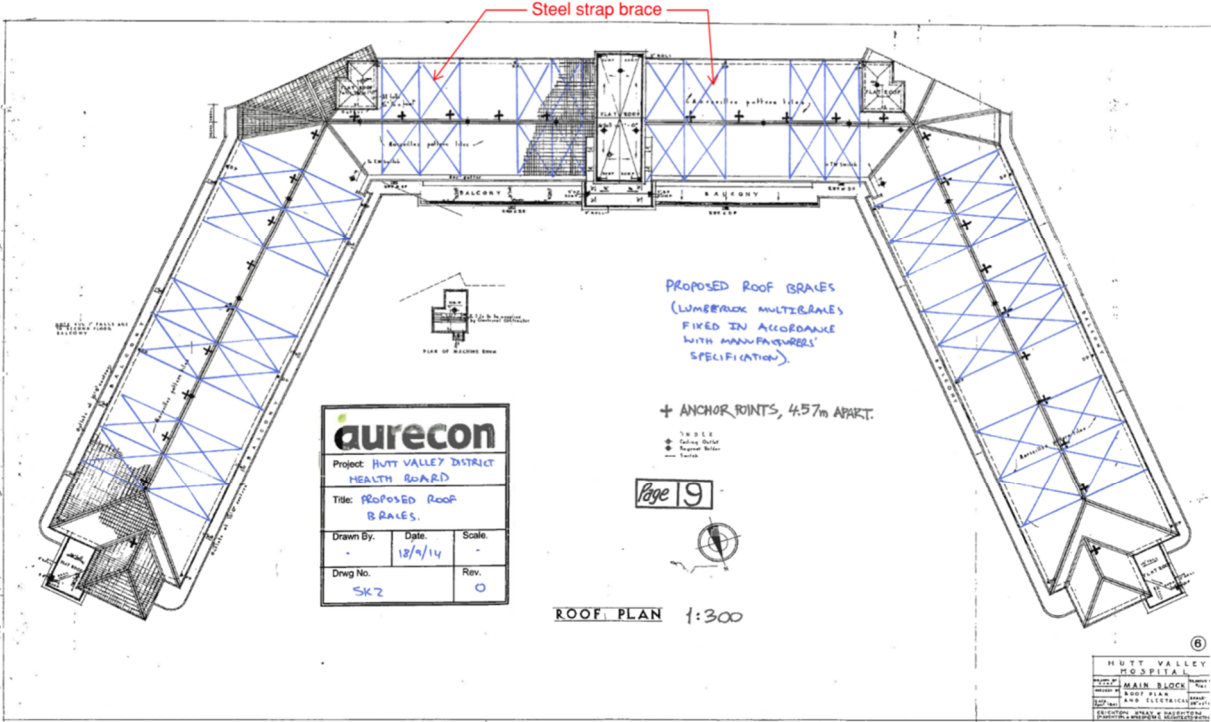
Figure 3-5 Clocktower Roof Plan View

For the roof diaphragm, Lumberlok Multibrace steel braces are employed to distribute the seismic forces from the timber roof structure to the concrete walls. Figure 3-5 illustrates the plan location of these braces at the roof level. The steel braces are connected to timber elements through nailed connections.

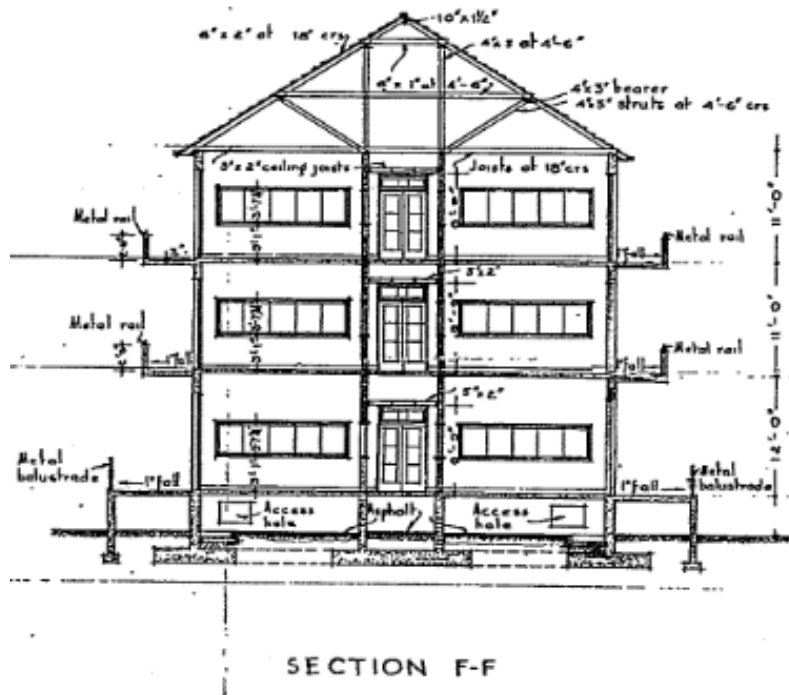
Figure 3-6 Architectural section through the East and West Wings

Based on the existing architectural drawings, it was evident that the building is supported by concrete shallow foundations. Unfortunately, the size of the foundations and the specifics of the reinforcement were not available. Please refer to Figure 3-6 and Figure 3-7 for sections through the Clocktower Wings, as depicted in the existing architectural drawings. Detailed structural information regarding the foundations was not accessible. The dimensions of the footings were measured whenever possible from the architectural drawings, and additional insights were derived from the 2008 SKM report.
