Document Title:	HCC Petone Wharf – Approach Structure – Pile Condition Survey & Reporting
Document No.:	UCL – 2021.01 – HCC Wharf Approach PCS&R001 – V2
	Prepared for: Tom Arthur – Calibre Group Janet Lawson – Hutt City Council Francis O’Riley – G.K. Shaw Ltd.

Petone Wharf – Approach Structure

Pile Condition Survey & Reporting

January 2021

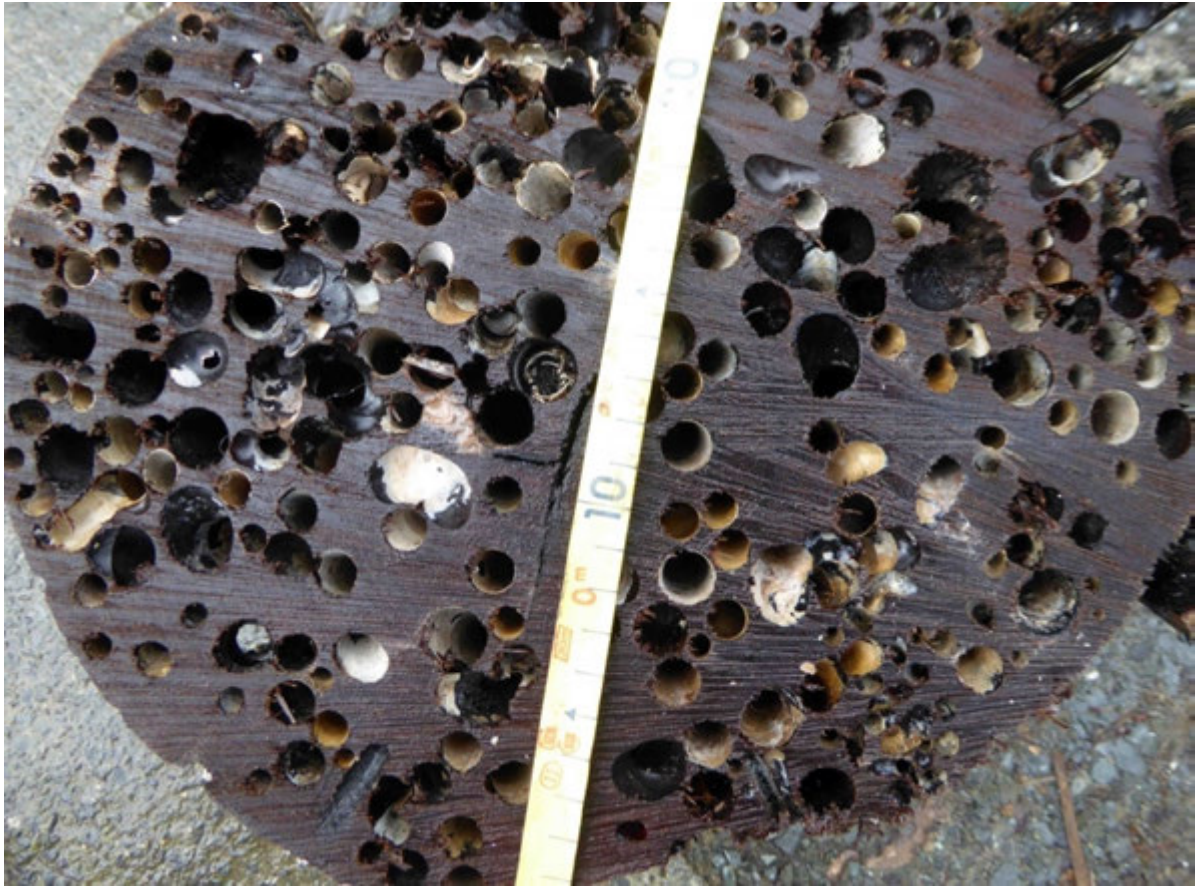
Example (from Petone Wharf) of how the Molluscan Borer 'Teredo' damages the hardwood timber piles internal integrity by significantly reducing the piles strength and mass

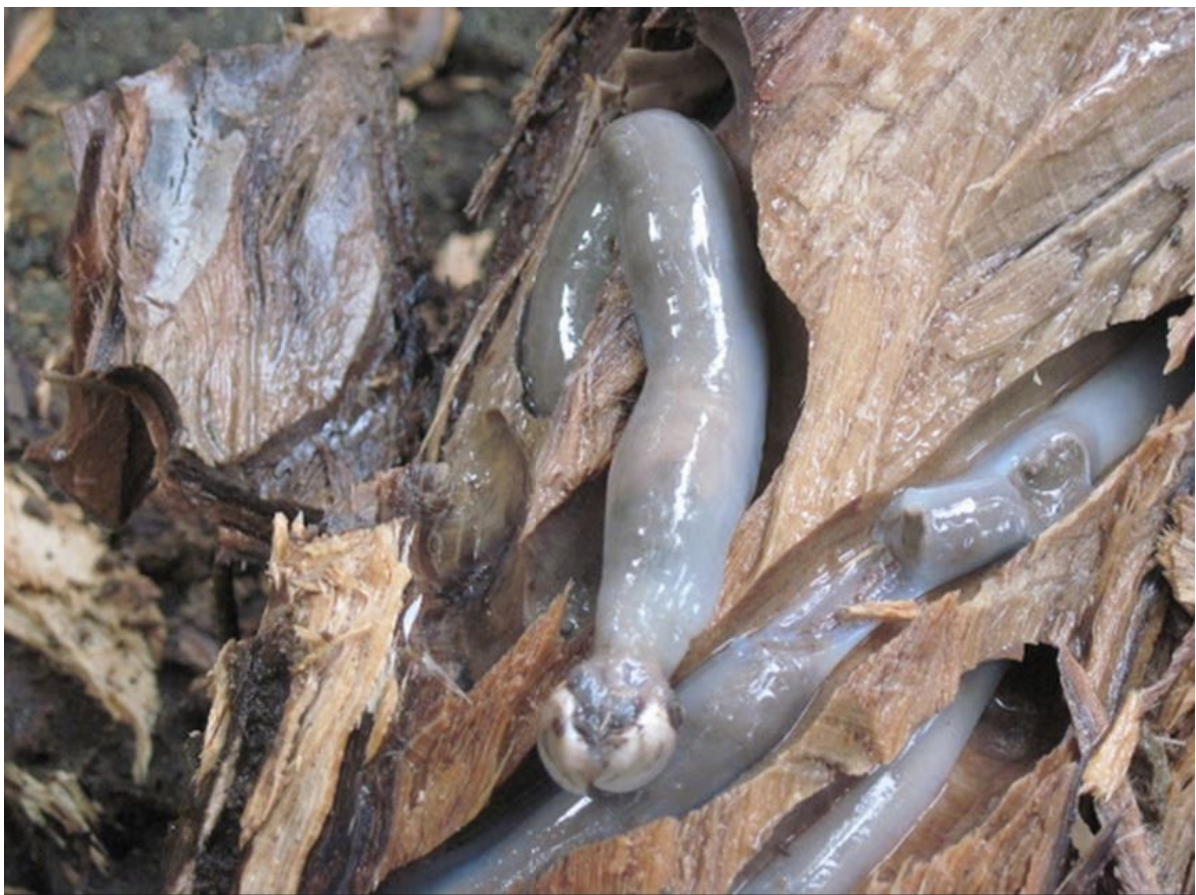
Teredo worm actively destructing a timber pile

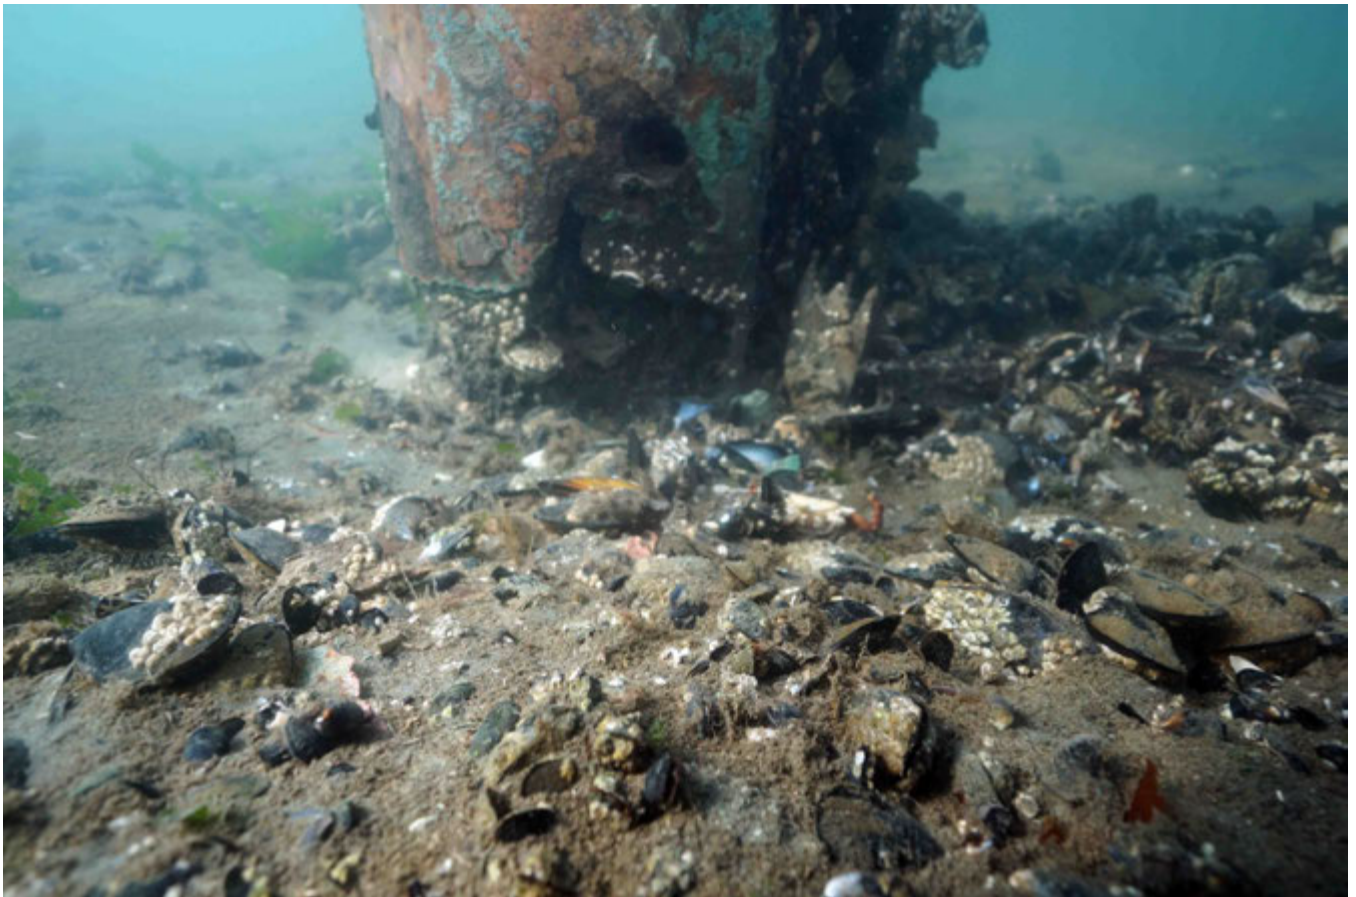
Pile 16C: Very Poor Condition – broken pile – FRP stump repair completed 13/01/2021

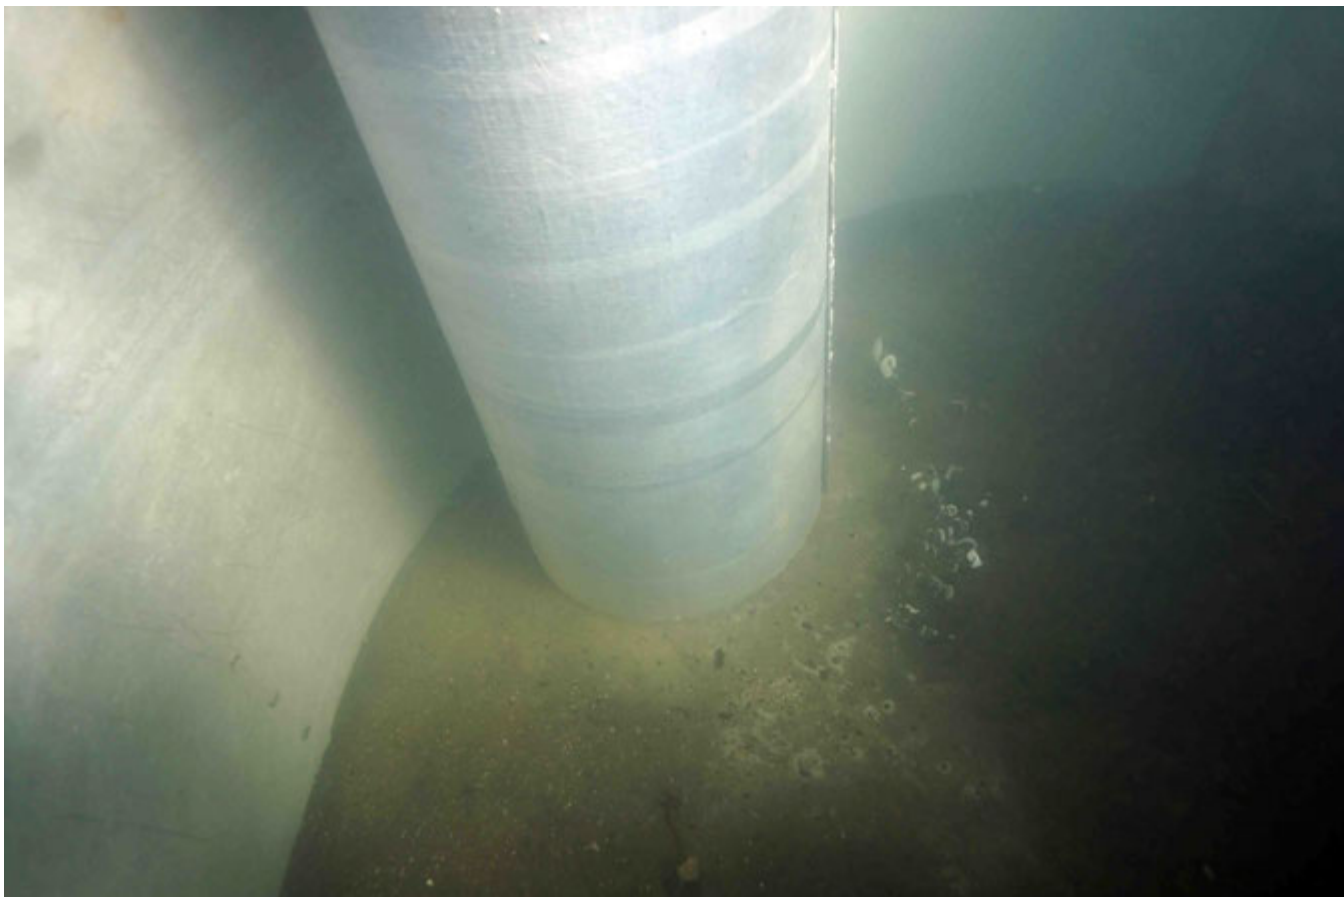
Pile 16D: Very Poor Condition – broken pile

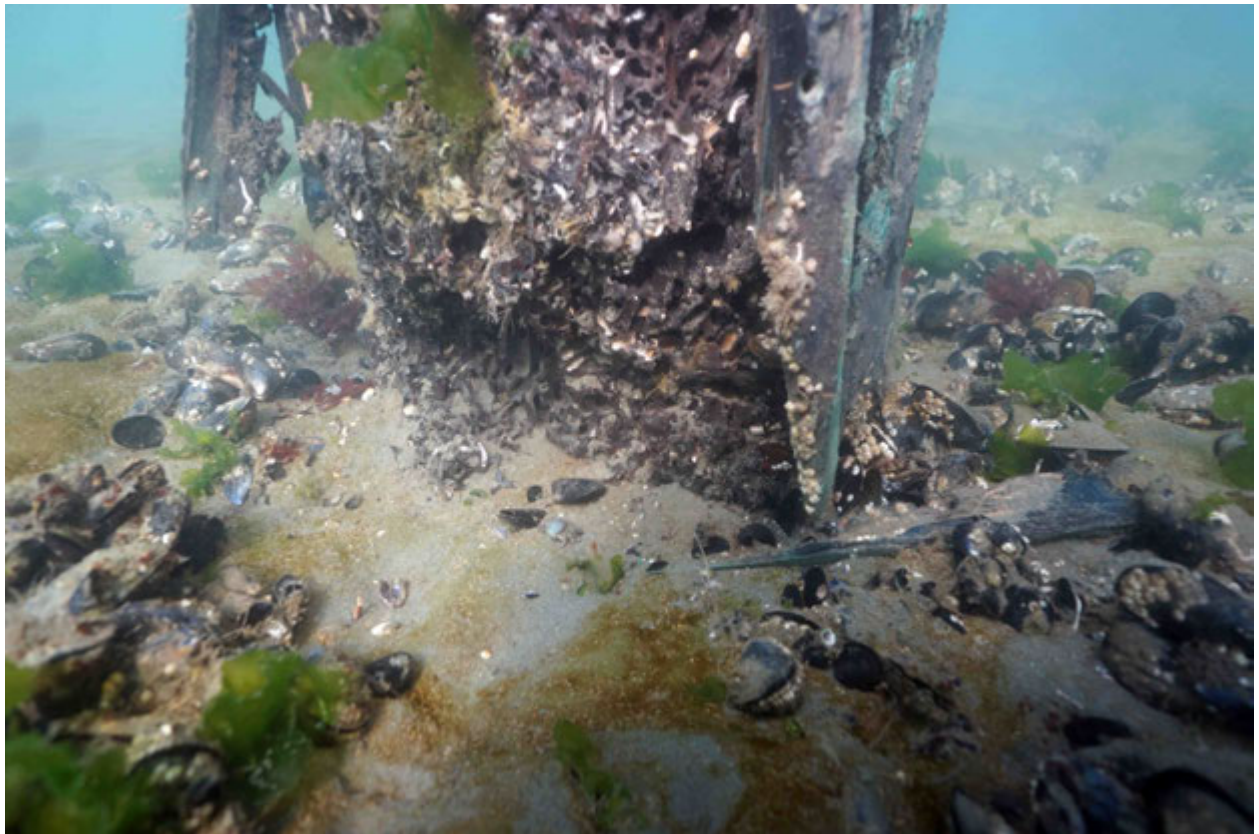
Pile 18C: Poor Condition – 50% loss of section within tidal zone

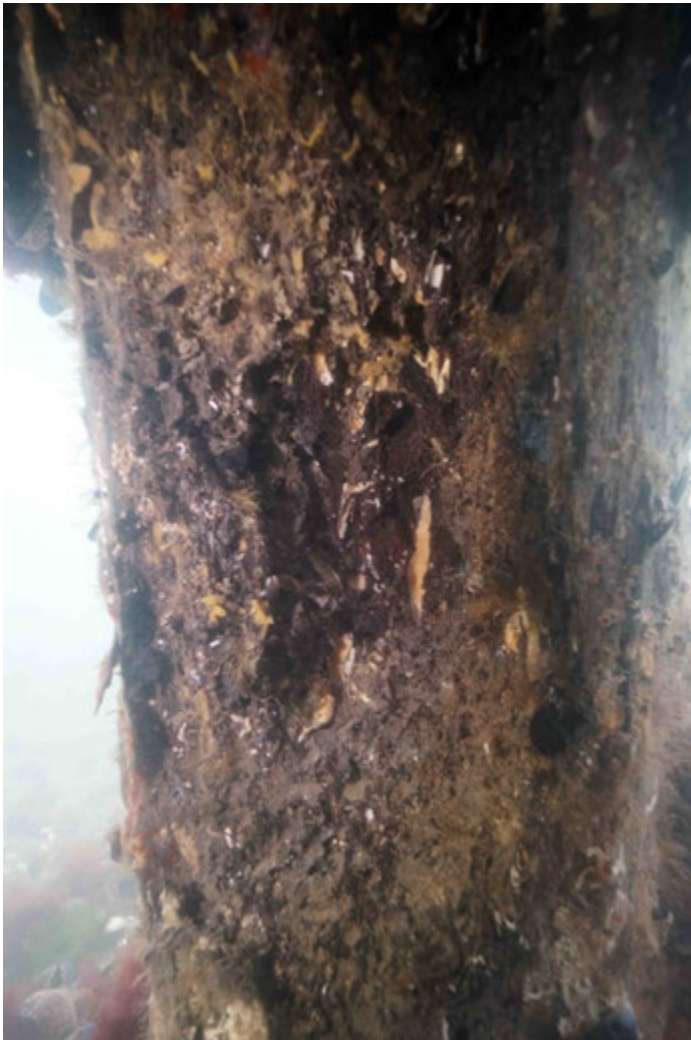
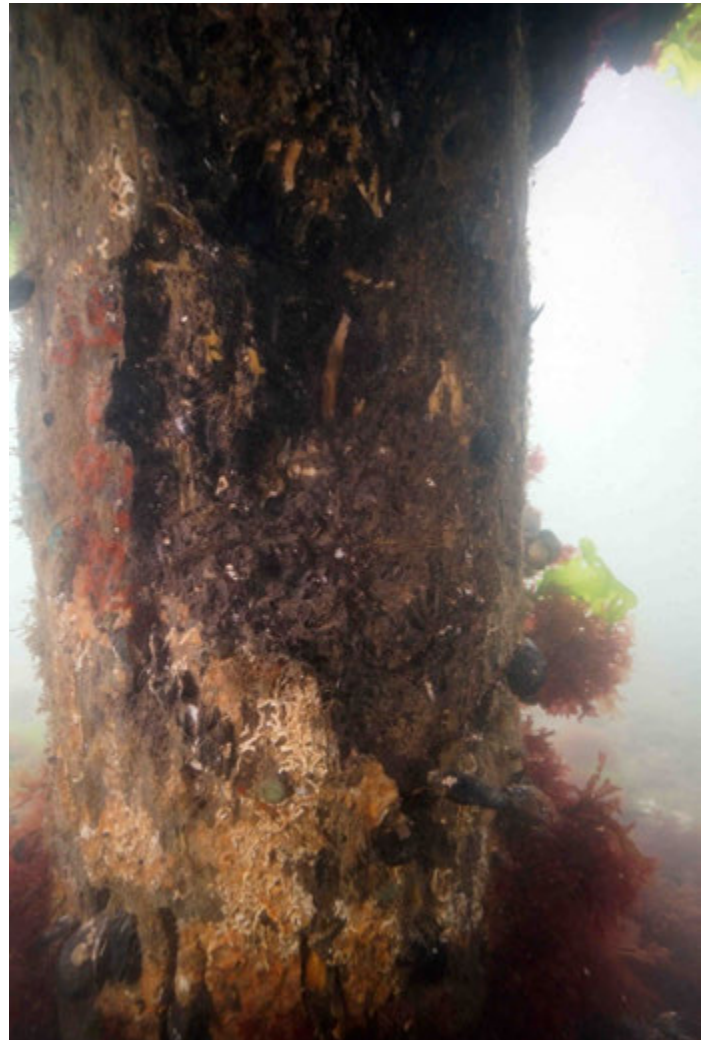
Pile 24D: Poor Condition – 50% loss of section within tidal zone
