Document Title:	HCC Petone Wharf – Approach Structure – Pile Condition Survey & Reporting
Document No.:	UCL – 2021.01 – HCC Wharf Approach PCS&R001 – V2
	Prepared for: Tom Arthur – Calibre Group Janet Lawson – Hutt City Council Francis O’Riley – G.K. Shaw Ltd.

Petone Wharf – Approach Structure

Pile Condition Survey & Reporting

January 2021

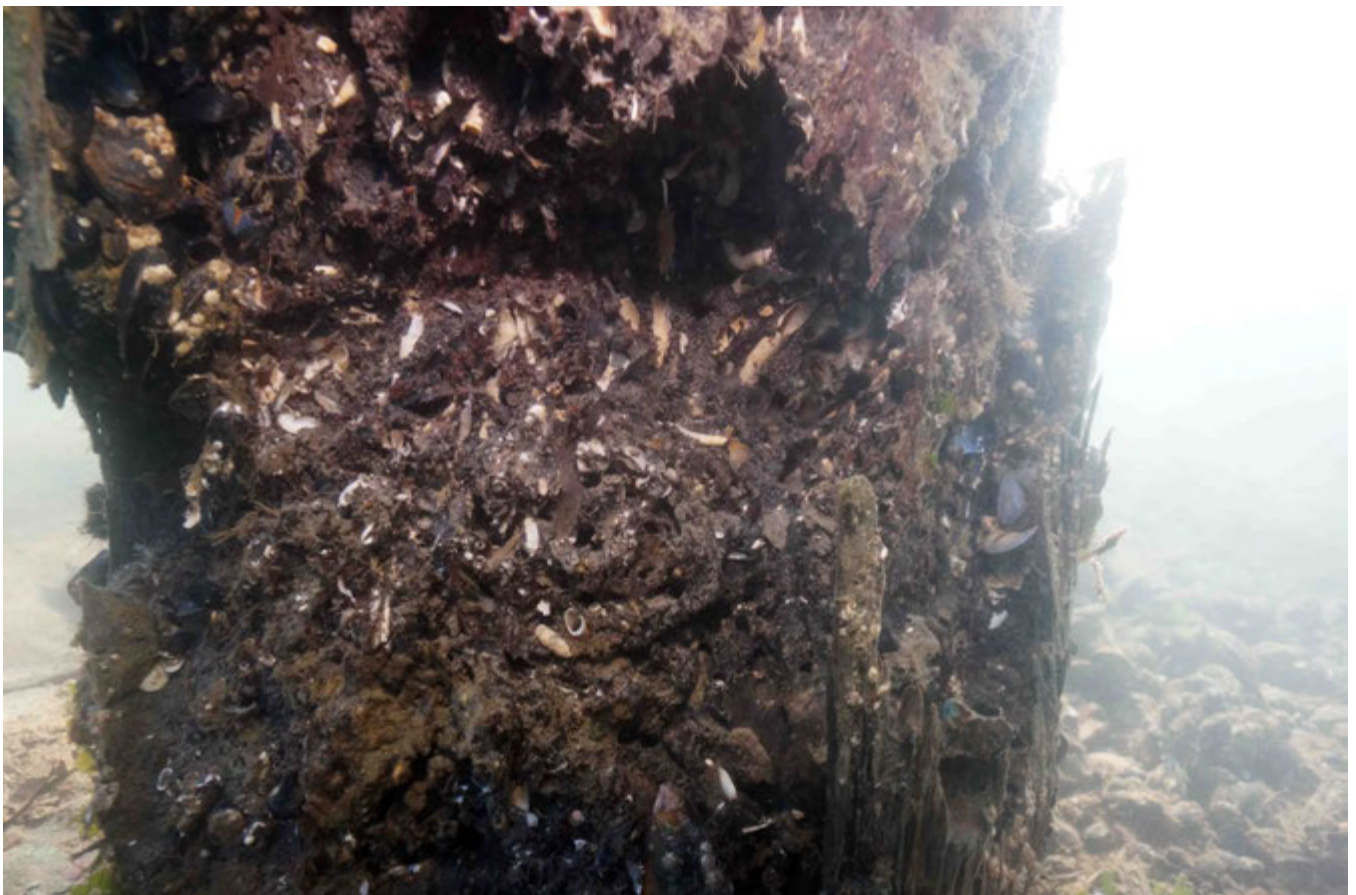
Pile 15C: Poor Condition – 50% loss of section within tidal zone

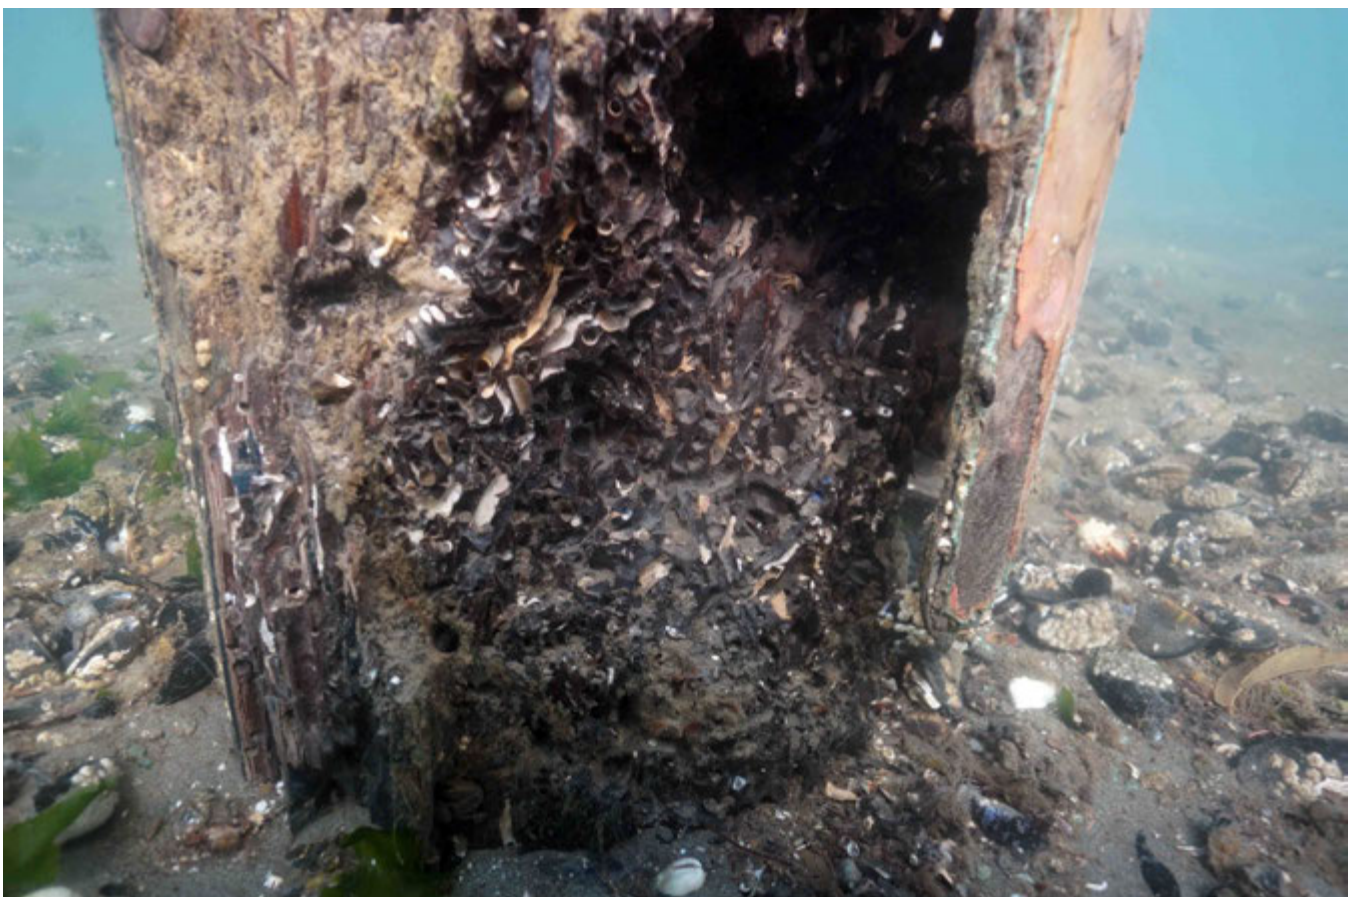
Pile 16C: Very Poor Condition – broken pile – FRP stump repair completed 13/01/2021

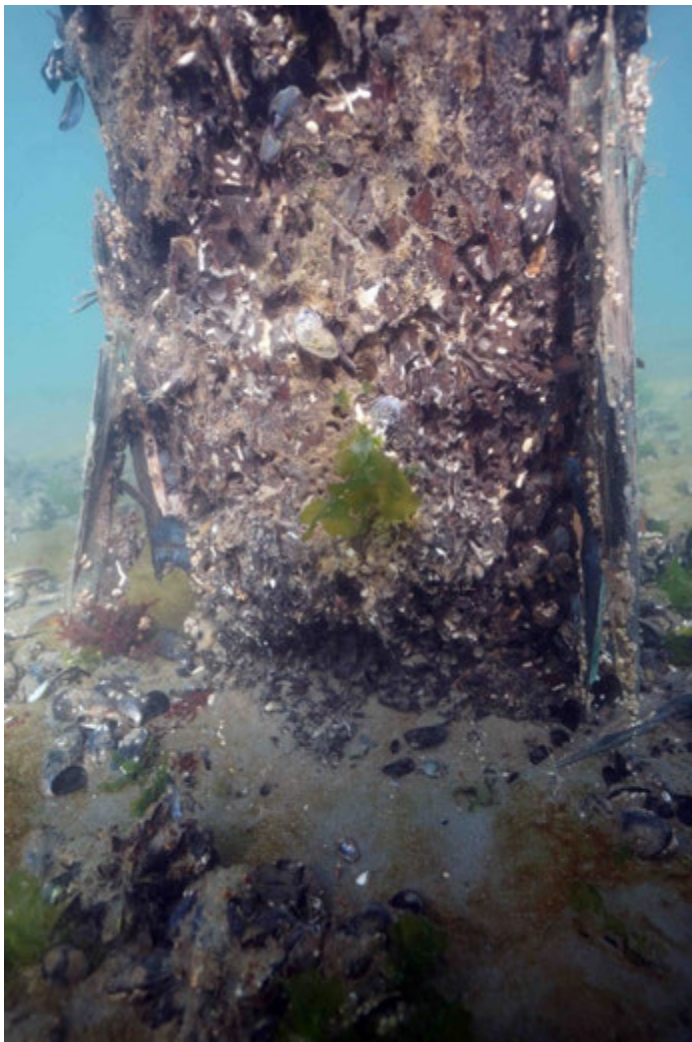
Pile 18C: Poor Condition – 50% loss of section within tidal zone

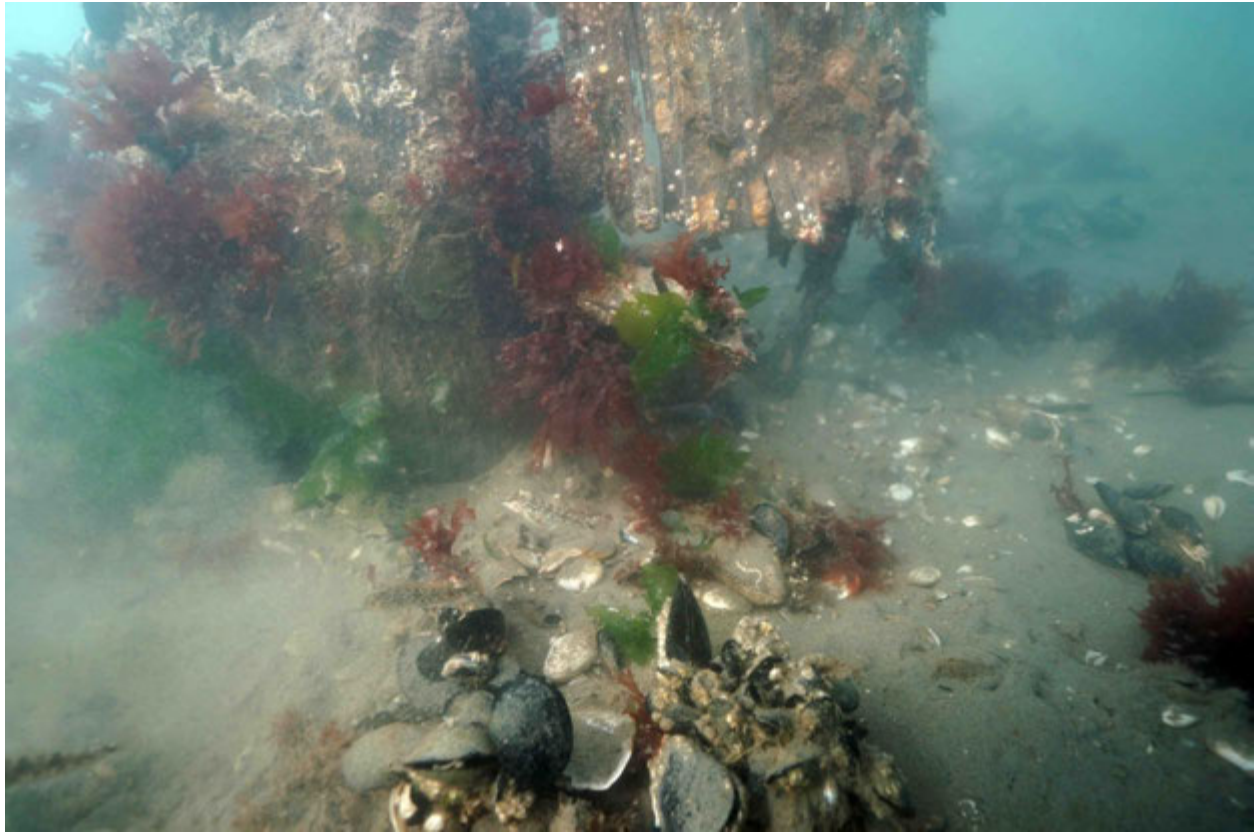
Pile 24D: Poor Condition – 50% loss of section within tidal zone

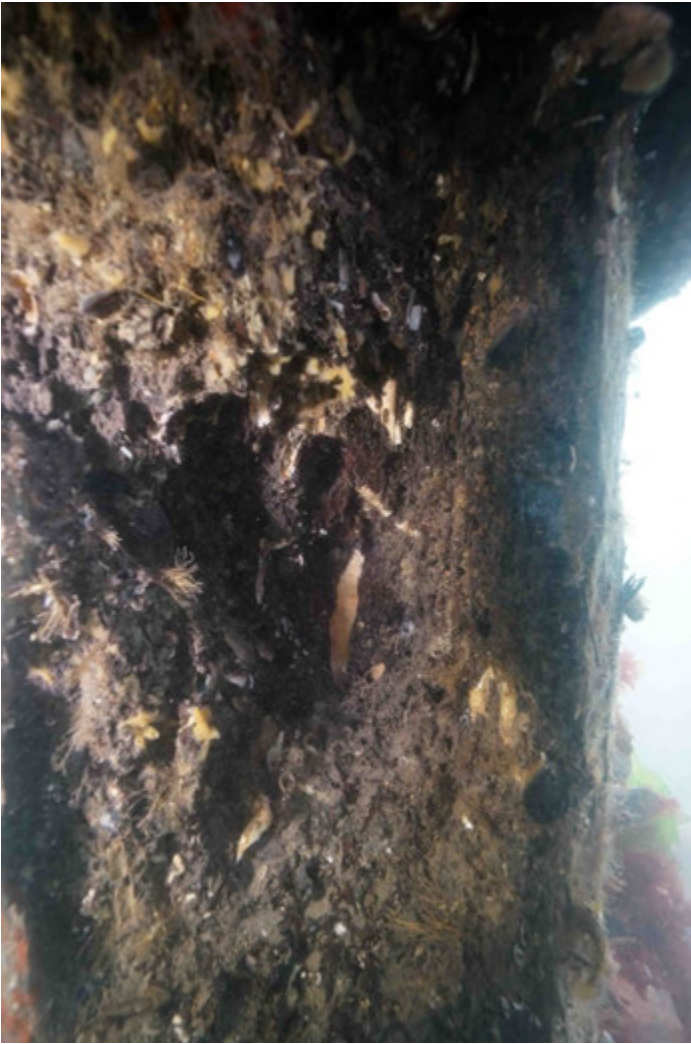
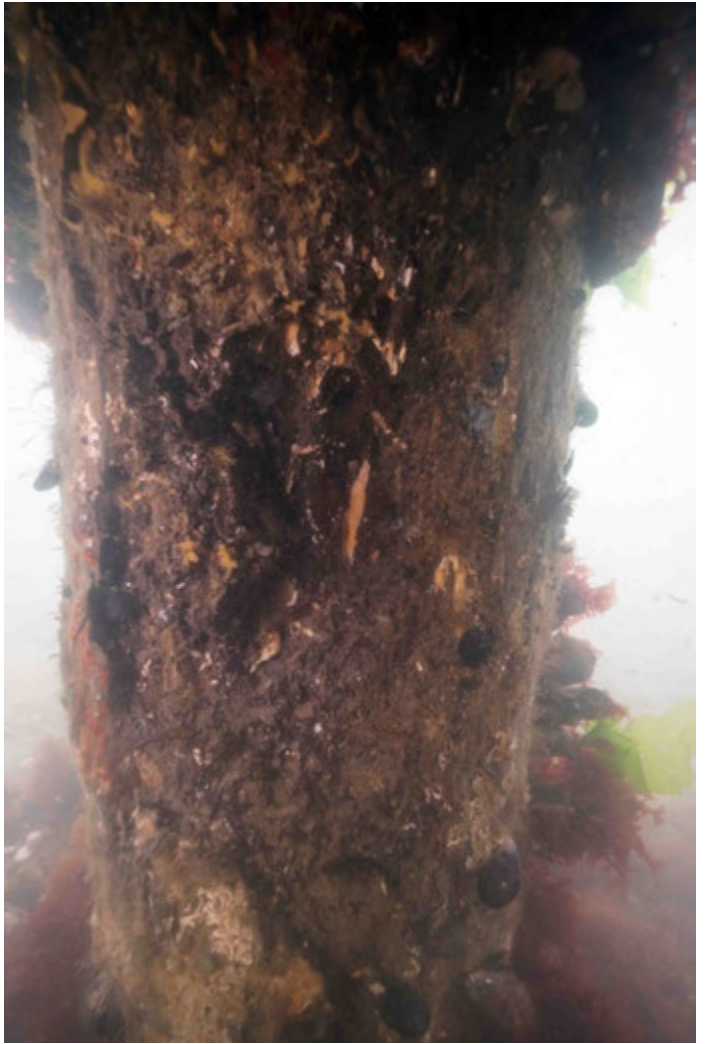
Pile 25C: Poor Condition – 40% loss of section within tidal zone. Severe hallowing

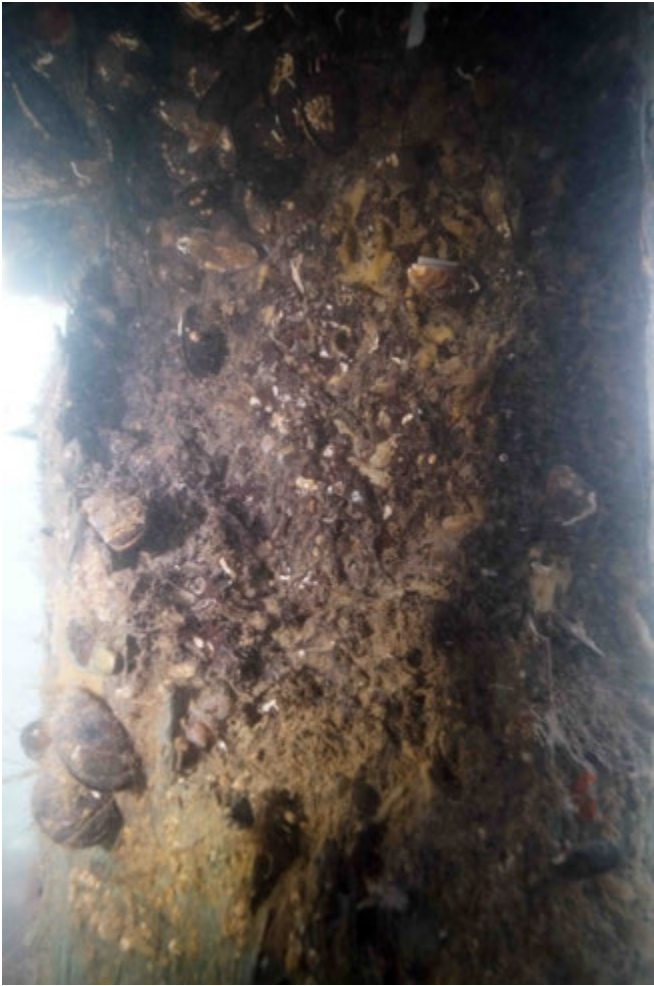
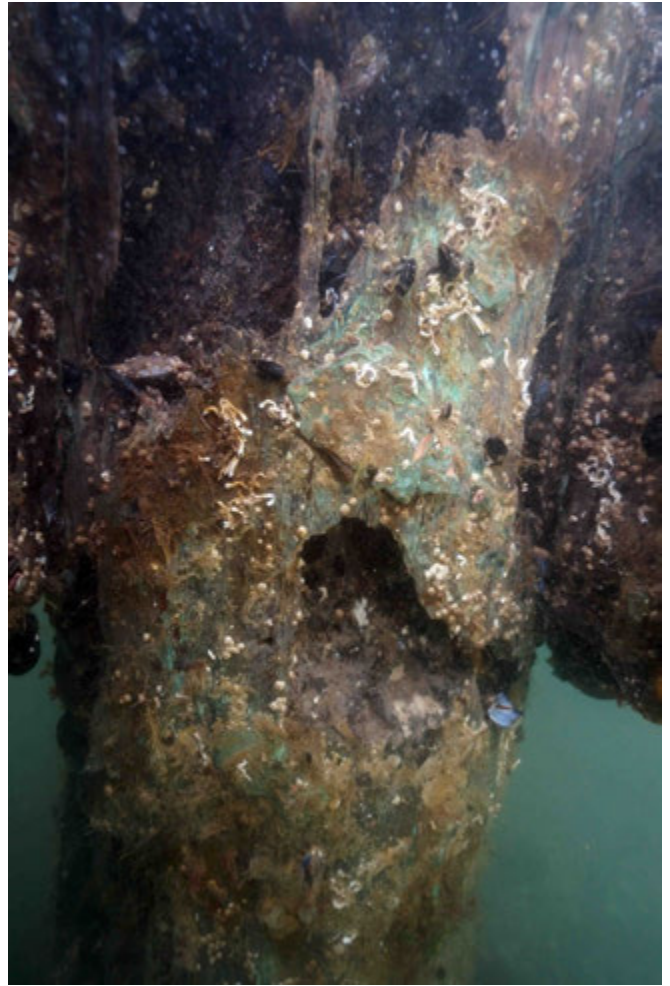
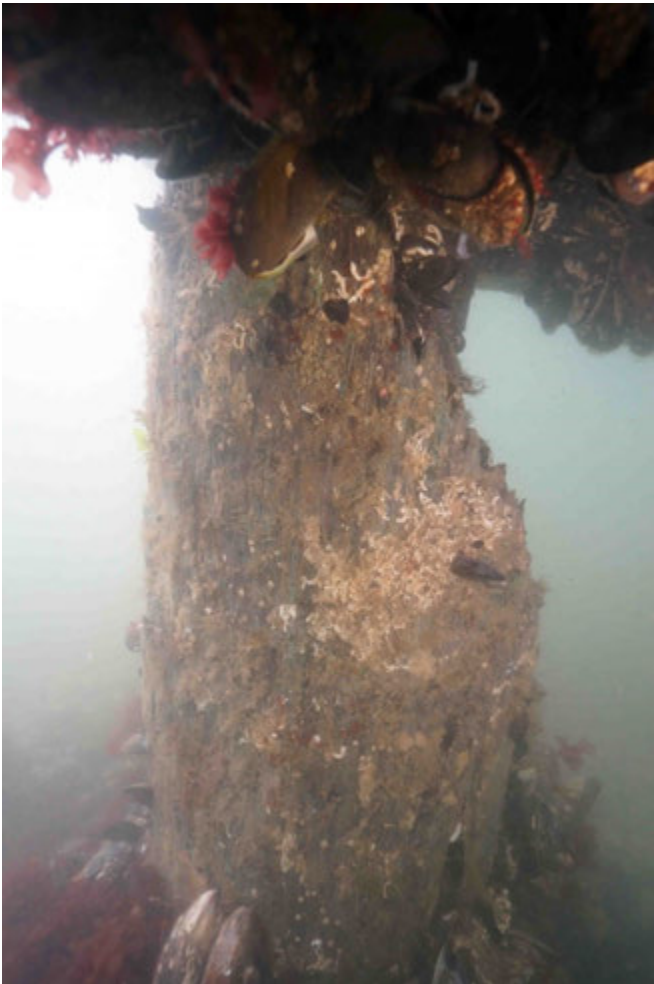
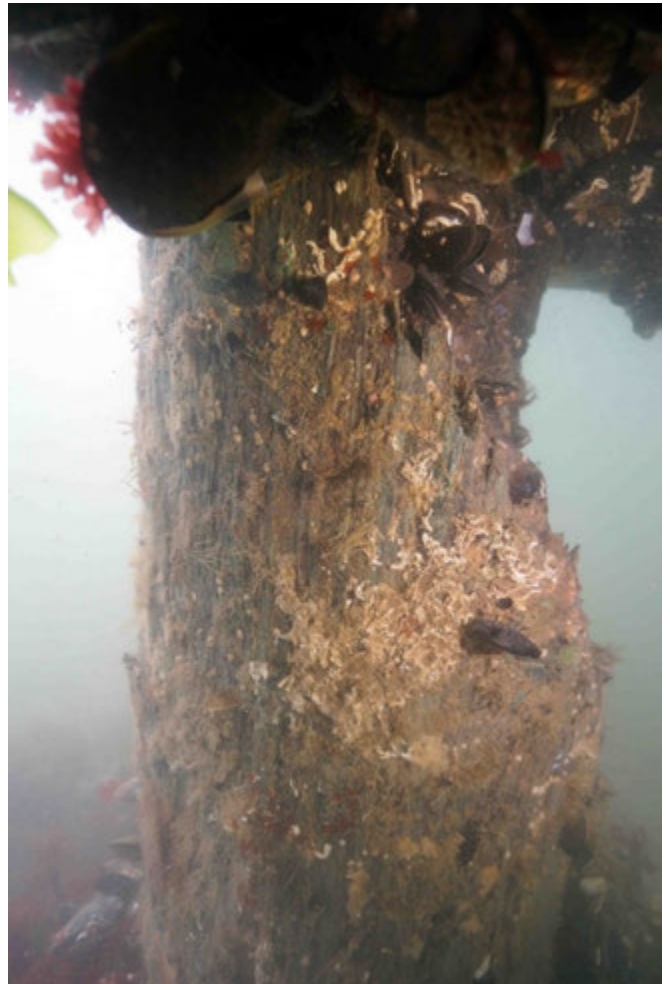
Pile 27C: Very Poor Condition – broken pile

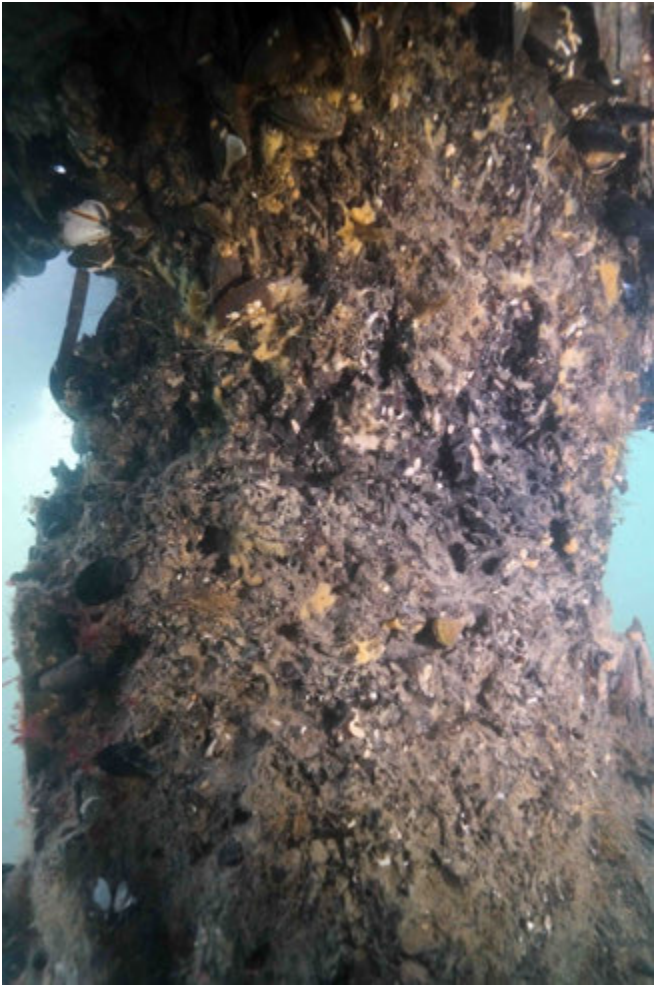
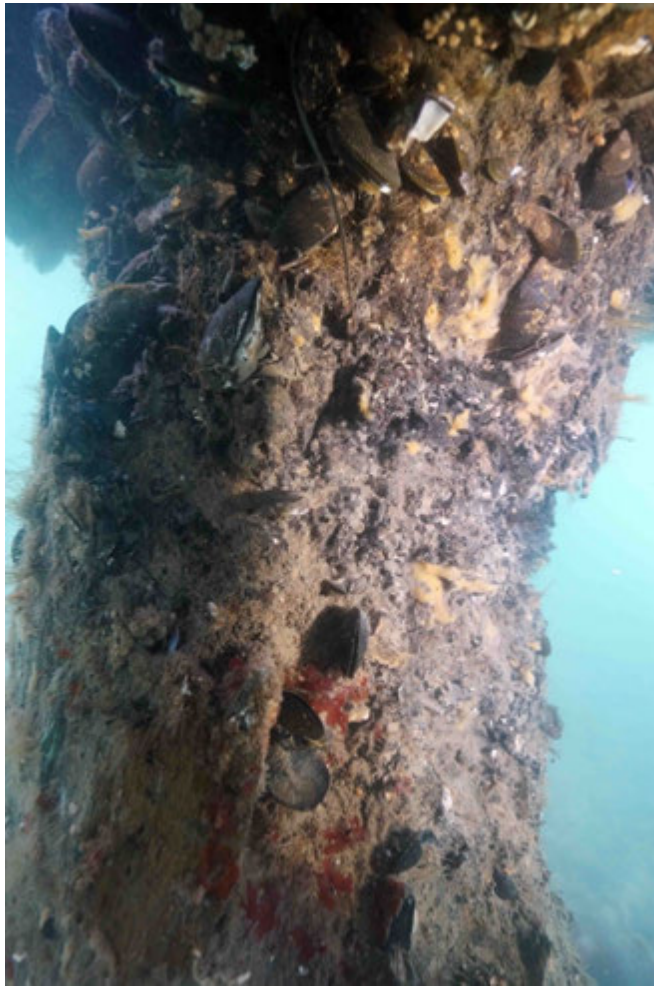
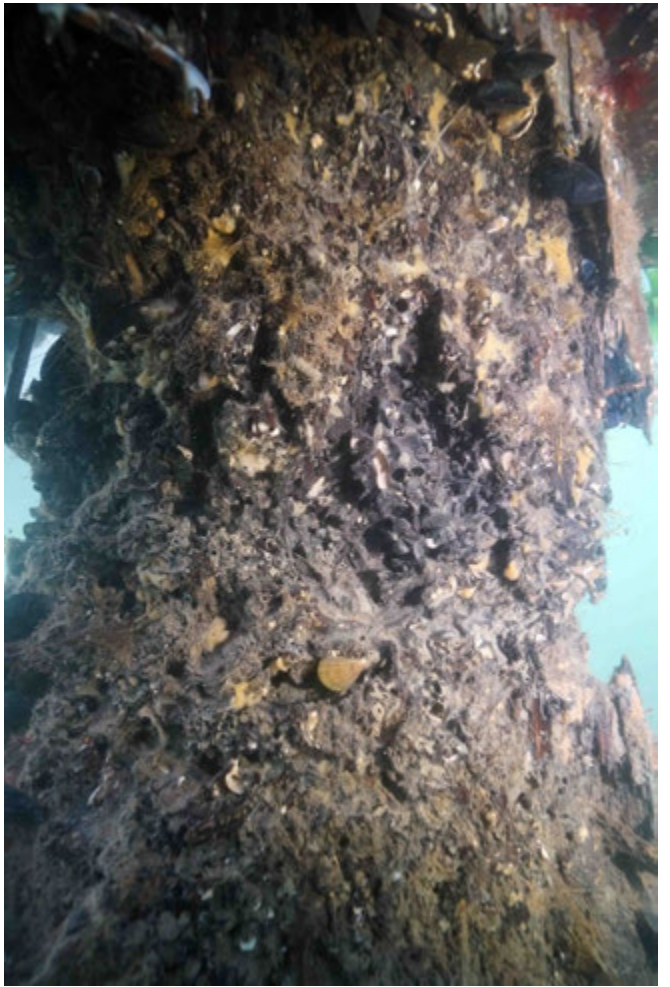
Pile 28C: Very Poor Condition – broken pile

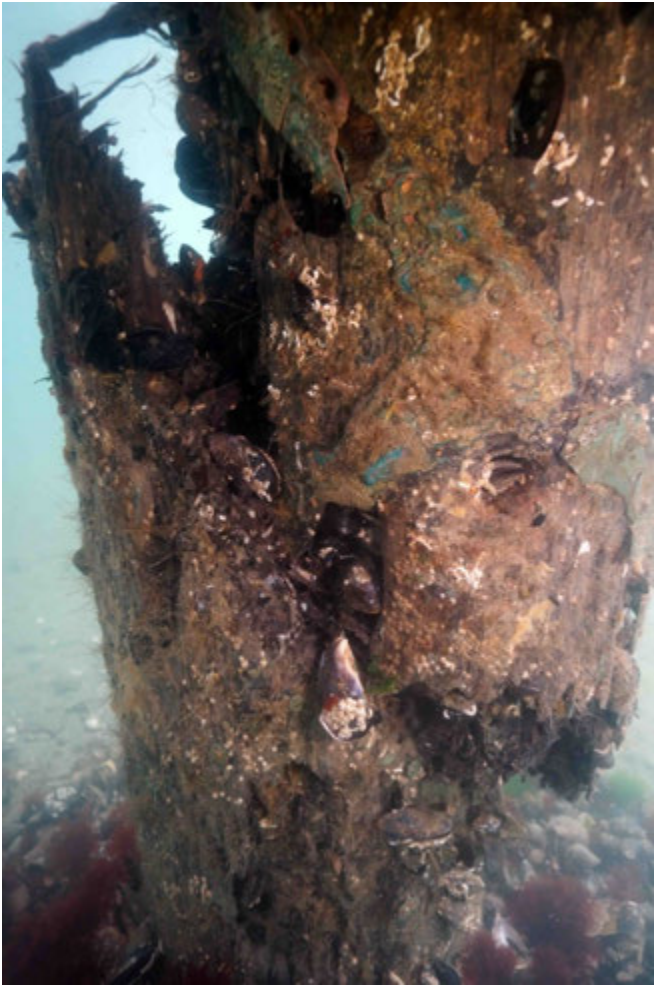
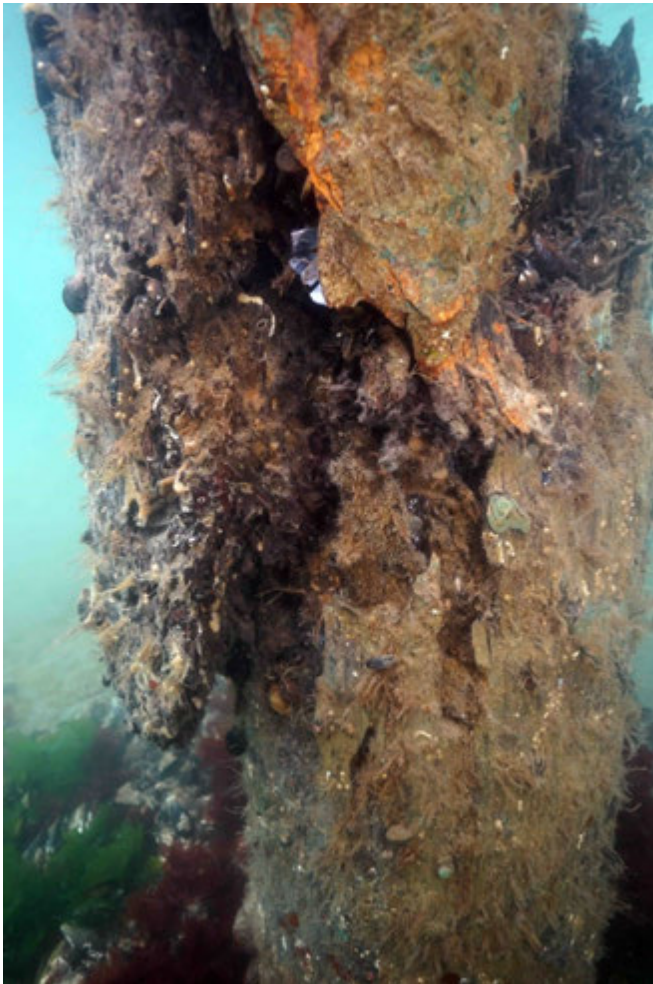
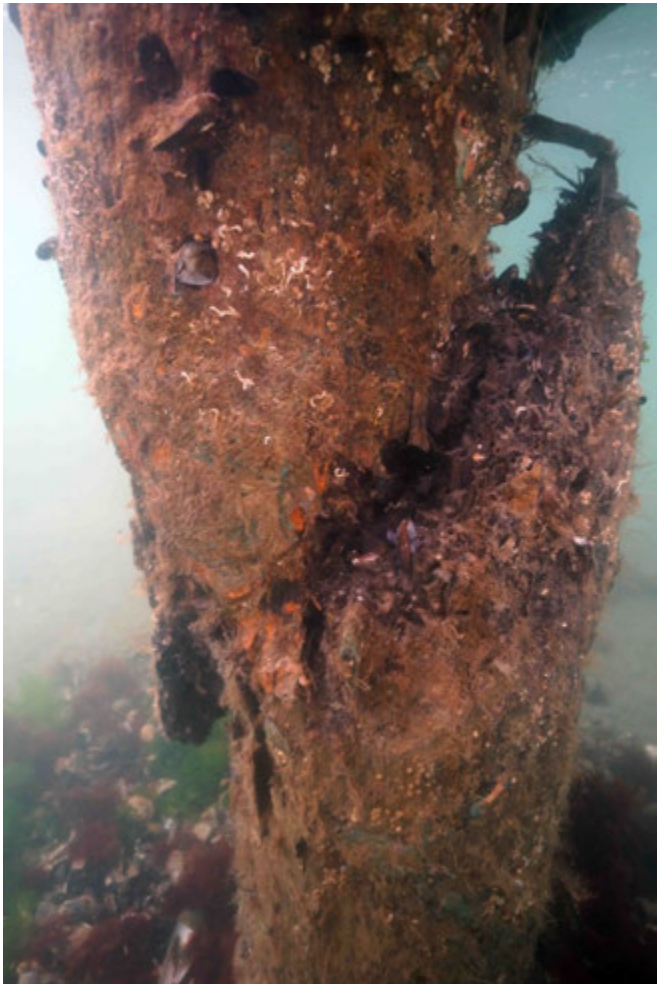
Pile 28D: Very Poor Condition – broken pile

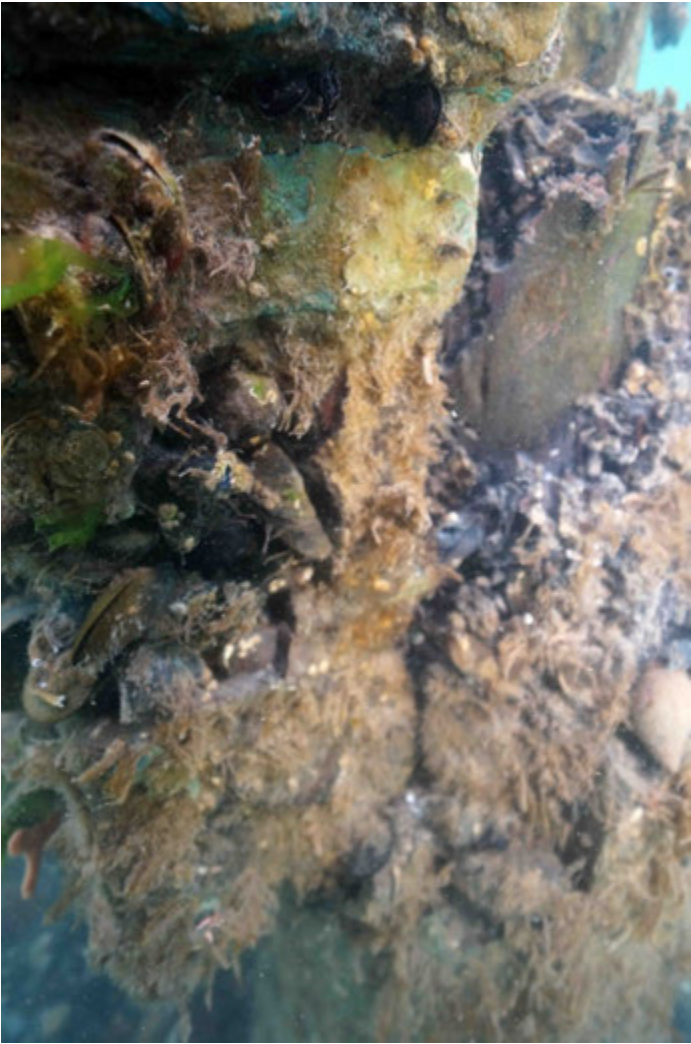
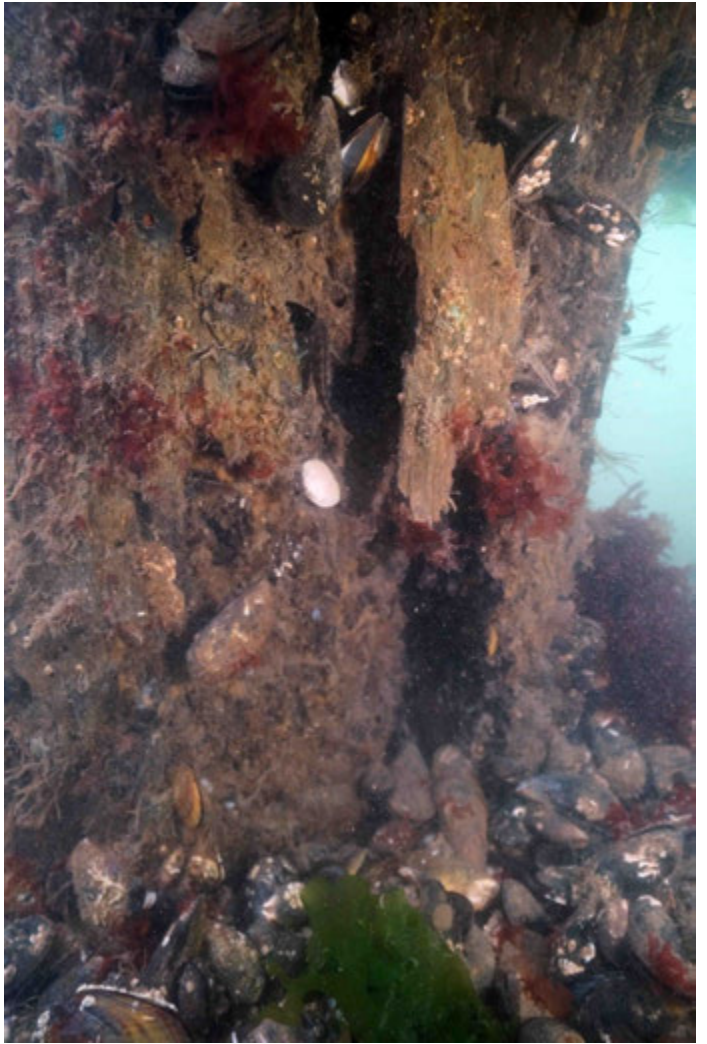
Pile 29D: Very Poor Condition – broken pile

It's recommended that as an absolute minimum, all Piles with a Poor and Very Poor designation be repaired by remedial process immediately.

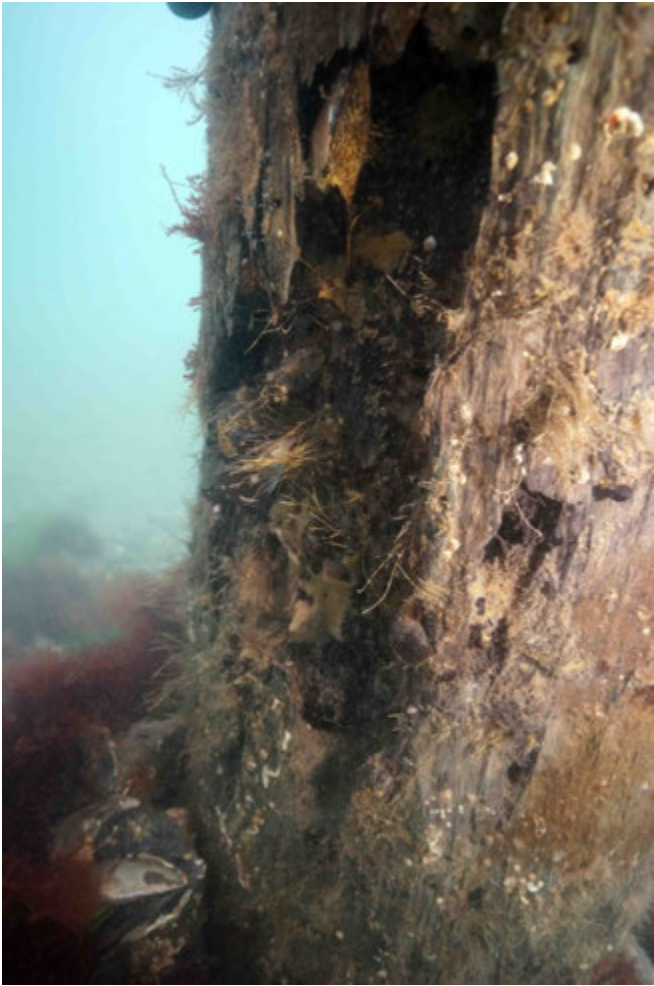
Pile 30C: Poor Condition – 40% loss of section – lower tidal zone

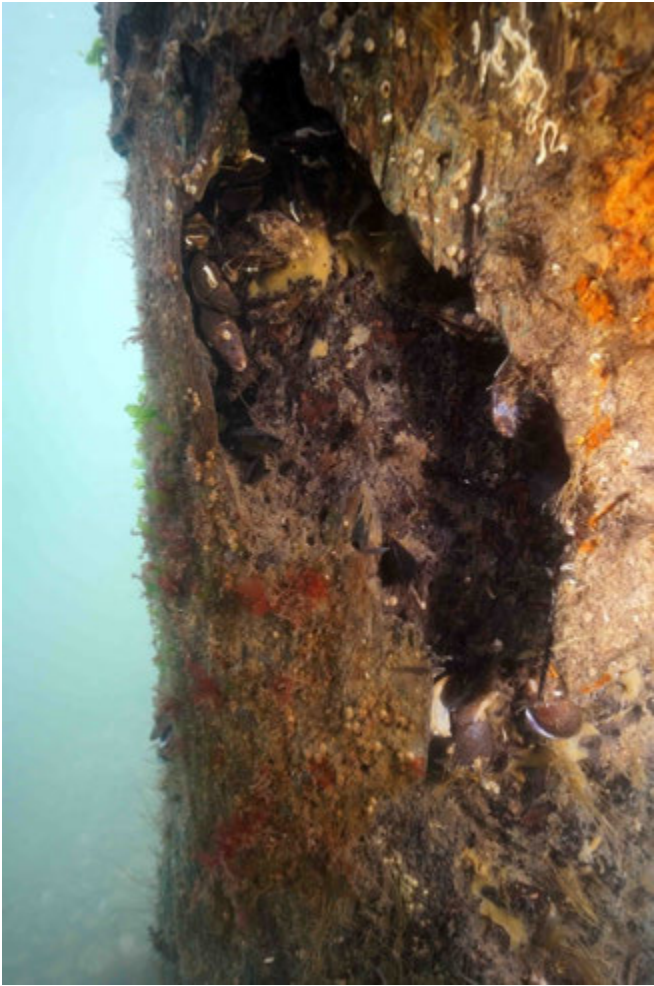
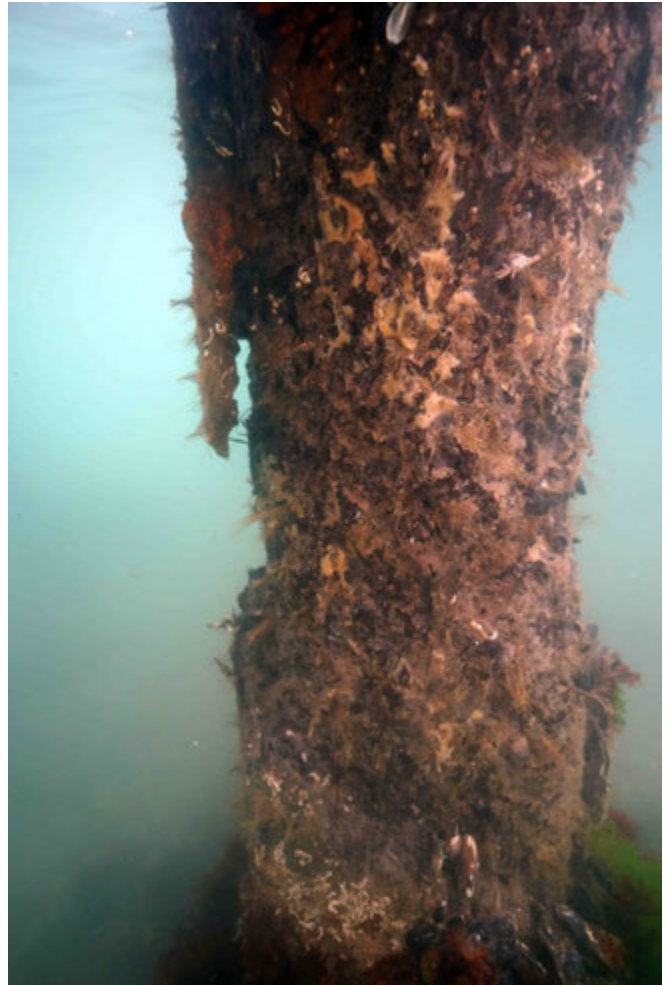
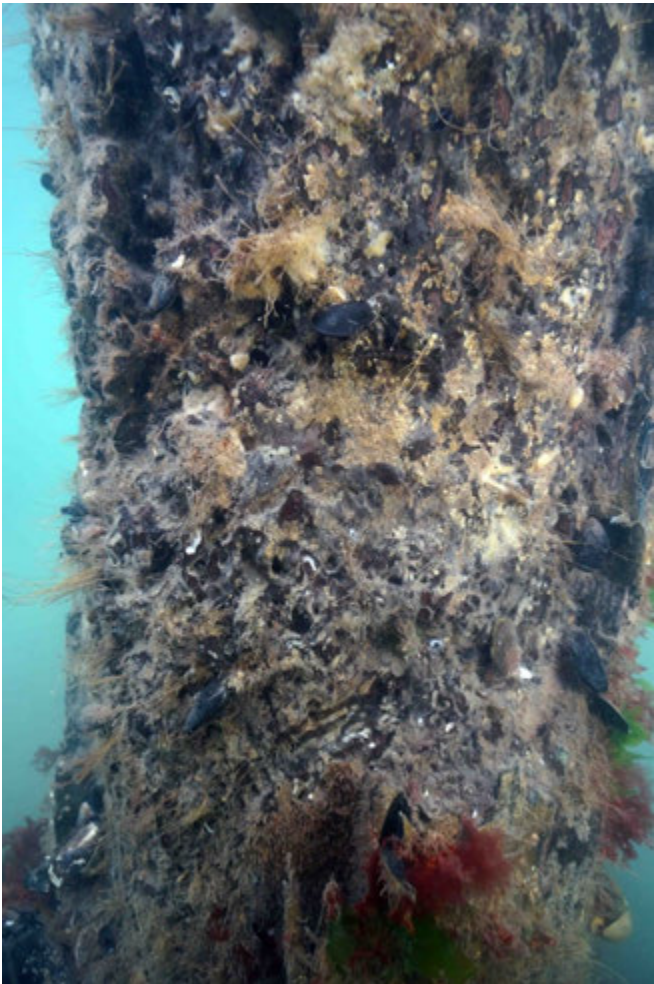
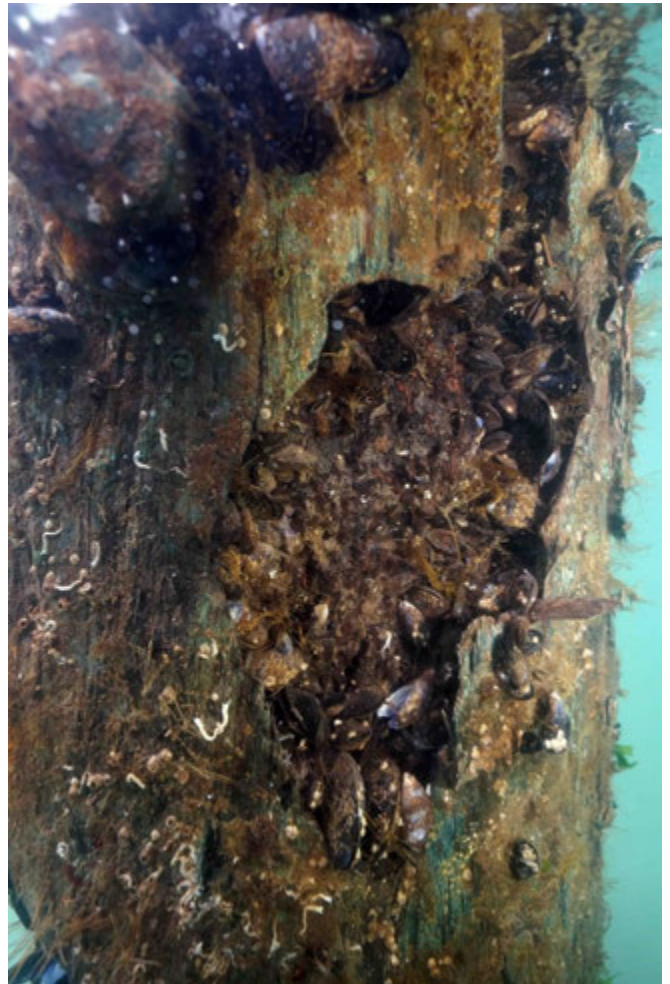
Pile 30D: Poor Condition – 50% loss of section – lower tidal zone

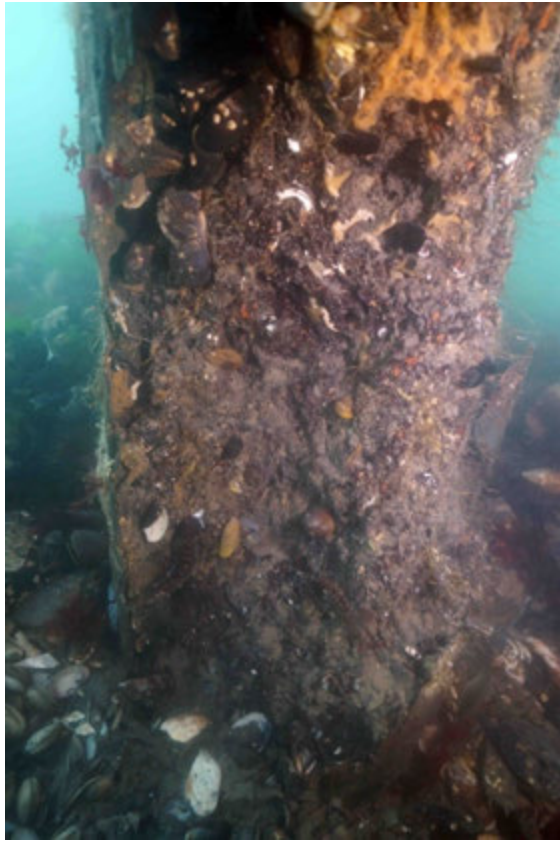
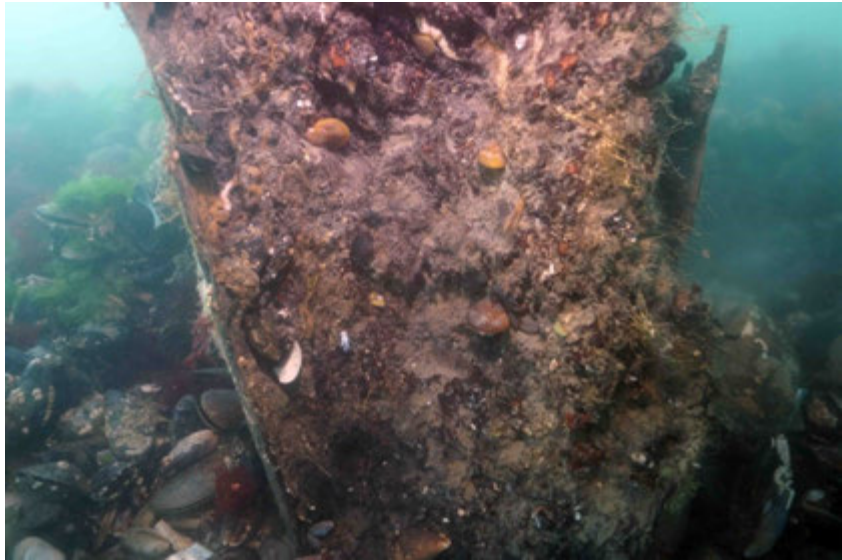
Pile 31D: Poor Condition – 60% loss of section – at seabed

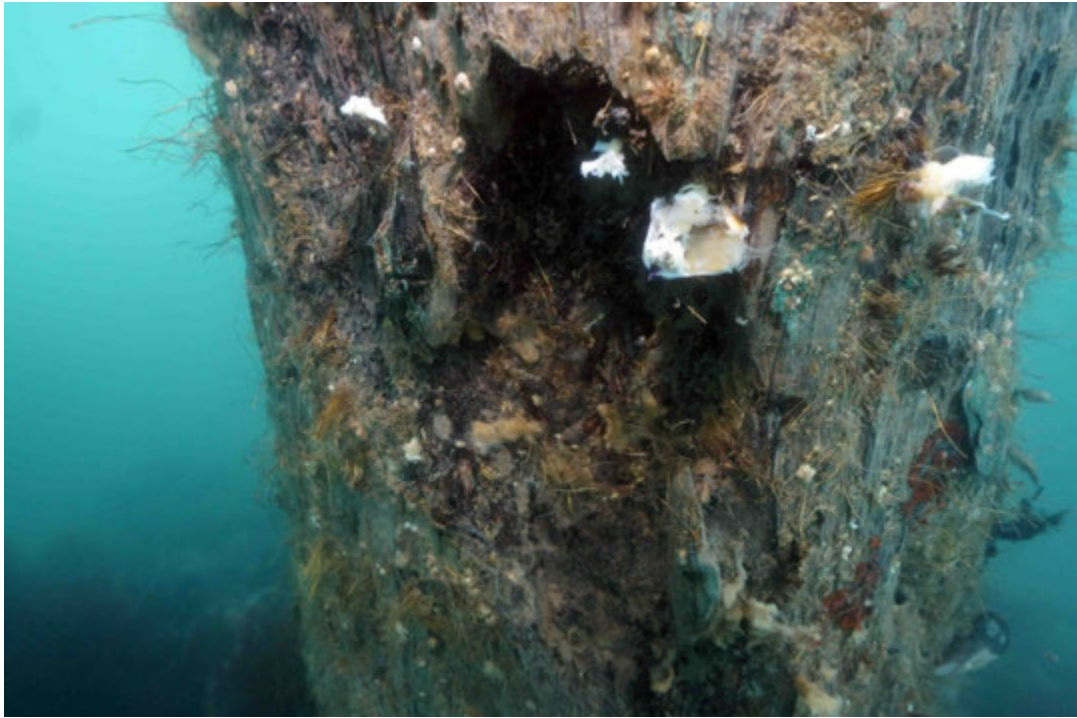
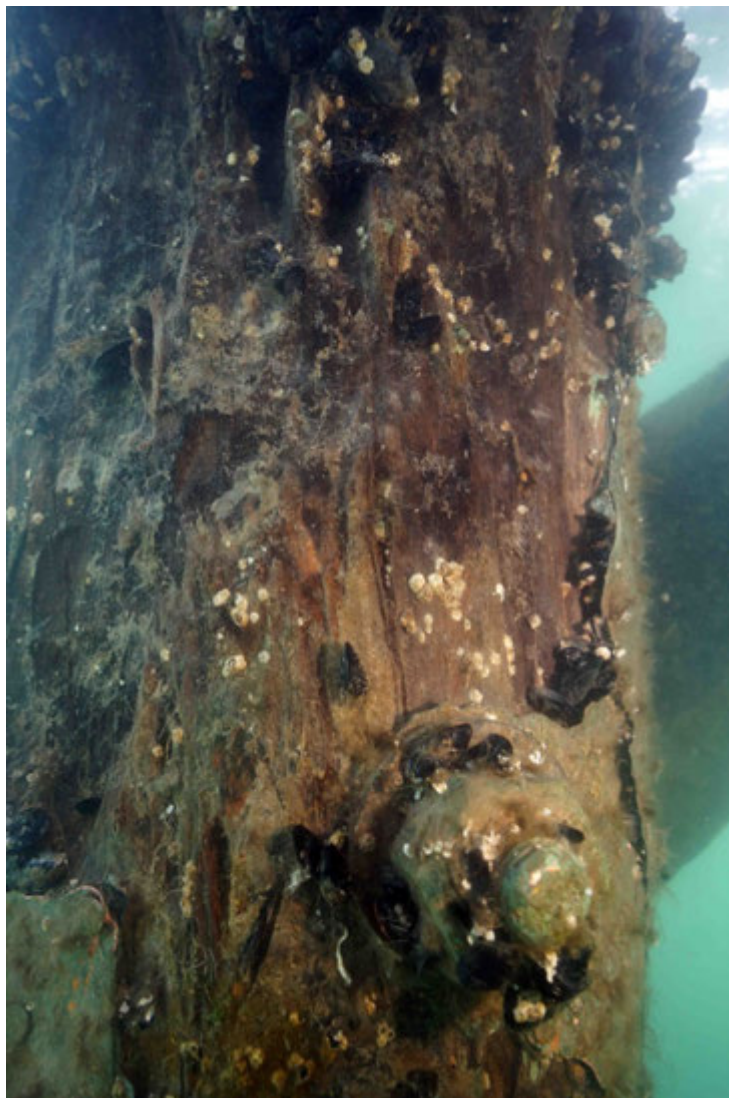
Fair Condition – 25% loss of section – lower tidal zone to seabed
Pictures of Piles 33C & D, and Pile 34D – have been entered for the benefit of those persons viewing this Report – to provide relevant detail of Fair Condition rated piles

- For maximum protection of piles within Bents 25 – 47, a 3.0 metre length FRP Jacket is recommended to be installed to piles.

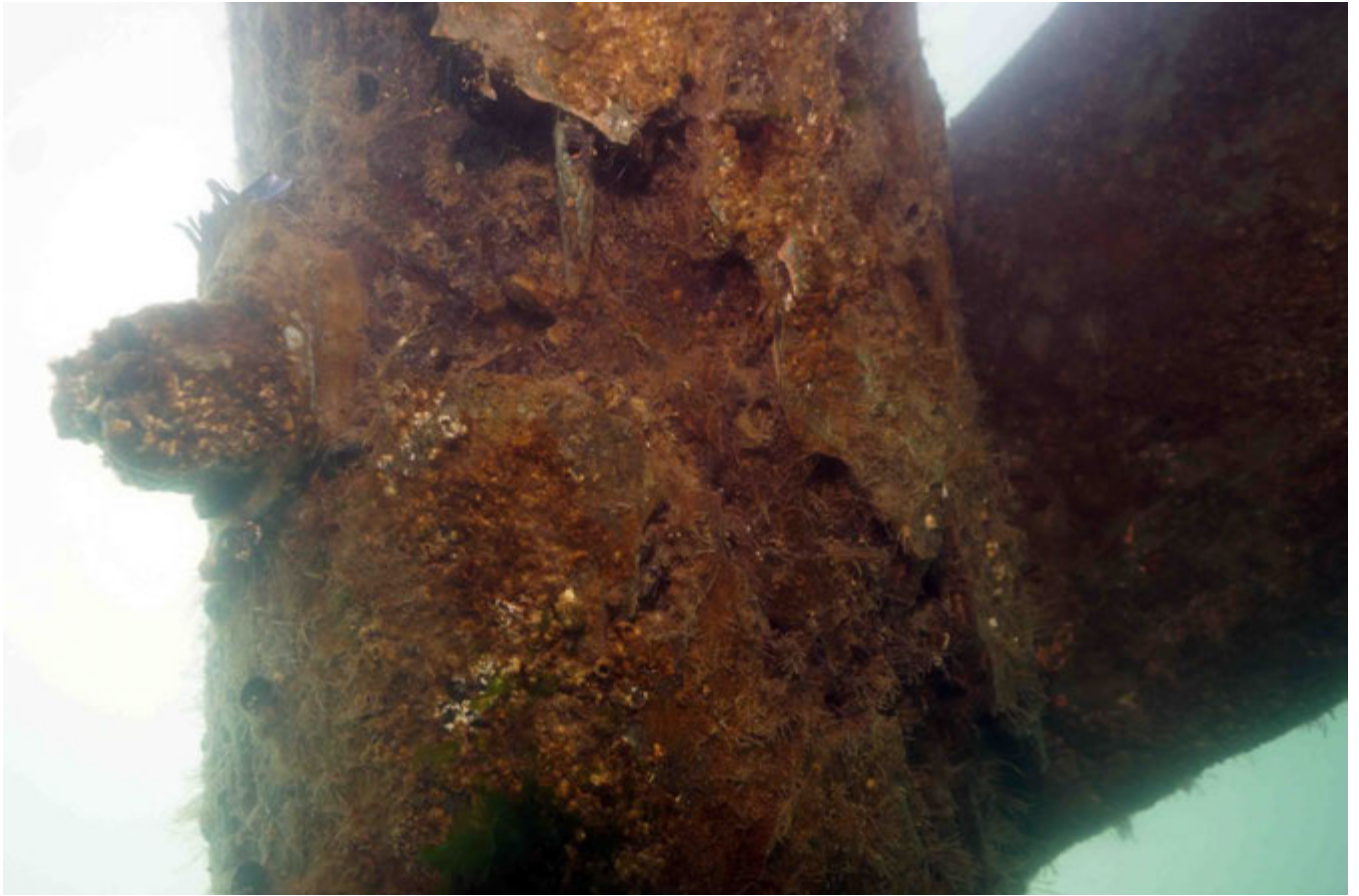
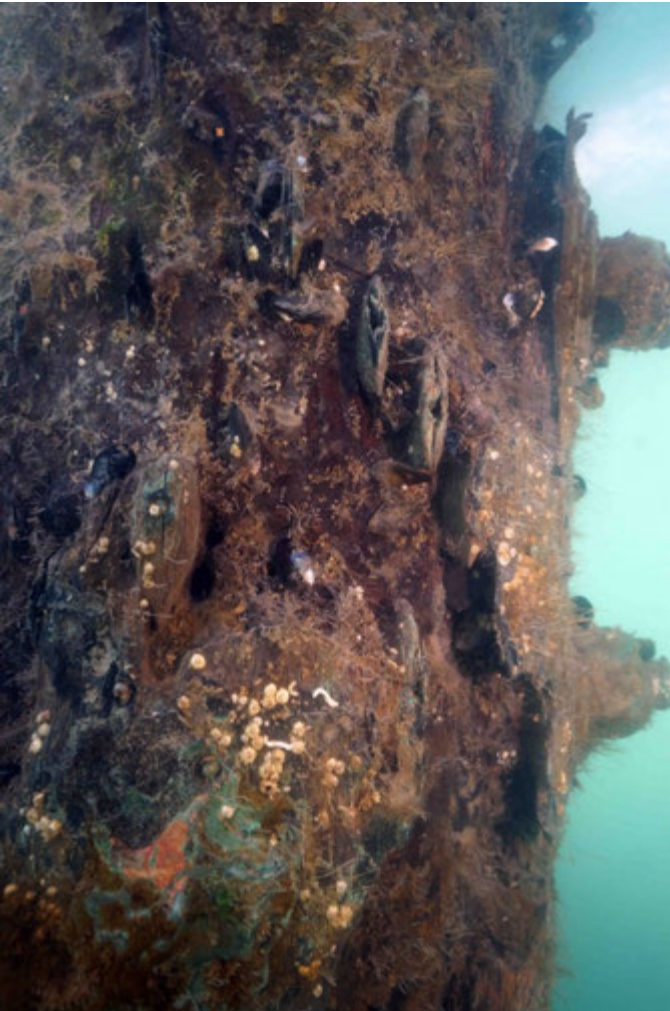
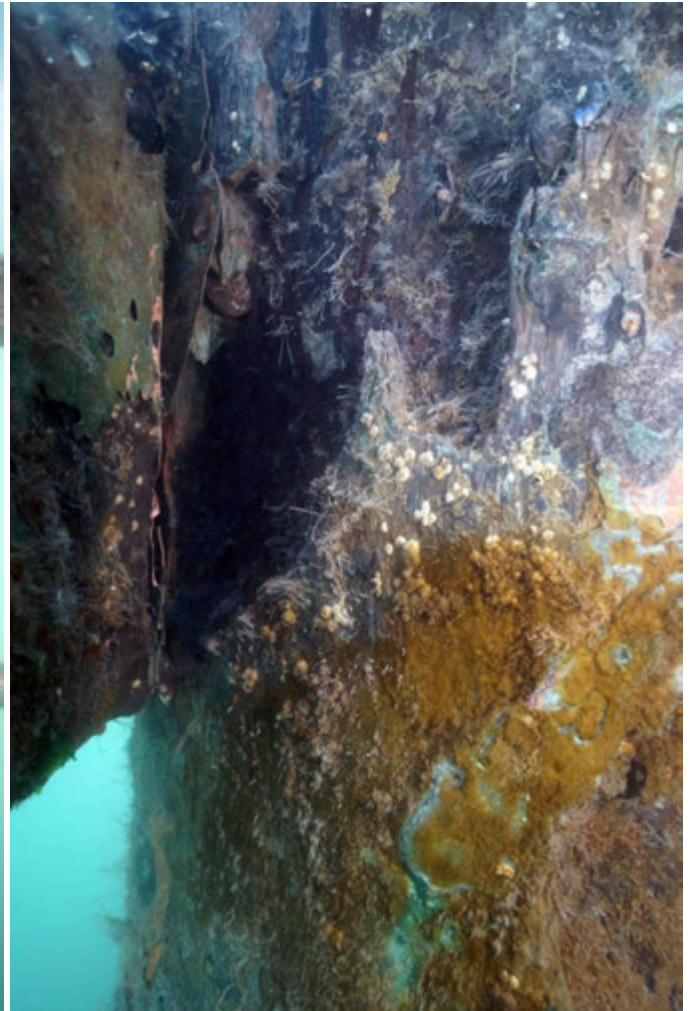
Pile 33D: Fair Condition – 20% loss of section – lower tidal zone
