Document Title:	HCC Petone Wharf – Approach Structure – Pile Condition Survey & Reporting
Document No.:	UCL – 2021.01 – HCC Wharf Approach PCS&R001 – V2
	Prepared for: Tom Arthur – Calibre Group Janet Lawson – Hutt City Council Francis O’Riley – G.K. Shaw Ltd.

Petone Wharf – Approach Structure

Pile Condition Survey & Reporting

January 2021

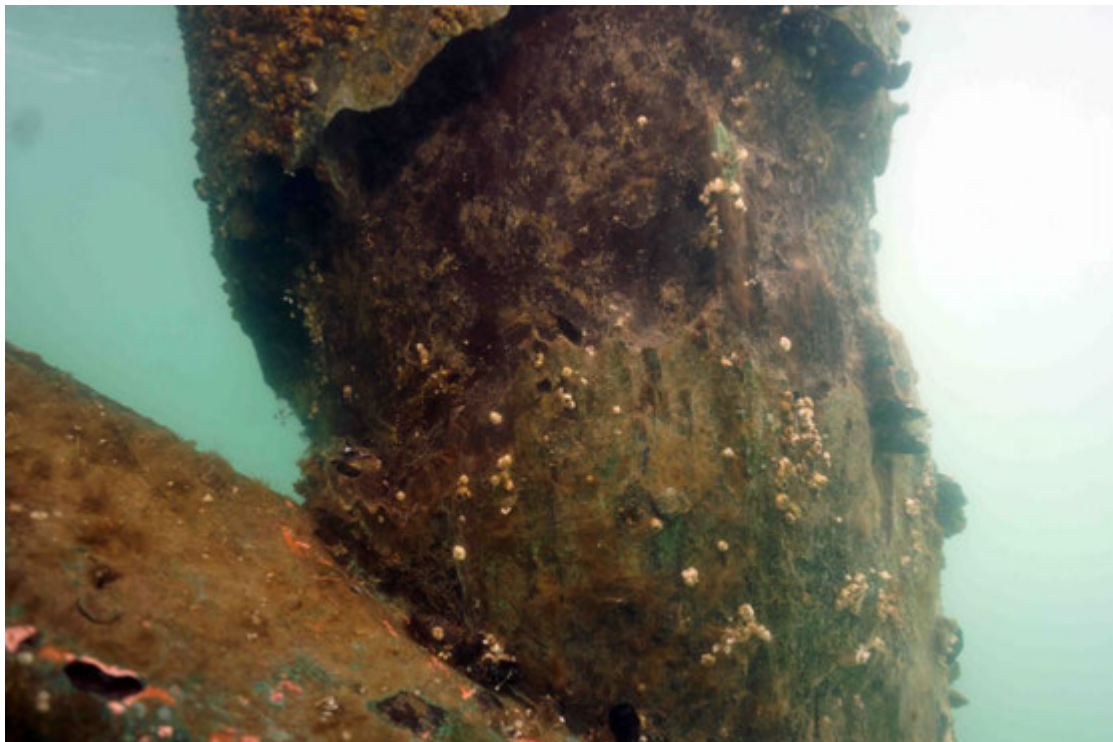
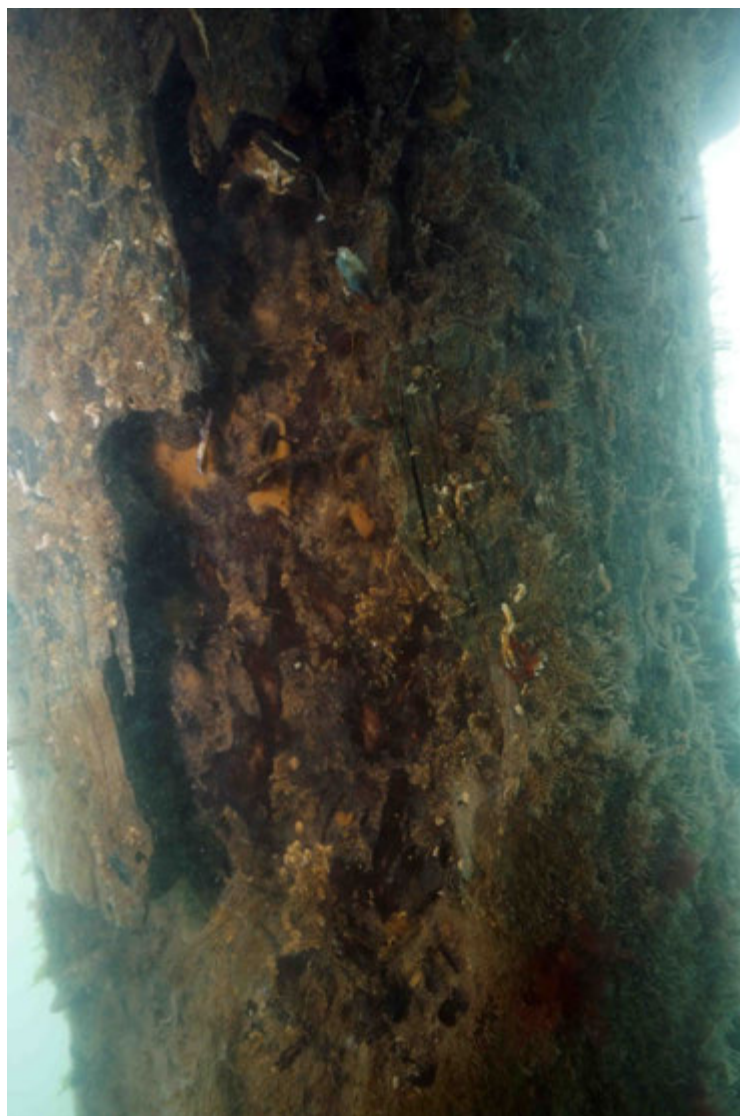
Pile 34D: Fair Condition – 30% loss of section – lower tidal zone
Note: Failed Wale Beams require removal

- For maximum protection of piles within Bents 25 – 47, a 3.0 metre length FRP Jacket is recommended to be installed to piles.

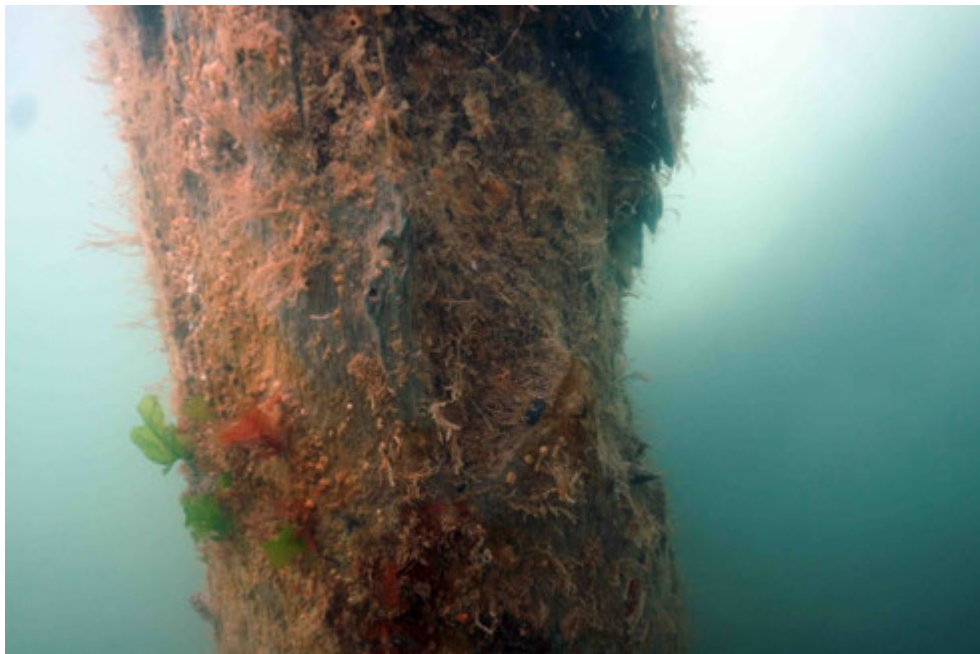
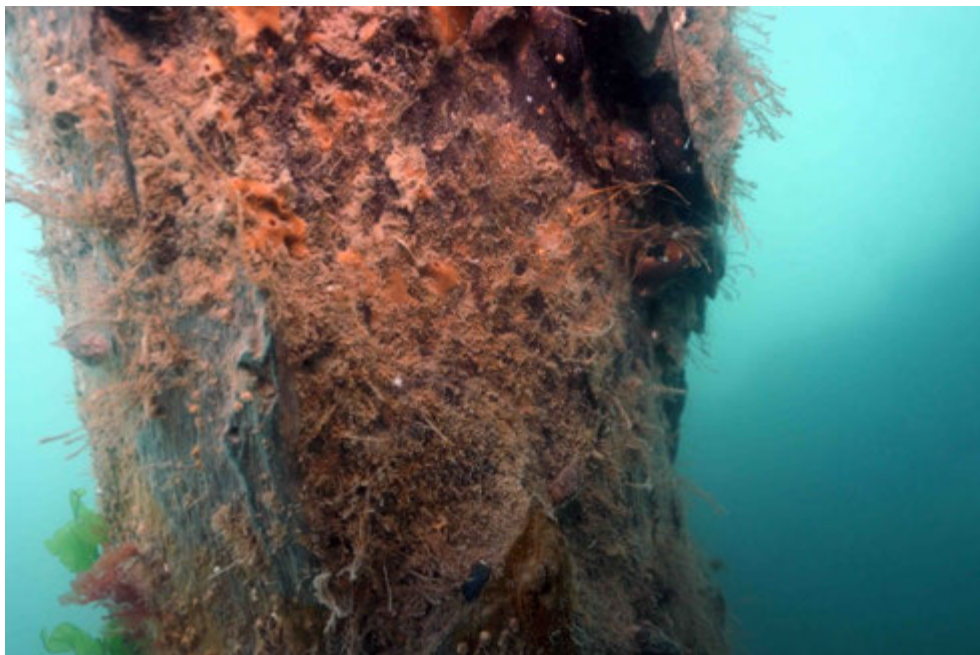
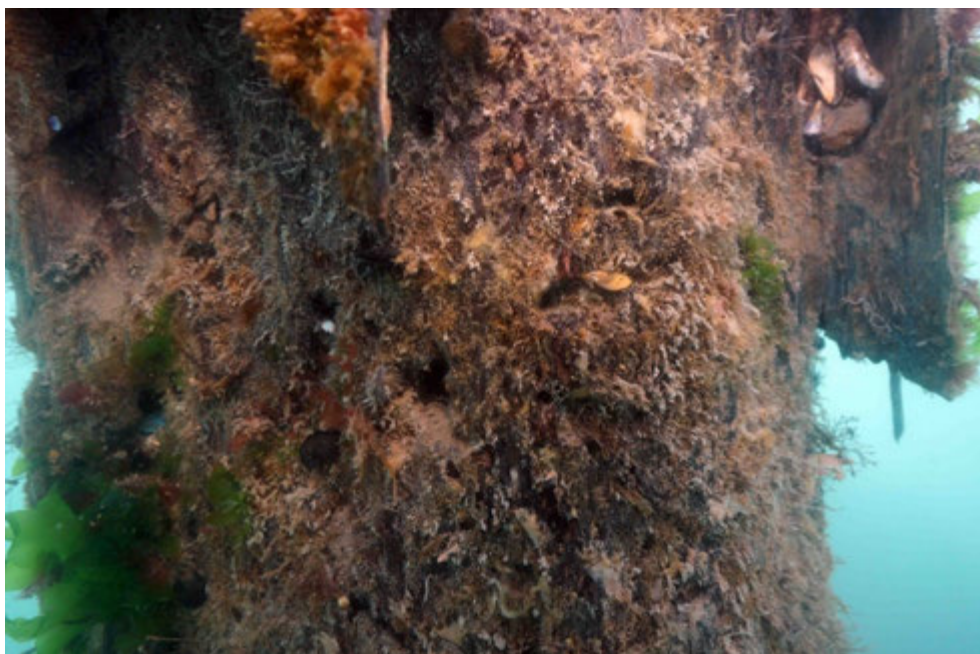
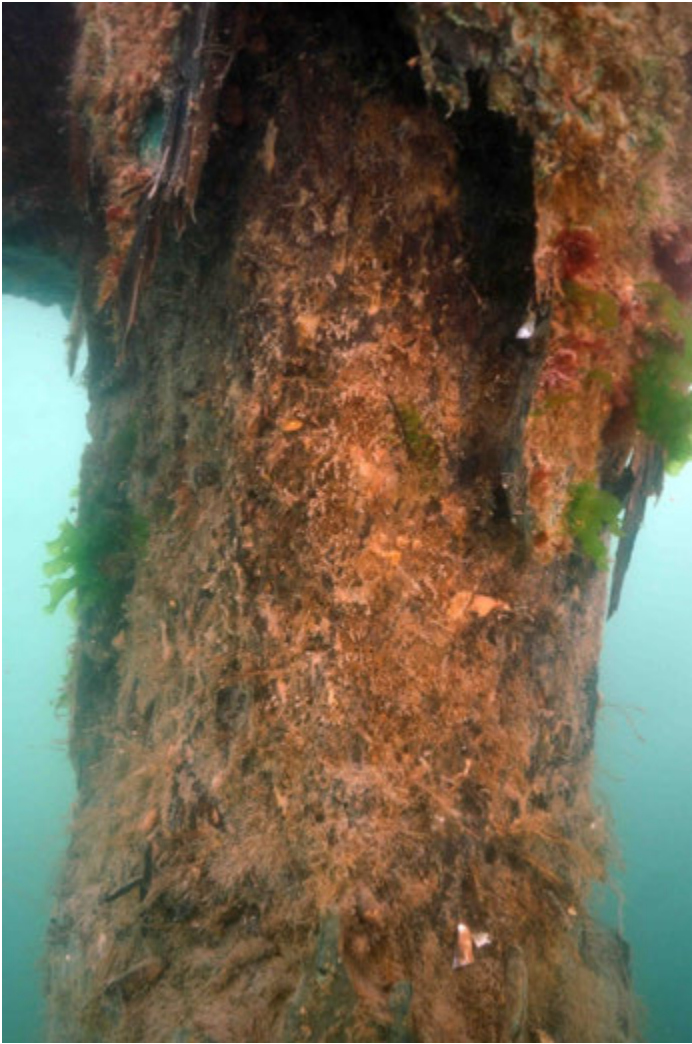
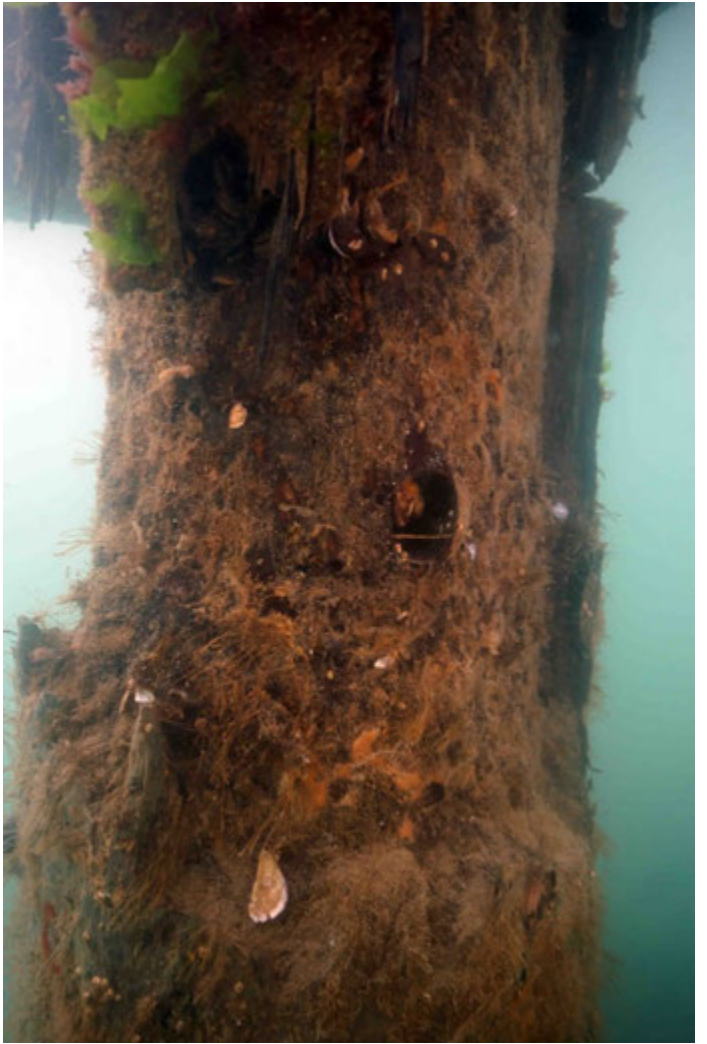
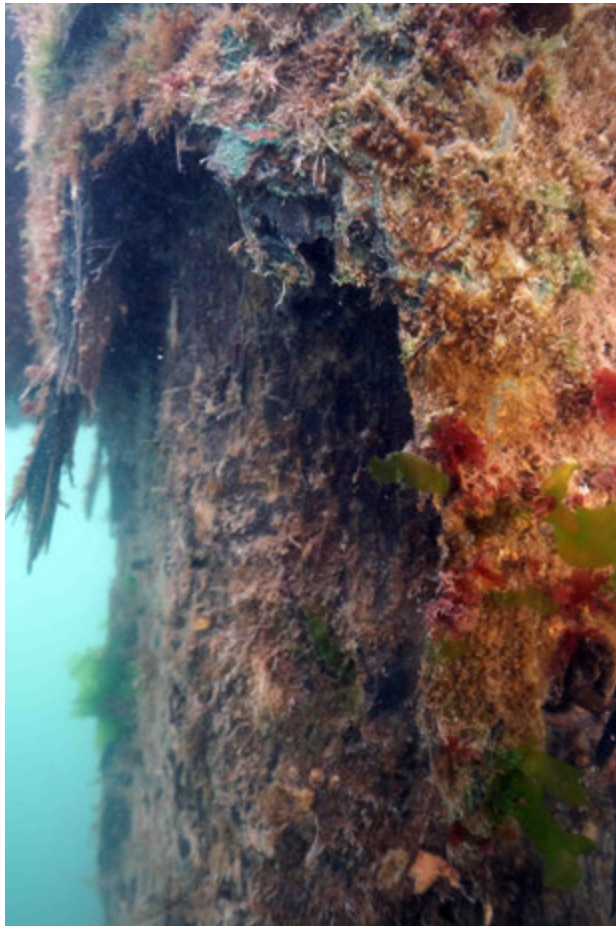
Pile 35C: Poor Condition – 40% loss of section – lower tidal zone

It's recommended that as an absolute minimum, all Piles with a Poor and Very Poor designation be repaired by remedial process immediately.

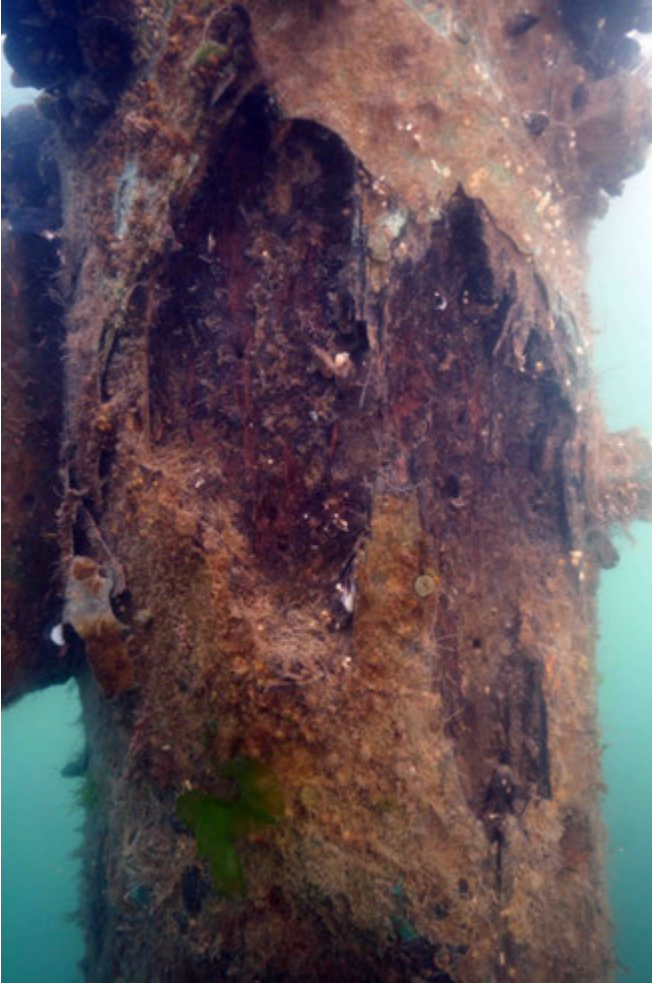
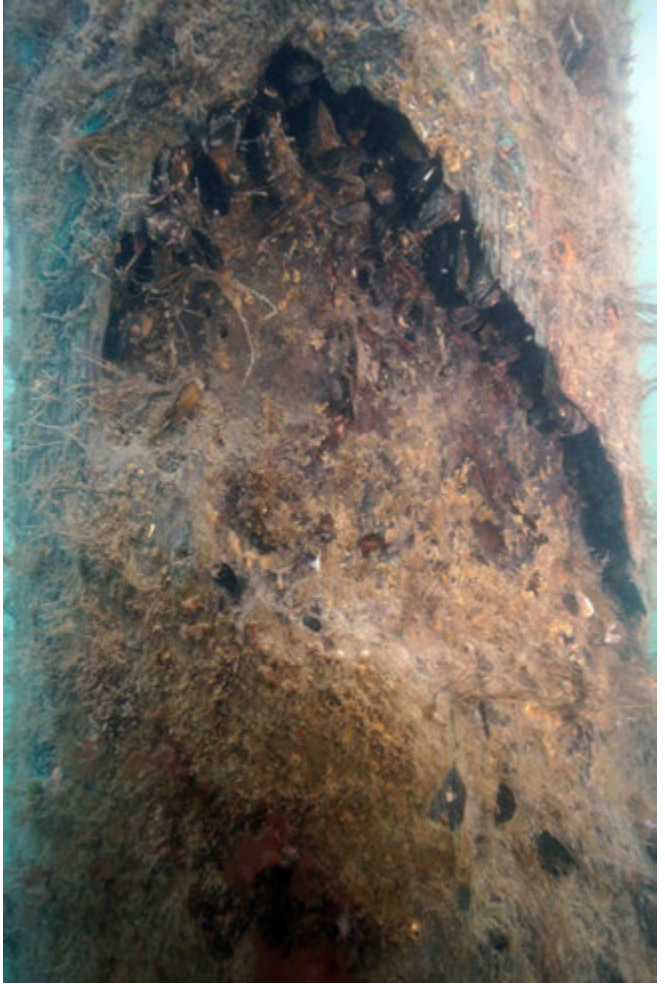
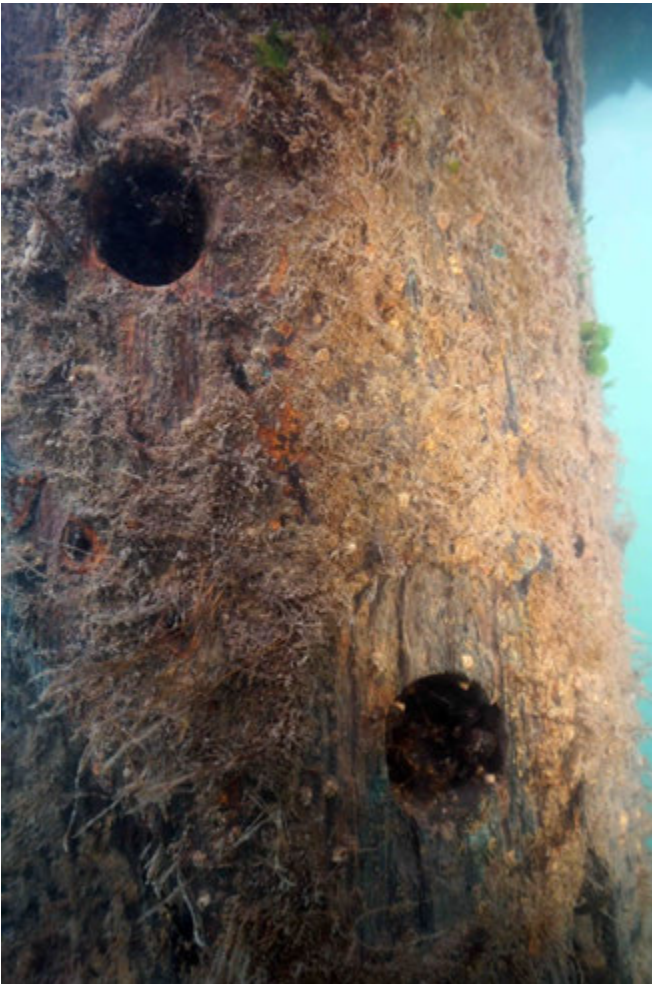
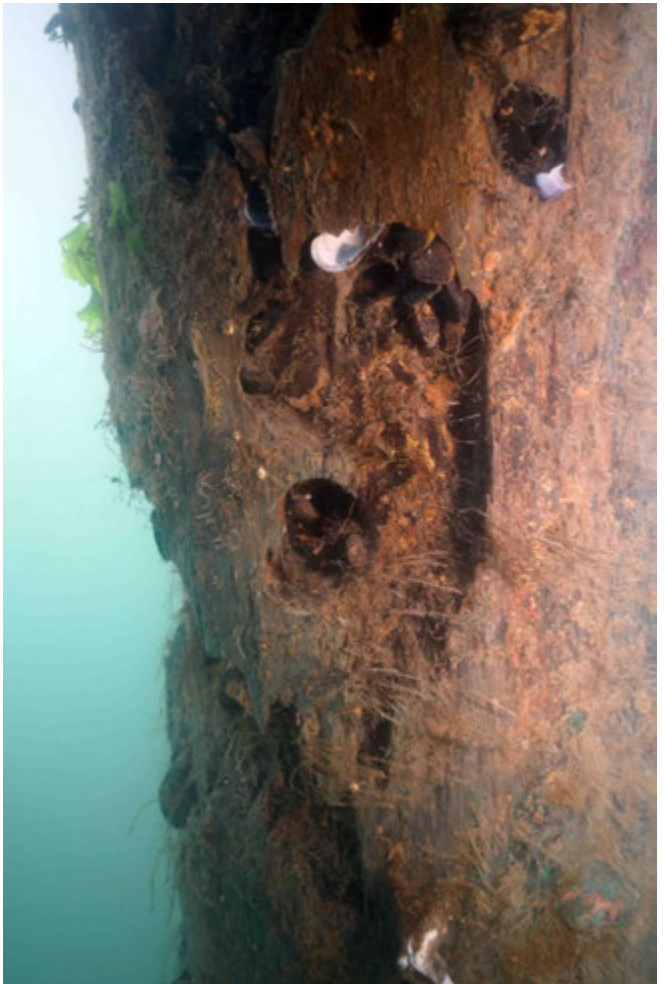
Pile 36C: Poor Condition – 35% loss of section – lower tidal zone. Moderate hollowing

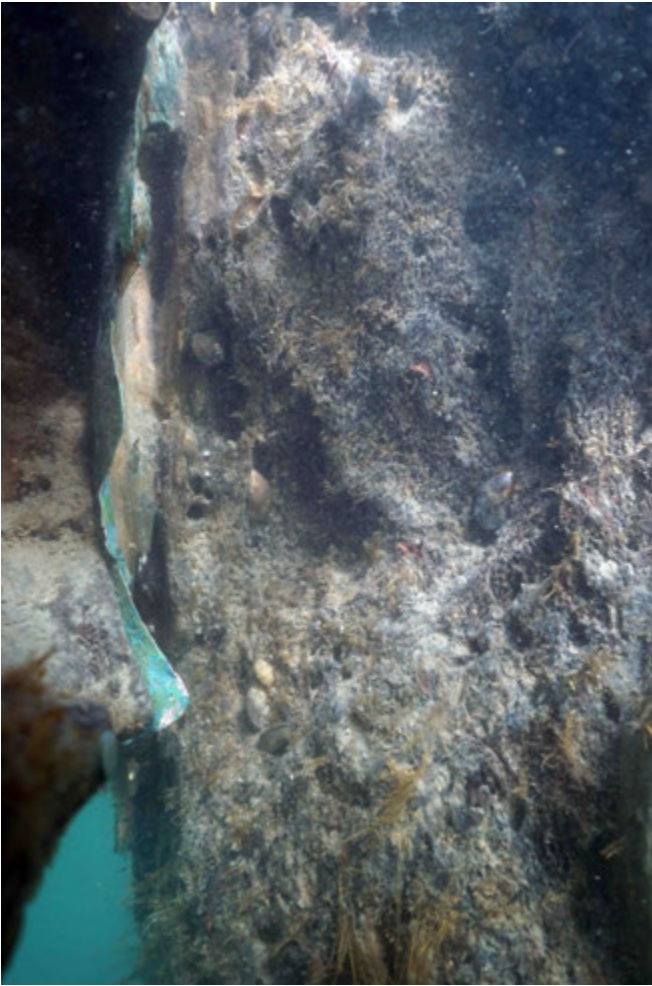
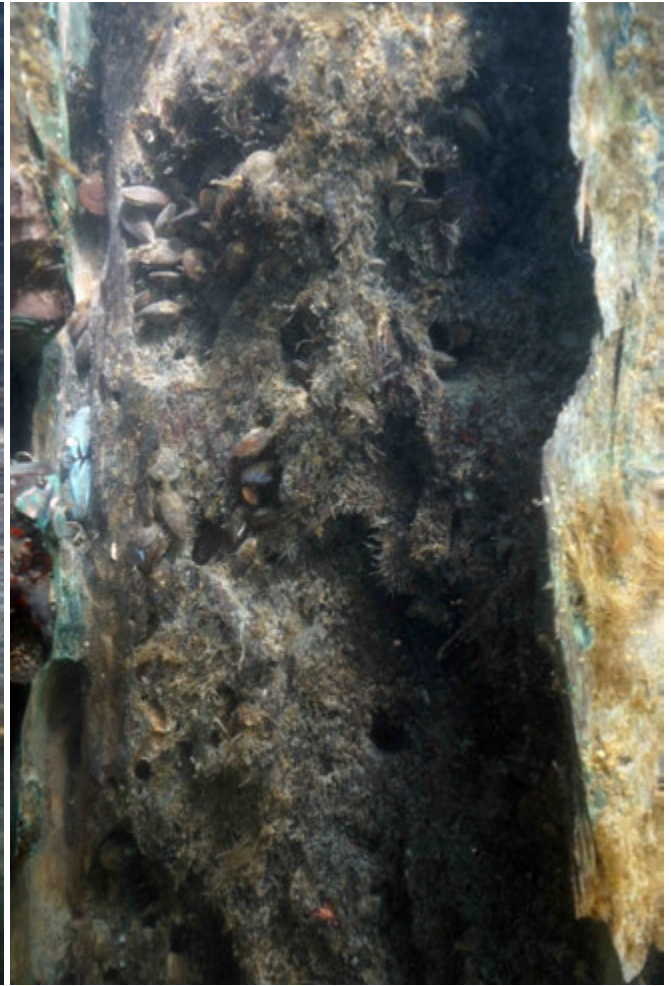
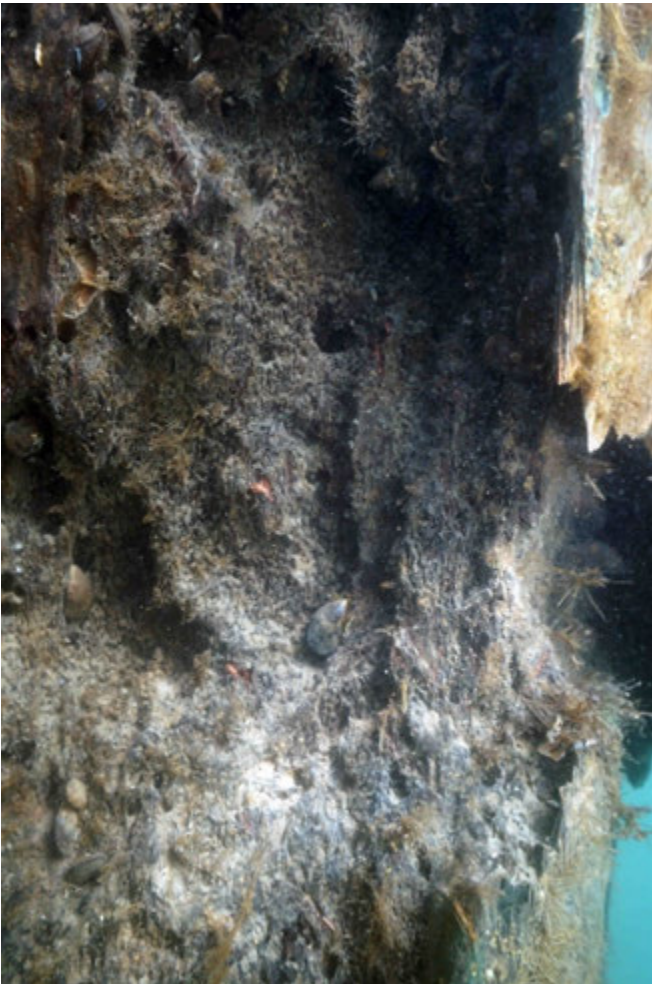
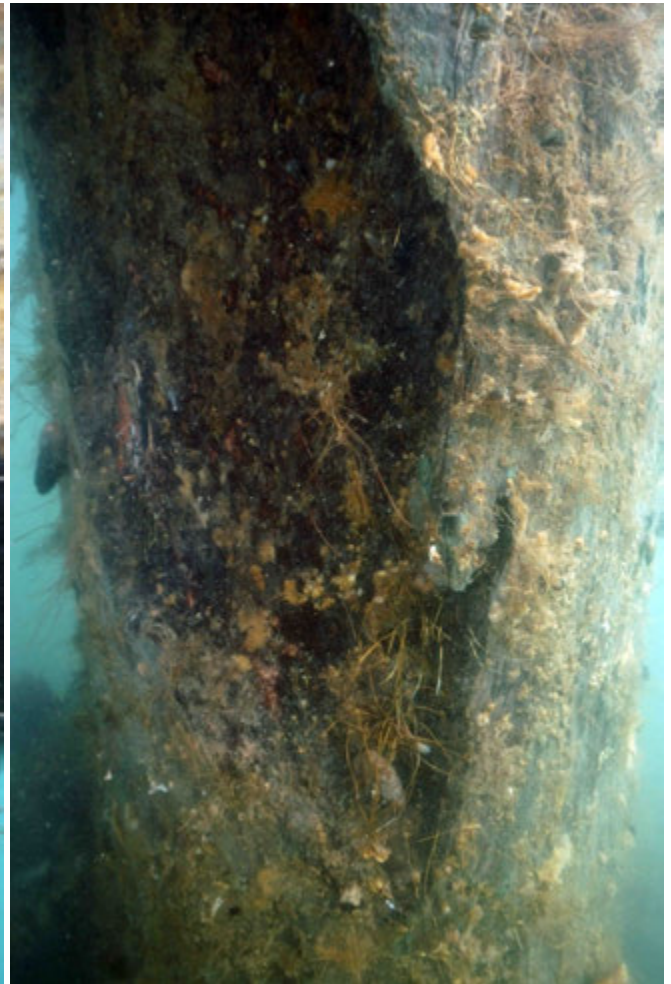
Pile 37C: Poor Condition – 45% loss of section – lower tidal zone to seabed

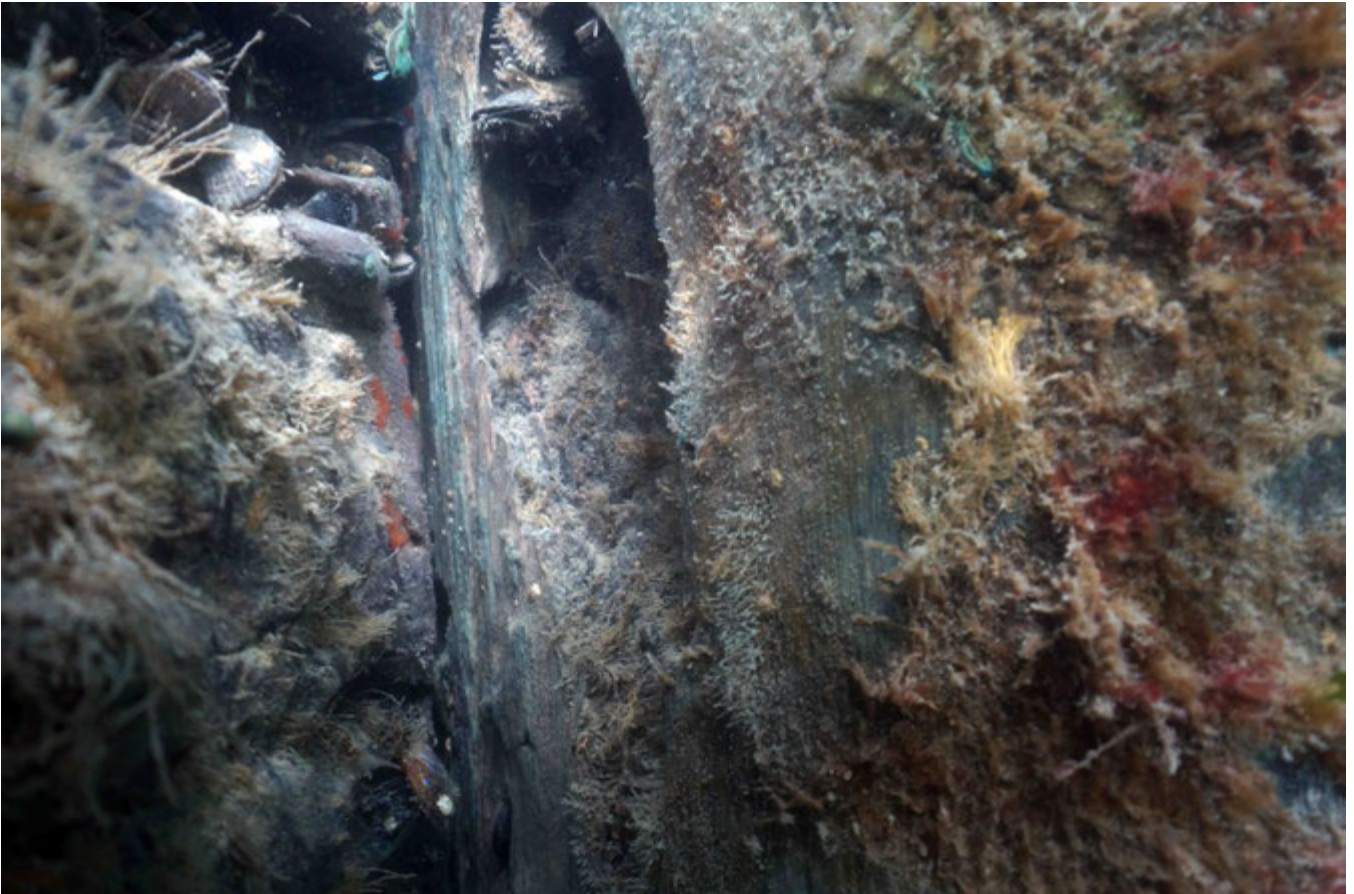
Pile 37D: Poor Condition – 35% loss of section – lower tidal zone

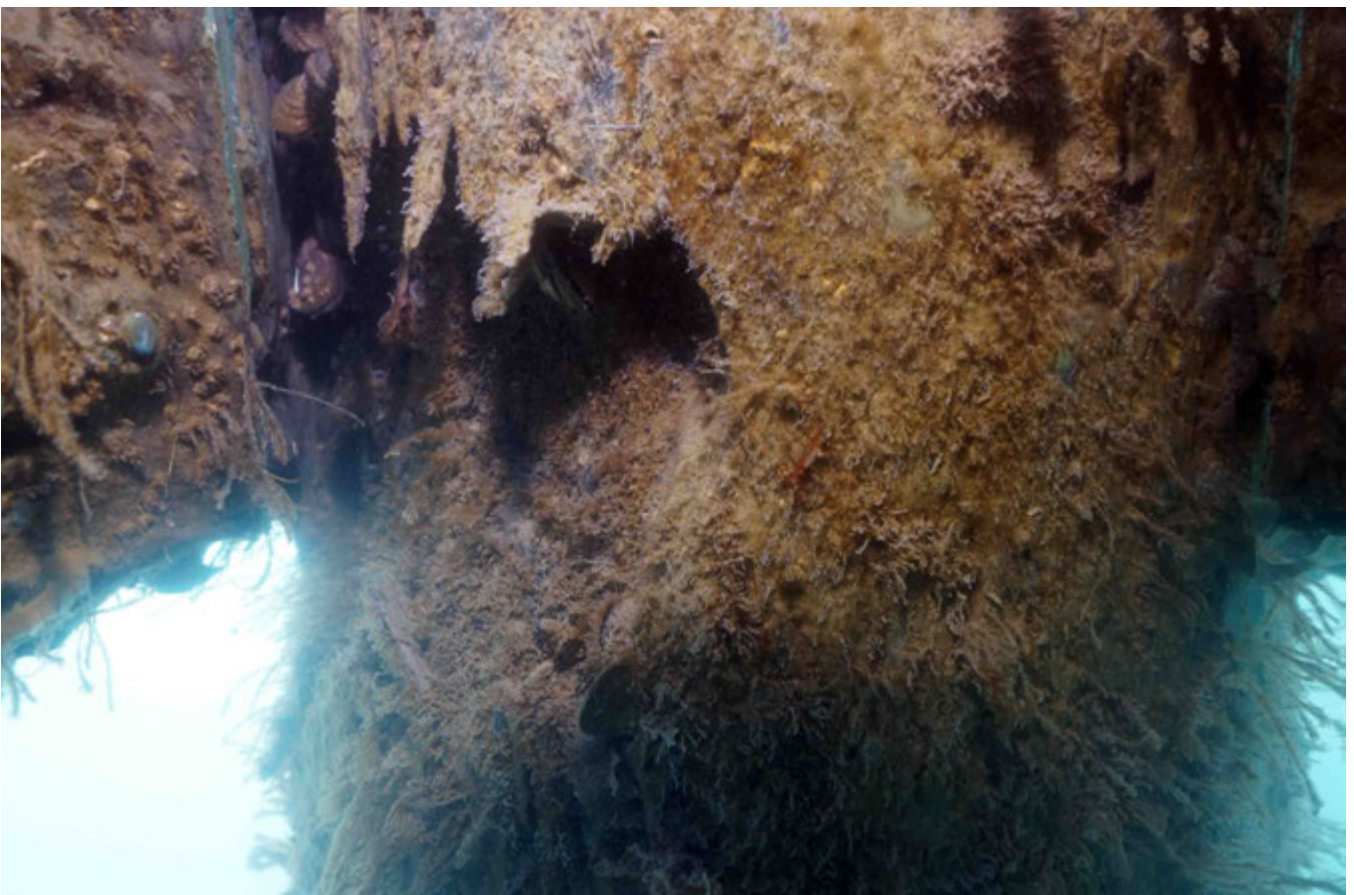
Pile 38D: Poor Condition – 35% loss of section – above tidal zone. Moderate hollowing & decay

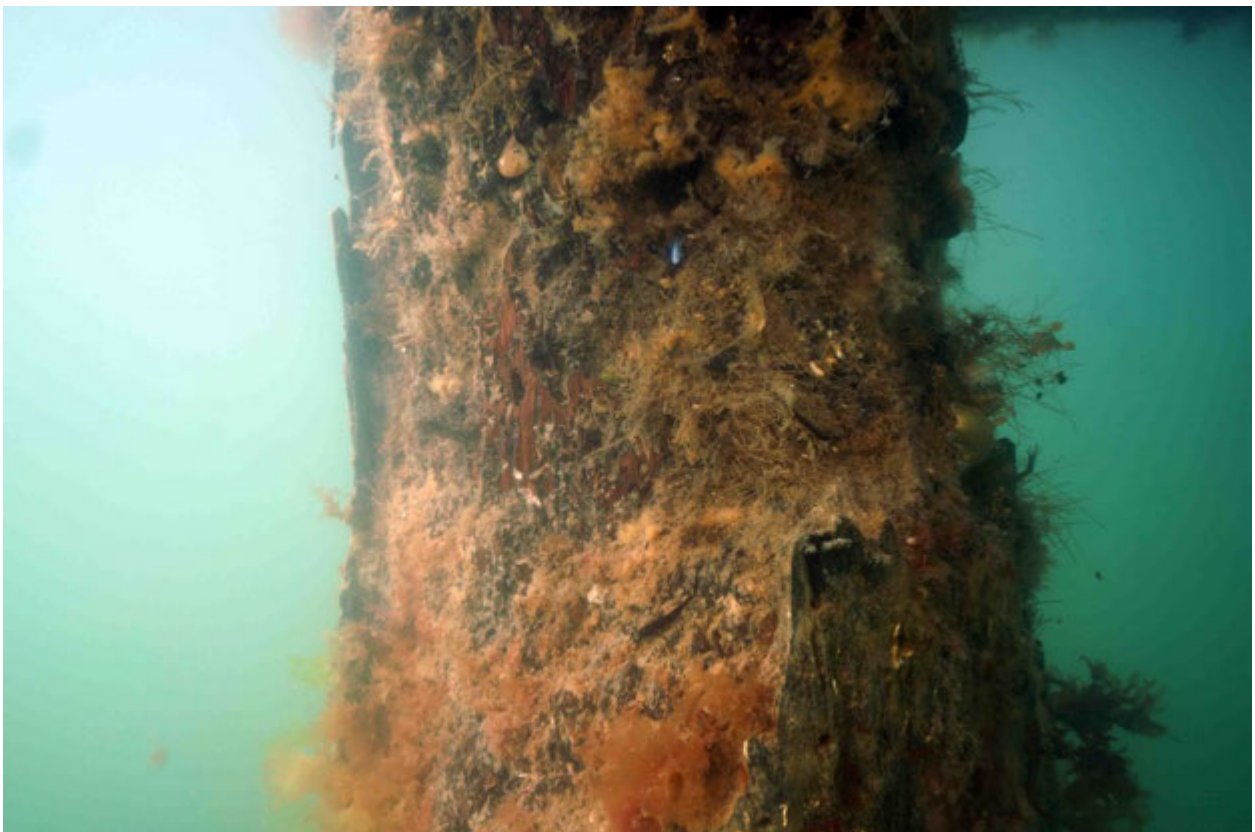
Pile 44C: Poor Condition – 40% loss of section – lower tidal zone. Top-end splitting
